Aviation Short Investigations Bulletin

Issue 34

ATSB Transport Safety Report
Aviation Short Investigations
AB-2014-138
Final – 3 September 2014

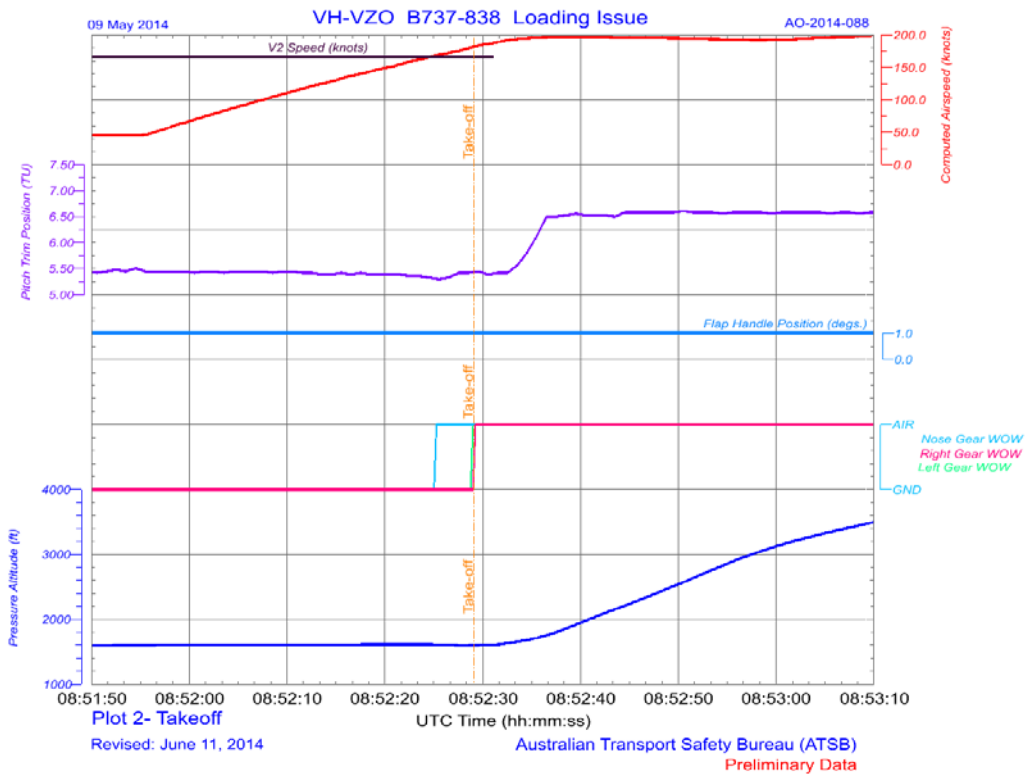
Figure 1: Flight data for the take-off phase

During the take-off, the aircraft appeared nose-heavy. To rotate the aircraft and lift off from the runway, the captain found that significant back pressure was required on the control column. Conscious of the potential of striking the aircraft tail on the runway if too much back pressure was applied to the controls, the captain maintained steady back pressure to ease the aircraft into the air. The aircraft exceeded the calculated take-off safety speed (V_2)¹ by about 25 kt. At $V_2 + 25$ kt, an exceedance was later detected during analysis of the aircraft quick access reference (QAR) data (Figure 1). The aircraft climbed at a higher initial climb speed than normal, which resulted in a slightly reduced climb gradient, but the crew did not receive any terrain or other warnings.

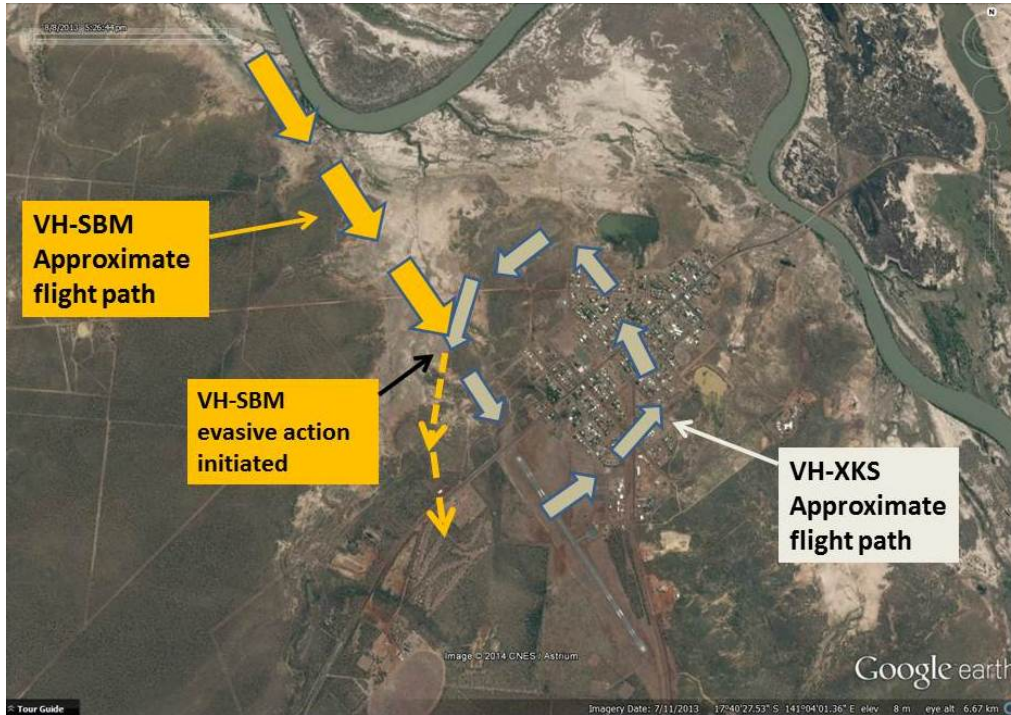
Figure 1: Flight paths approaching RWY 14 at Normanton

obscured by SBM’s engine nacelles, but was on a converging track about 50 ft below, and less than 50 m laterally.

Given the rate of descent and airspeed of the Kingair, the pilot quickly assessed that, without immediate evasive action, a collision was imminent. He initiated a climbing right turn, keeping the Saratoga in sight. He was aware that the Navajo that was approaching from the south was also due in the circuit, so he called the pilot of that aircraft to and advise of the conflict and his new intentions. He tried to make contact with the pilot of the Saratoga, but did not receive a response.

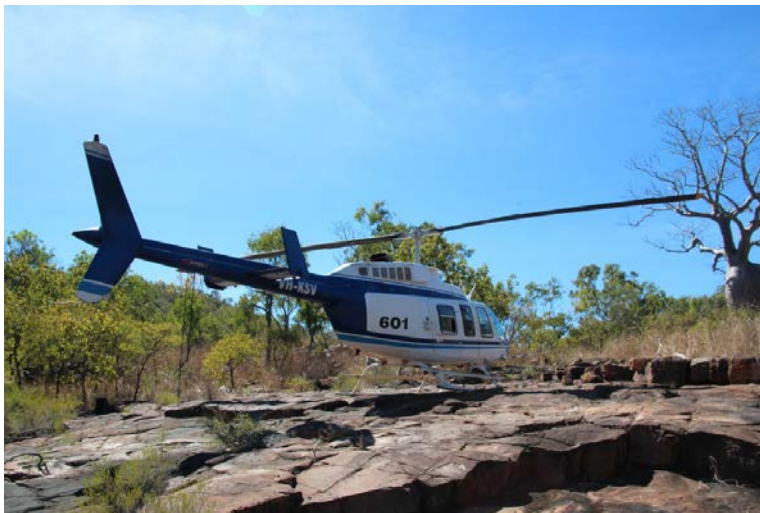
Figure 1: Landing site and KSV

As the helicopter descended over trees, the pilot observed that the helicopter was slightly higher than optimal for the approach, but still within limits for a safe approach. From a high hover, at about 10 ft AGL, the pilot continued to lower the helicopter slowly, and assess the landing area. The passengers were standing immediately behind the tree line, and the pilot elected to land towards the rear of a rocky sandstone platform to remain clear of the passengers. Behind the platform the ground sloped away, and from the air, during the approach, the pilot did not observe the slope to be overly steep (Figure 1).

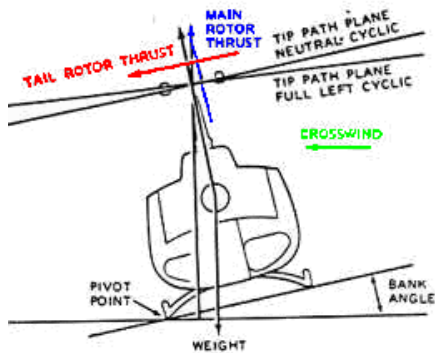
Figure 3: Dynamic rollover

Dynamic rollover is usually the result of the helicopter pivoting about a skid which remains in contact with the ground. In this incident, the long-line pulled taut under the skid and became the support under the pivot point resulting in a dynamic roll over (Figure 3).

During normal takeoffs to a hover and landings from a hover, cross slope takeoffs and landings, and takeoffs from the ground with bank angle or side drift a situation can exist where the helicopter will pivot about the skid/wheel which remains on the ground and enter a rolling motion that cannot be corrected with full lateral cyclic input.
