ATSB TRANSPORT SAFETY REPORT
Marine Occurrence Investigation No. 252
Final

Independent investigation into the grounding of the
Marshall Islands registered passenger ship

Van Gogh

at Devonport, Tasmania
23 February 2008

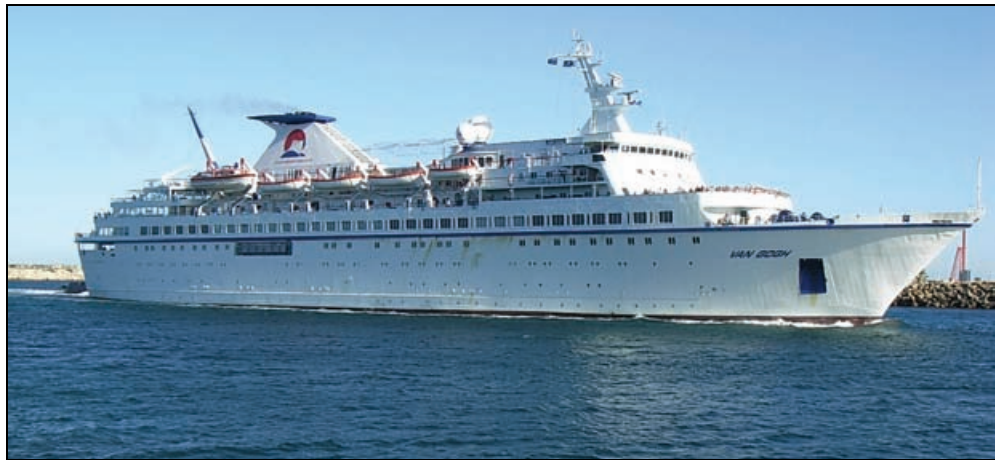
Figure 1: *Van Gogh*

Van Gogh is a Marshall Islands registered passenger ship (Figure 1). It is owned by Maritiem and Leasing, Bahamas and operated by Club Cruise Entertainment, Netherlands. It is classed as a ✕1A1 Ice-C Passenger Ship with Det Norske Veritas (DNV).

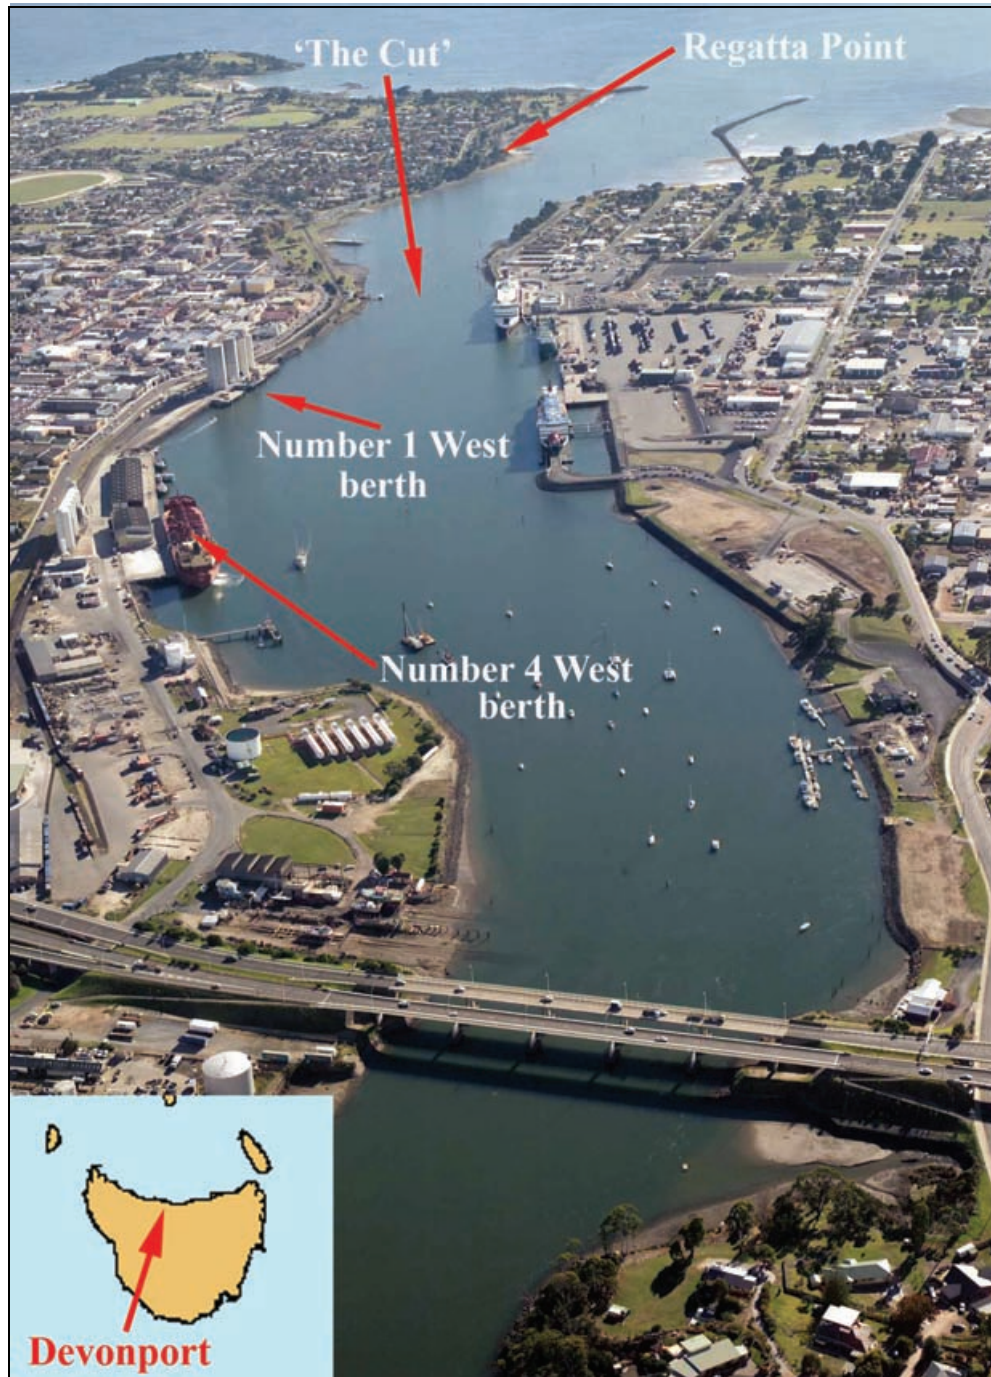
Figure 2: Aerial photo of Devonport and the Mersey River

Tidal streams, both flooding and ebbing, attain a rate of one to two knots inside the river. After heavy rain, fresh water outflows from the river's catchment, combined with an ebb tide, have been known to increase the rate of the tidal stream to up to four knots⁸. While there is a transmitting electronic tidal height gauge in the Mersey River, there is no current meter capable of measuring and transmitting the speed of the current.
