**ATSB TRANSPORT SAFETY REPORT**  
Marine Occurrence Investigation No. 253  
Final

Independent investigation into the engine room fire  
on board the Marshall Islands registered container ship

# **MSC Lugano**

off Esperance, Western Australia  
31 March 2008

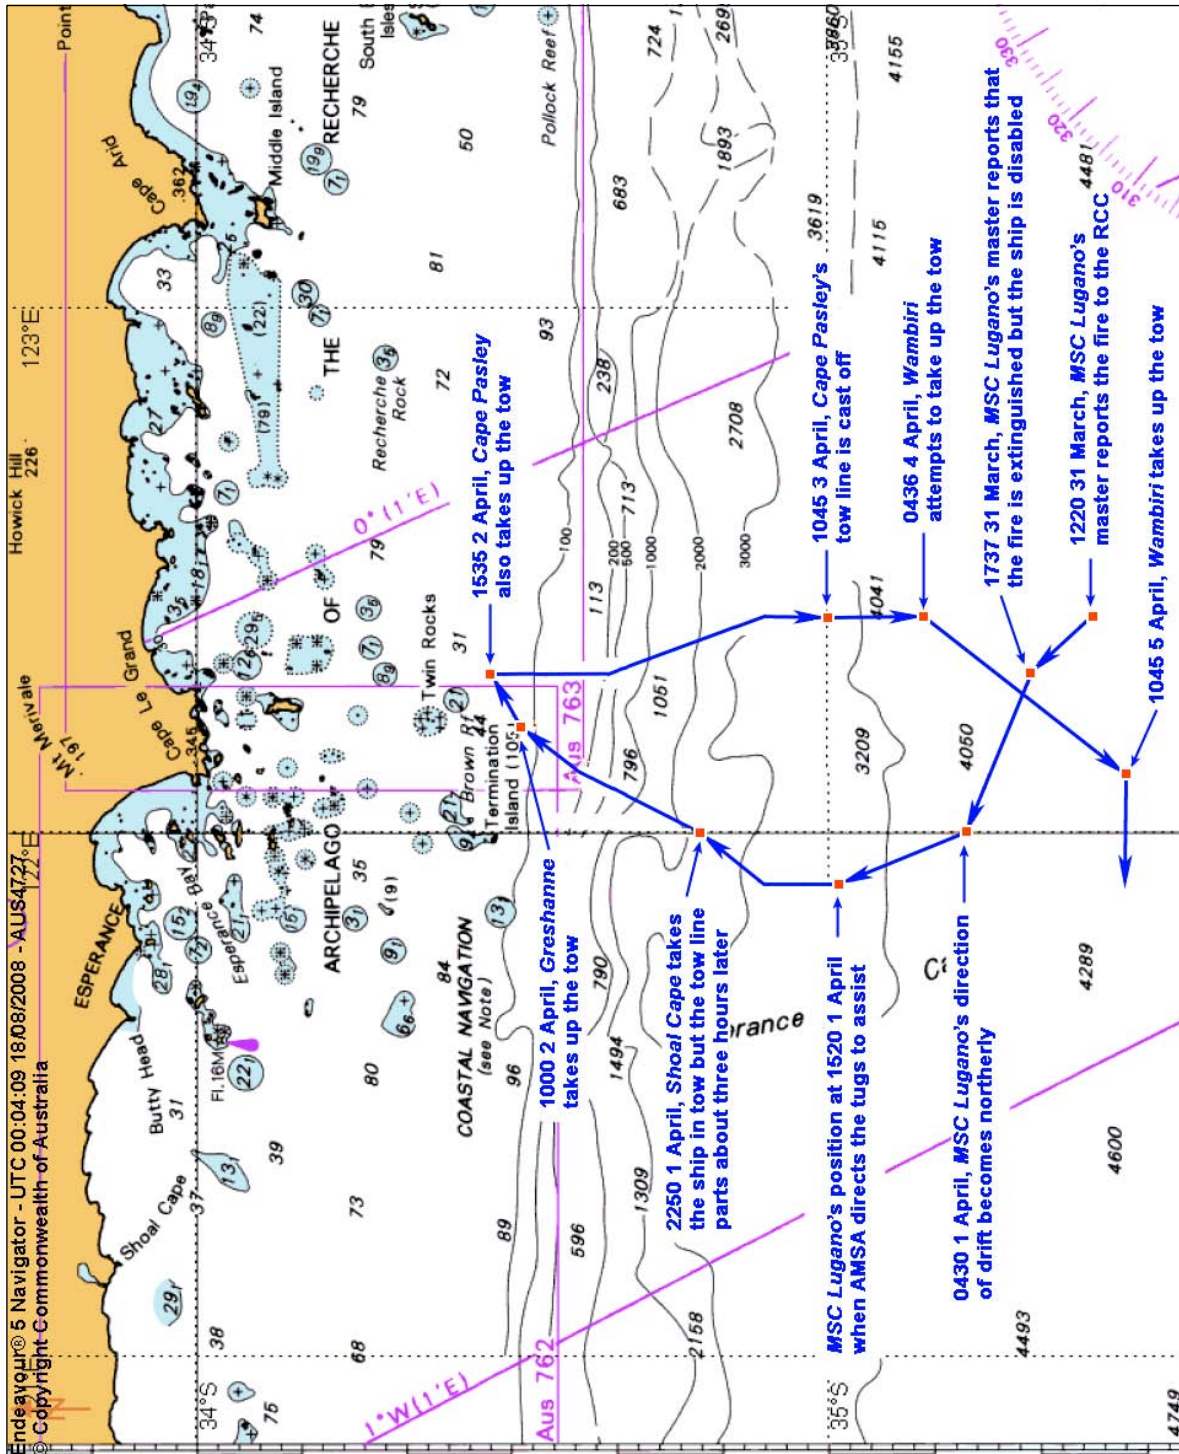
Figure 11: Section of navigational chart Aus 4727 showing the ship's track from the time the fire was reported to the RCC until *Wambiri* successfully took the ship in tow

The ship was now about 60 miles south of the outer edge of the Archipelago of the Recherche (Twin Rocks), and drifting in a north-westerly direction (Figure 11). The wind was from the southwest at force four (11 to 16 knots) with a moderate south-westerly swell. The weather forecast indicated that over the next 24 hours the wind would increase to force six to seven (22 to 33 knots) and that the sea would build to two metres on a two metre swell.

By 1000, *Greshanne*'s tow line had been made fast to the ship. However, the ship was only about seven miles south of Twin Rocks and an uncharted area within the Archipelago of the Recherche and it was drifting northwards (Figure 11). The wind was now from the south-southwest at force seven (28 to 33 knots) and the swell had increased to about three metres.

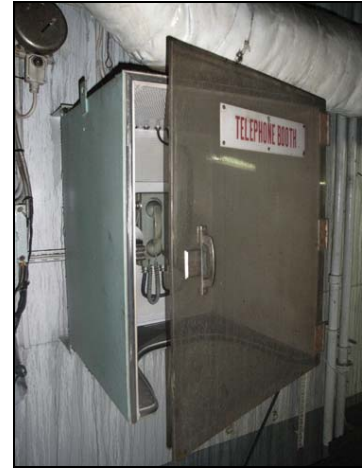
**Figure 23: Undamaged booth**

As the primary fire developed, it engulfed a telephone booth located near the engine control stand, destroying it (Figure 22). When this occurred, the perspex door fitted to the telephone booth (Figure 23) caught fire. The burning liquid perspex dripped downwards and landed behind a shadow board located directly below (Figure 21). Pieces of timber stowed behind the shadow board were then ignited by the burning perspex and a fire started in this area, eventually engulfing the oily water separator.
