Descent below the minimum permitted altitude involving Boeing 737-838, VH-VXB

35 km SW of Canberra Airport, Australian Capital Territory | 17 October 2012

ATSB Transport Safety Report
Aviation Occurrence Investigation
AO-2012-138
Final – 29 October 2014

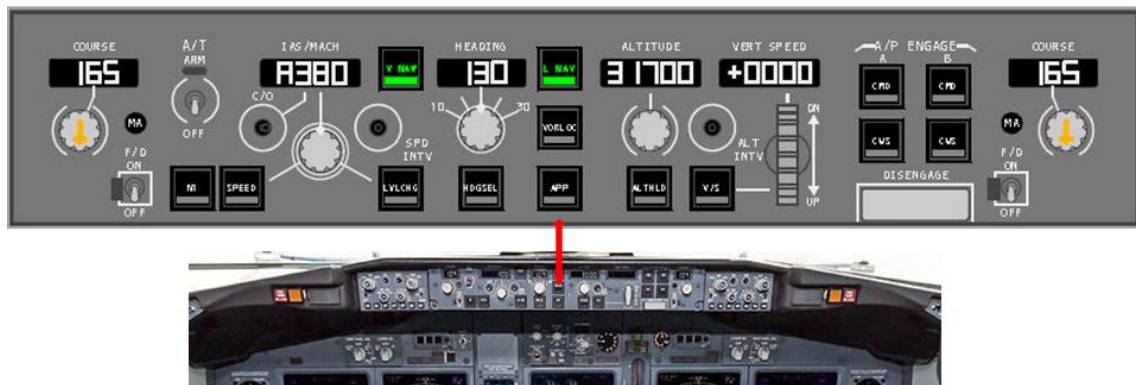
Figure 2: Glareshield with expanded MCP

As the FO responded to the ATC clearance at 2044:57, the captain changed the altitude in the MCP to 7,000 ft, which removed the 8,000 ft ALT ALERT warning. As a result of changing the MCP altitude while in the ALT ACQ mode, the autopilot changed its vertical control mode from the FMC-calculated vertical path (VNAV PTH) to vertical speed (V/S). On entering the V/S mode, the MCP airspeed and vertical speed windows (the IAS/MACH and VERT SPEED labelled windows at Figure 2) opened and displayed the current airspeed of 310 kt and rate of descent of 3,400 fpm.

The aircraft continued to descend at about 3,000 fpm in the CWS P mode until at 2045:21, as the aircraft descended through about 7,400 ft, the captain selected the level change (LVL CHG) mode on the MCP (Figure 2). The captain reported expecting that the automation would have reduced the airspeed to 250 kt by 7,000 ft, as set up in the FMC before commencing the descent. However, as the aircraft passed about 7,200 ft, it became evident that the automation was not slowing the aircraft sufficiently, so the captain selected the V/S mode with the aim of levelling the aircraft and reducing the airspeed. The selection of the V/S mode caused the VERT SPEED window to open at the current rate of descent, which the captain then reduced to zero. At 2045:33, the captain reduced the MCP airspeed from 274 kt to 250 kt and observed that the aircraft had inadvertently descended below the VNAV PTH. The captain's intention was to correct this condition by reducing the airspeed to 250 kt in level flight and then re-intercept the VNAV PTH from below.

CWS may be engaged through the selection of the CWS switch on the MCP (Figure 2) or, when the autopilot is engaged, through either deselection of the current pitch or roll mode or by the application of force to the control column. When CWS is engaged, the autopilot manoeuvres the aircraft in response to the control pressures applied by either pilot to the control column. When control pressure is released, the autopilot maintains the current attitude. CWS disengages the respective AFDS mode; that is CWS R/CWS P disengages the respective AFDS roll/pitch modes, which in turn is reflected by the blanking of the FMA roll/pitch indication and display of the CWS P/CWS R annunciators. The CWS P mode may engage independently of CWS R due to control wheel pressure.

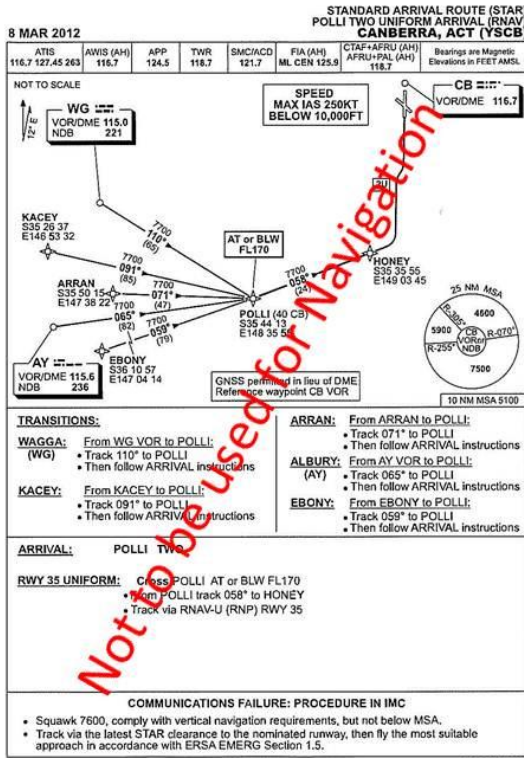
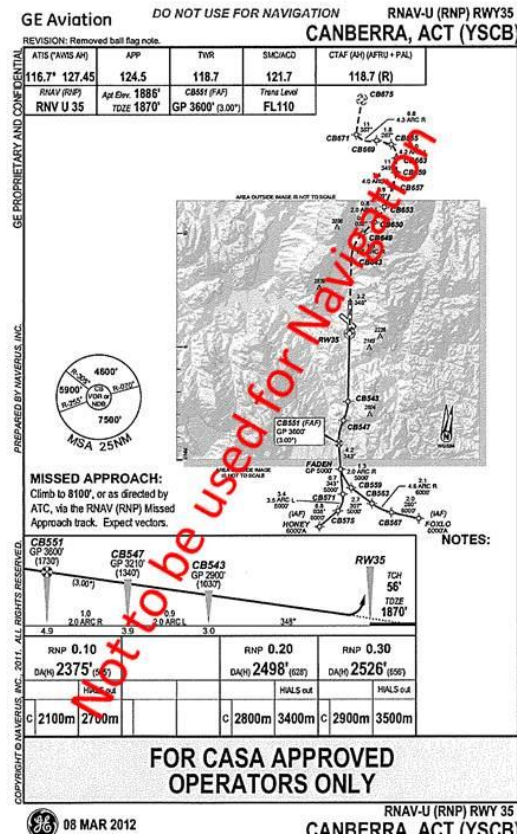
Appendix B – Relevant Canberra instrument approach charts

The flight crew were using a Qantas-issued Jeppesen chart for the RNAV-U (RNP) RWY35 approach (see Figure 1). This chart had a segment altitude of 6,000 ft between HONEY and CB575, meaning aircraft could not descend below 6,000 ft in that segment. However, there was no altitude restriction displayed on the chart, or in the aircraft's FMC database for HONEY itself. Airservices Australia also published a chart relating to the approach, for the awareness of other operators. This chart included an altitude limitation of not below 6,000 ft at HONEY.
