Aviation Short Investigations Bulletin

Issue 30

ATSB Transport Safety Report
Aviation Short Investigations
AB-2014-064
Final – 26 May 2014

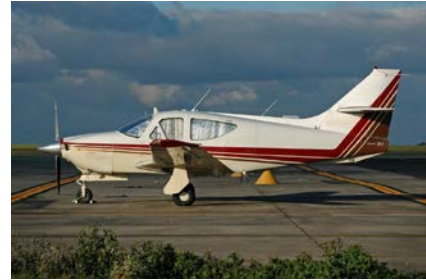
Rockwell 114

The pilot indicated he did not remember hearing the aircraft's landing gear warning horn at any stage during the landing.

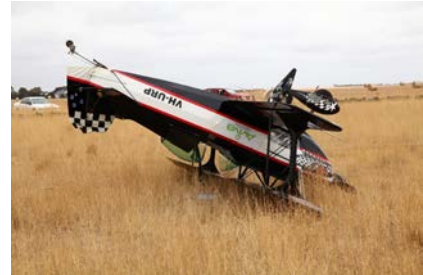
Figure 1: Damage to VH-URP

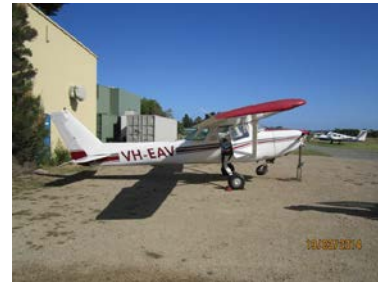
VH-EAV

After the accident, the pilot observed the windsock veering in an arc from the south-south-east to south-south-west and reported that windshear may have contributed to the incident.

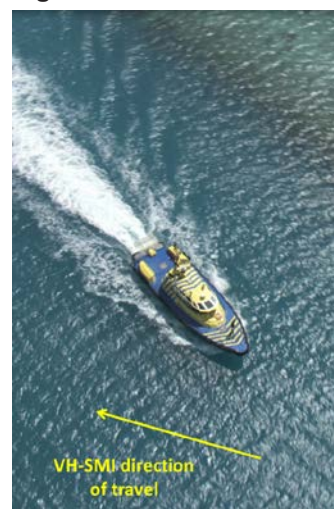
Figure 4: Prior to LTE

After having completed the film shot (Figure 4), when at about 450 ft, the helicopter entered an uncommanded yaw right by about 25-30° and started to experience a loss of tail rotor effectiveness (LTE). In response, the pilot attempted to manoeuvre the helicopter into wind by applying forward and left cyclic.¹ The pilot reported that the helicopter rotation stopped, but shortly after, it began to yaw right again. The pilot believed that he was not going to be able to recover from the situation.

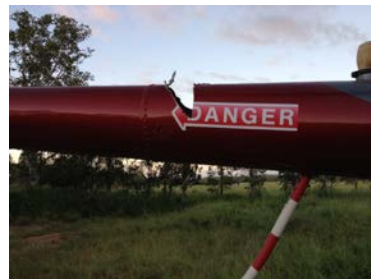
Damage to VH-YY5

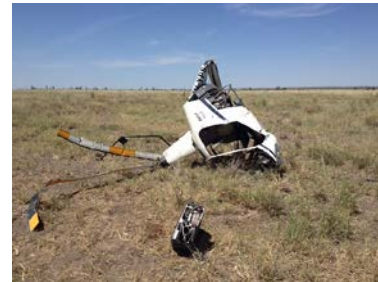
Damage to VH-YPS
