# Derailment of freight train 3MP9

East of Malbooma, South Australia | 10 April 2014

**ATSB Transport Safety Report**  
Rail Occurrence Investigation  
RO-2014-006  
Final – 25 March 2015

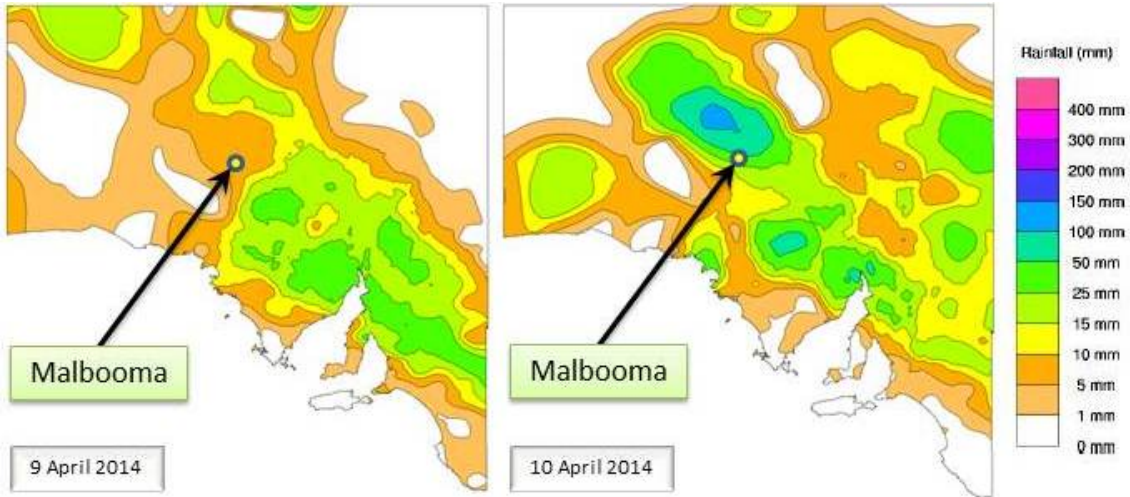
**Figure 4: Daily rainfall intensity maps - April 2014**

The rainfall persisted, breaking April daily rainfall records over many inland areas of South Australia (Figure 4). The BoM data showed that in April 2014, rainfall in South Australia was 257% above the monthly average, with record-breaking rains falling on April 9 and 10.

It was evident that widespread rainfall in the Northwest Pastoral District, and heavy rain at several locations (Figure 4), resulted in water flowing against the track formation in a number of areas between Kingoonya (about 80 km east of Tarcoola) and Malbooma. The extent of flooding that occurred through the derailment site was witnessed by the drivers of train 3MP9 and visible evidence of debris deposited on the track formation remained after the water had subsided.

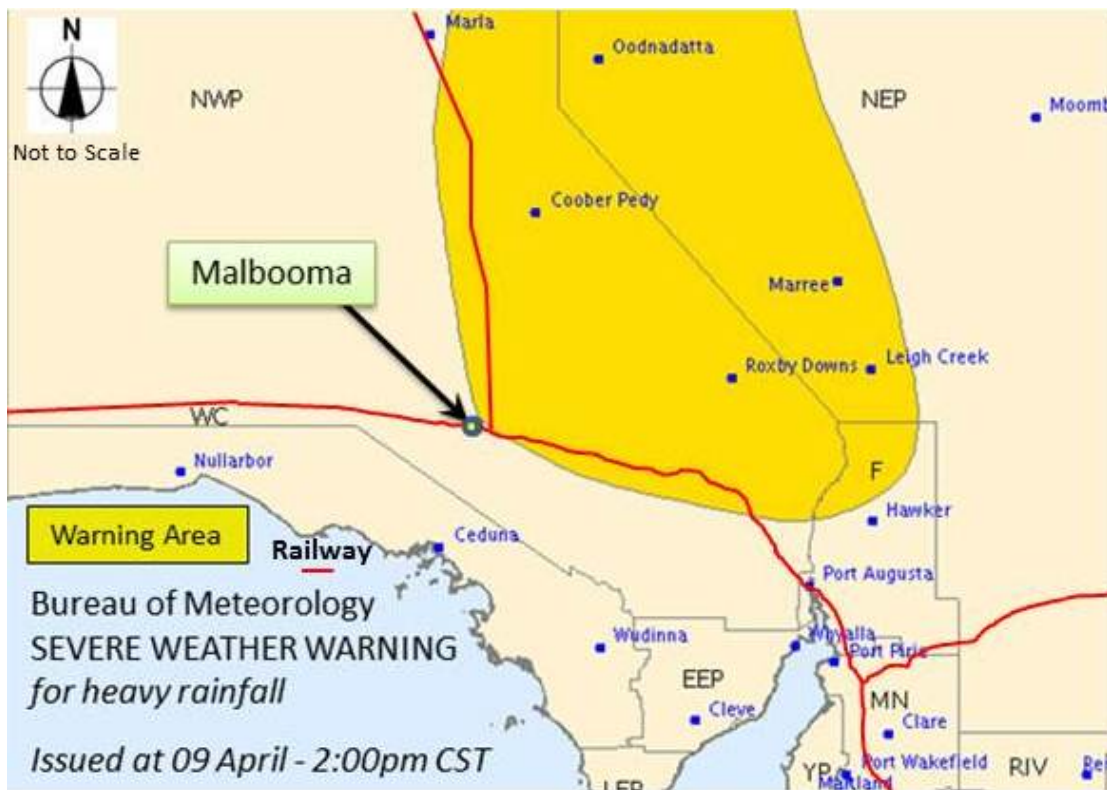
**Figure 7: Severe Weather Warning Alert – 1400 - 9 April 2014.**

The warning at 1400 (Figure 7) forecast areas of heavy rain and isolated thunderstorms and these were expected to extend further south. This was the third warning of the day and the first to include a large section of track between Port Augusta and Malbooma. The forecast stated that 60 - 100 mm of rain may fall, leading to flash flooding within the affected area.

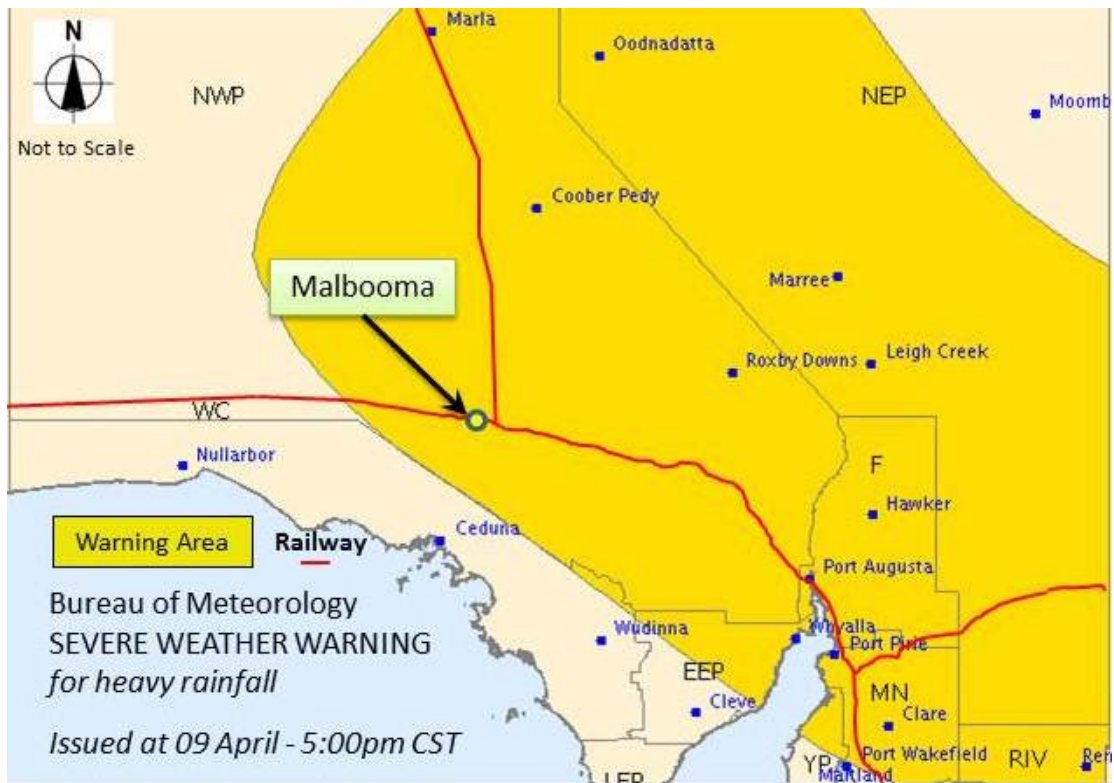
Figure 8: Severe Weather Warning Alert – 1700 - 9 April 2014.

The warnings at 1700 and 1951 were almost identical; forecasting thunderstorms and flash flooding for the Northwest and Northeast Pastoral, Flinders, Mid North and Riverland districts extending south-east to parts of Eyre Peninsula, Yorke Peninsula and the Murraylands (Figure 8).

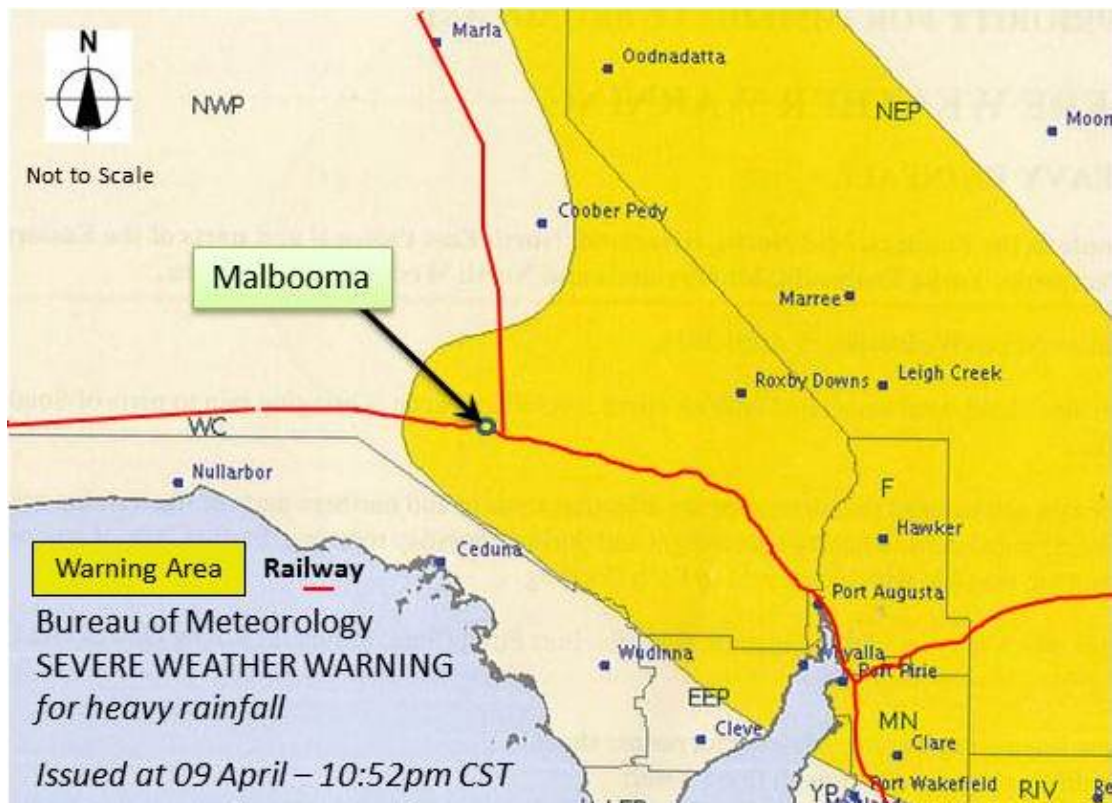
Figure 9: Severe Weather Warning Alert – 2252 - 9 April 2014.

As the weather system travelled in a south-easterly direction, the EWN warning issued at 2252 (Figure 9) remained over the Malbooma region. Rainfall between 50 - 80 mm was forecast for all previously affected regions and was expected to continue during the morning of 10 April.

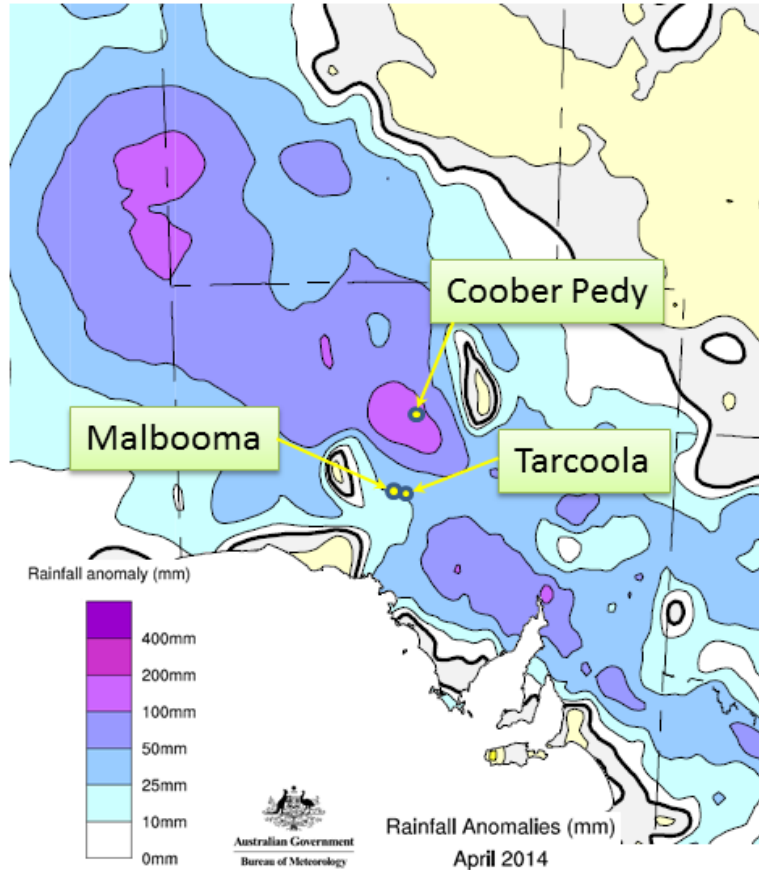
**Figure 10: Rainfall anomalies map of Central and South Australia – April 2014**

An anomalies map published by the BoM for April 2014 (Figure 10) showed areas of concentrated rainfall throughout South Australia, including localities north of Tarcoola. The BoM monthly rainfall summary also reported the 115 mm of rain at Coober Pedy airport on 10 April 2014 was the highest daily rainfall for more than 20 years.
