Derailment of freight train 3PS6

Yunta, South Australia | 17 January 2013

ATSB Transport Safety Report
Rail Occurrence Investigation
RO-2013-002
Final –26 May 2015

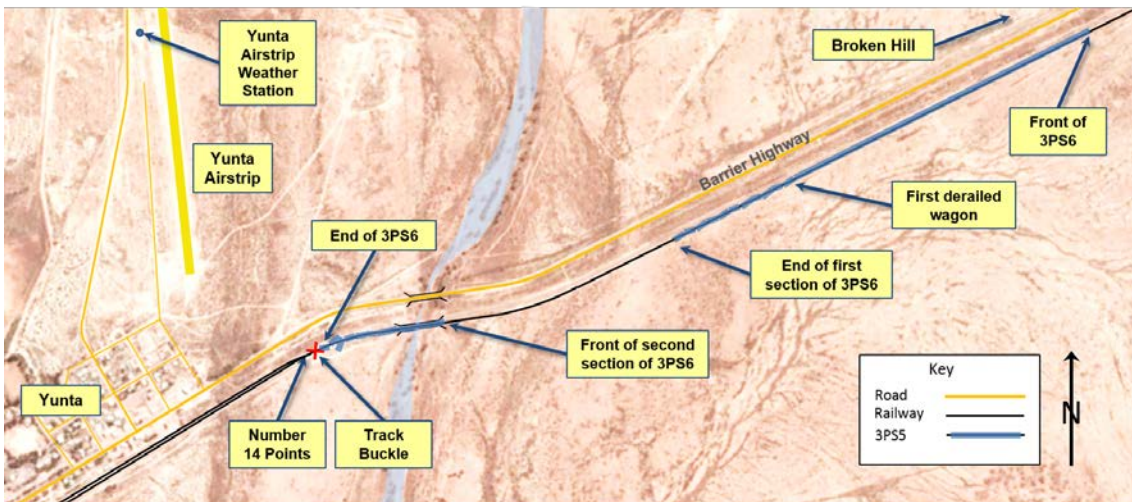
Figure 3: Map of derailment site showing location of 3PS6 and track buckle

The crew found that the rear 19 wagons of the 52 wagons hauled by train 3PS6 had derailed, with the last 11 of these wagons separated from the front portion of the train by approximately 800 m (Figure 3). The last wagon of the train stopped approximately 30 m past number 14 points and a notable track buckle was evident between the train and the turnout.

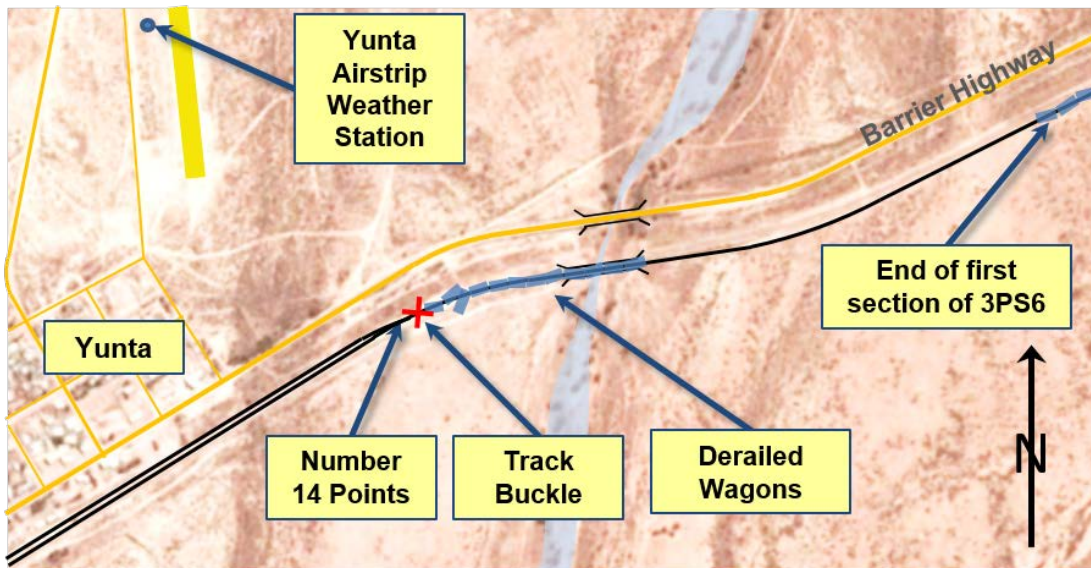
Figure 4: Map of derailment site showing location of 3PS6 and track buckle

Yunta is in South Australia, approximately 280 km north-northeast of Adelaide (Figure 1). Situated at the 196 km mark², Yunta is the location of a crossing loop and the derailment occurred on the main line immediately after number 14 points at the north eastern end of the loop (Figure 4). Train control was provided by the Australian Rail Track Corporation (ARTC) from a network control centre located at Mile End in Adelaide.

of large radius curves at the north eastern end of the loop (Figure 4). The first curve started before the end of the crossing loop and number 14 points were located approximately 1/3 into this curve, forming a short tangent in the curve.

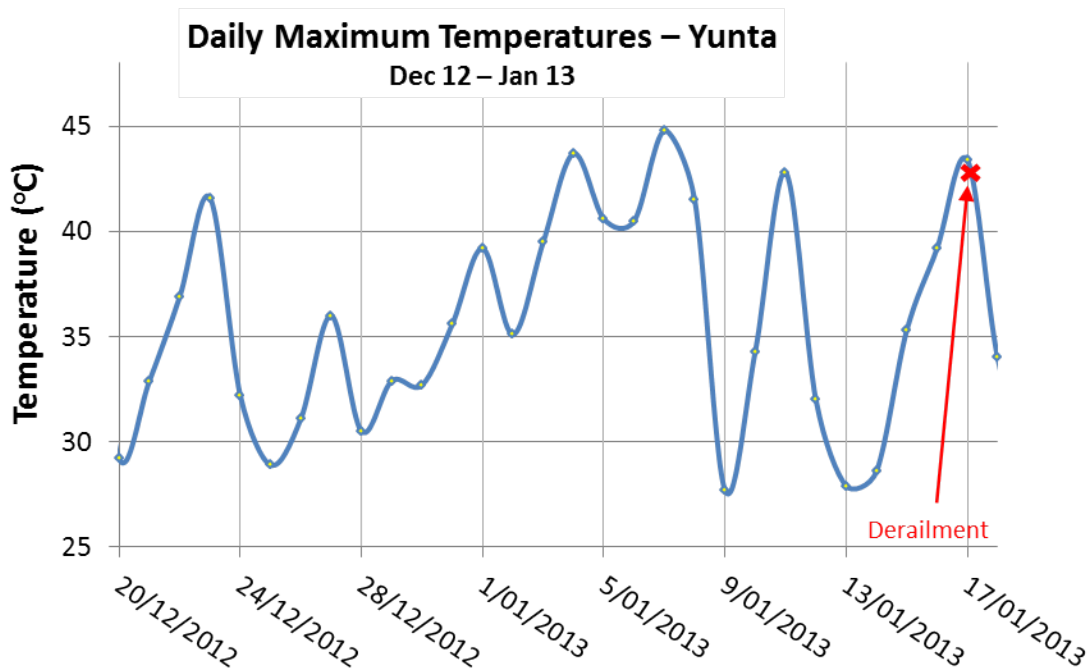
Figure 8: Daily maximum temperatures at Yunta (December 2012 - January 2013).

Figure 8 illustrates the maximum temperatures for Yunta over the month leading up to the derailment. Eight days in that period had daily maximums higher than 40 °C. The graph shows the daily maximum temperatures climb over a number of days then drop quickly. A succession of progressive temperature increases followed by sudden drops can result in the accumulation of compressive force in the rail, effectively reducing the track's ability to remain stable at higher temperatures. This process is progressive and can take many years to have an impact upon the rail's neutral temperature. However if the rail's neutral temperature was not set correctly, then this temperature pattern may be enough to increase the risk of a track buckle.
