Australian Government
Australian Transport Safety Bureau

Aviation Short Investigations Bulletin

Issue 35

ATSB Transport Safety Report
Aviation Short Investigations
AB-2014-146
Final – 15 October 2014

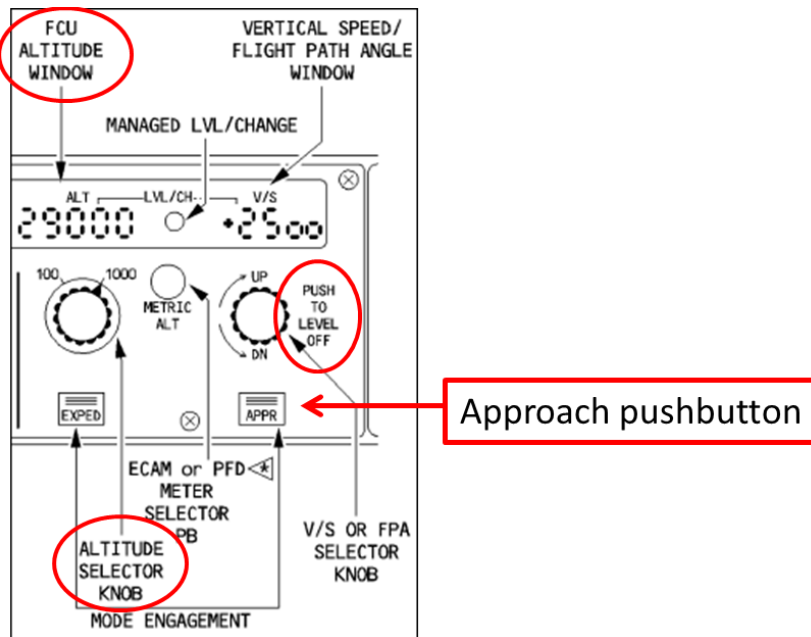
Figure 1: Relevant part of FCU panel (vertical control area)

Soon after altitude capture, the crew wound the FCU altitude window to 5,000 ft by rotating the altitude selector knob, then inadvertently pulled the altitude selector knob. This action caused the auto-flight system to engage in open climb mode⁴ contrary to the intent of the crew which was to continue descent and resume the approach. In open climb mode, the auto-flight system (flight directors) commanded a climb to 5,000 ft – the altitude now set in the FCU altitude window. As engine thrust increased however, the FO initially maintained a shallow descent, having moments earlier disconnected the auto-pilot and assumed manual aircraft control. The combined effect of the increase in engine thrust and the shallow descent resulted in unwanted aircraft acceleration.

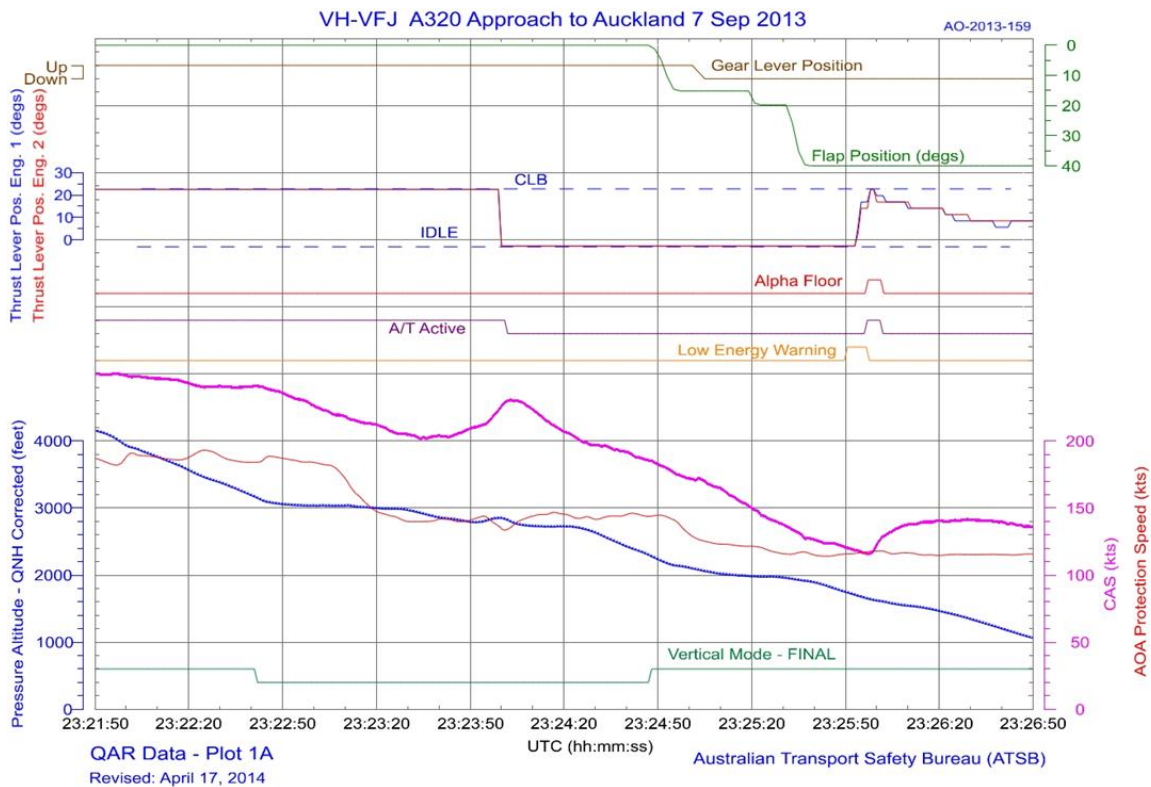
Figure 2: Quick access recorder data plot - selected parameters

The alpha floor auto-thrust mode automatically re-activated the auto-thrust system and initiated the application take-off/go-around (TOGA) thrust, even though the captain was manually advancing the thrust levers at the same time. The captain disconnected the auto-thrust system using the instinctive disconnect pushbutton on the thrust levers about 5 seconds after alpha floor mode engagement, thereby allowing the crew to establish manual thrust control¹³ and accelerate the aircraft to the approach speed. At the moment the captain disconnected the auto-thrust system, the aircraft was accelerating through about 129 kt and descending through about 1,600 ft. Manual thrust management was retained for the remainder of the flight, which continued from that point to an uneventful landing. A selection of recorded data that graphically represents the occurrence is shown in Figure 2.

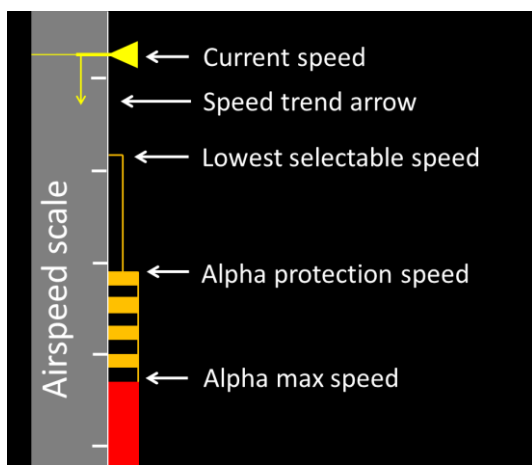
Figure 3: Representation of primary flight display airspeed indicator low speed protection markings (normal law)

The airspeed indicator is located on each pilot's primary flight display. In addition to current airspeed, the indicator includes references to predicted speed and high angle-of-attack protection speeds (normal law). Some relevant information includes (Figure 3):

Note that the speed at which the low energy 'speed speed speed' alert will sound and the speed at which alpha floor auto-thrust mode will engage are not depicted on the airspeed indicator.

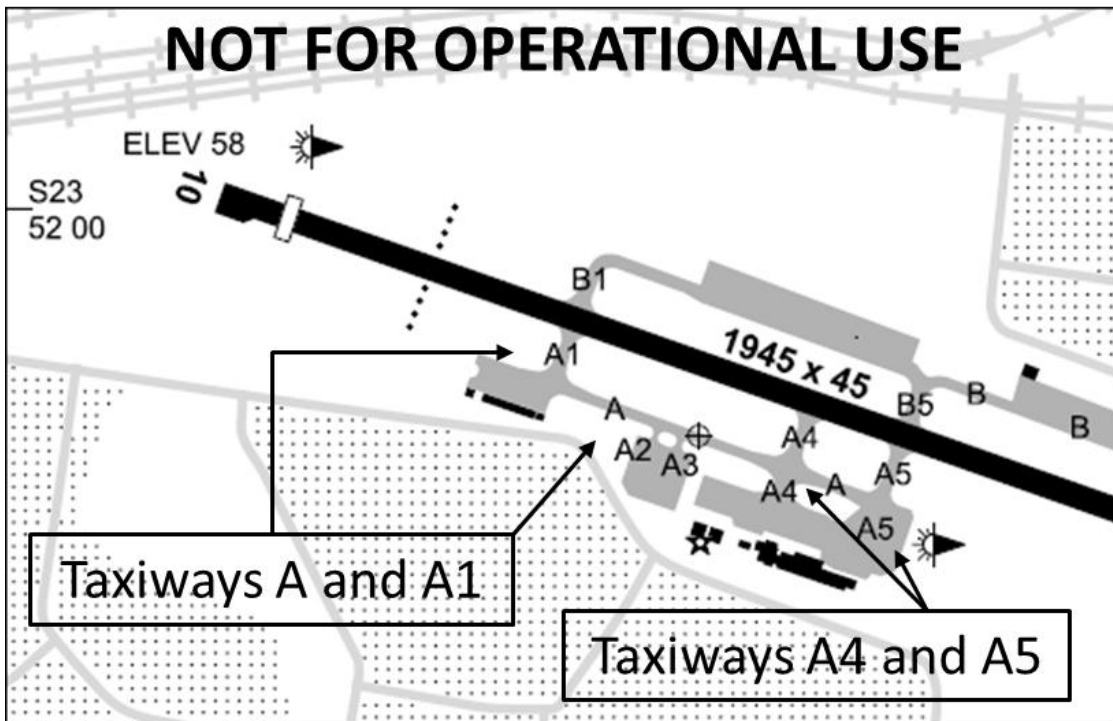
Figure 4: Excerpt from Gladstone aerodrome chart

Noting the position of the ATR-72, the crew of VH-QOP elected to taxi in a westerly direction along taxiway A, planning to enter the runway via taxiway A1 after the ATR-72 had landed. The crew commented they would probably have used taxiway A4 or A5 to enter the runway had it not been for the inbound ATR-72. Although they were not all that familiar with Gladstone Airport, the crew of VH-QOP were aware that runway entry via taxiway A4 or A5 was more common, if the air traffic situation allowed (Figure 1).

The crew of VH-QOP made a right turn from taxiway A onto taxiway A1 as the ATR-72 was on late final approach, but did not notice the holding point line near the commencement of taxiway A1 (Figure 2). The crew inadvertently continued over the holding point line before coming to a stop on taxiway A1, as the ATR-72 continued its approach and landed.²

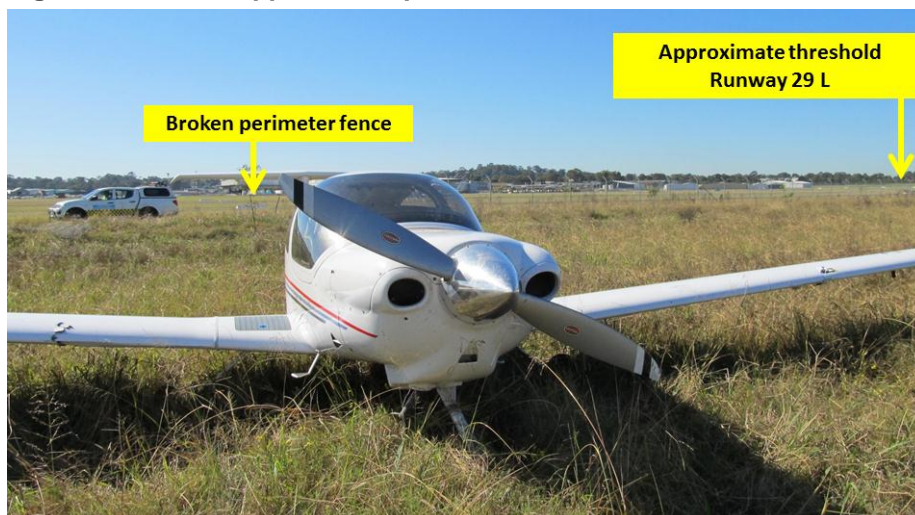
Figure 2: VH-CGT approximate path of travel

Within seconds, the aircraft rolled rapidly to the left and stalled, resulting in the left wingtip striking the ground (Figure 1). The aircraft then turned further left through about 100 degrees, and the wings levelled. It continued in this direction, crossing over taxiway Bravo, then through a wire perimeter fence, coming to rest about 25 m later, in the long grass of an open paddock (Figure 2).

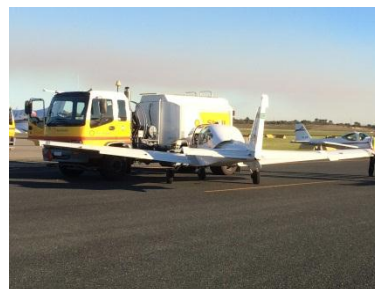
VH-ZYM and fuel vehicle

Shortly after, the aircraft's left wing struck the front grille of the vehicle and the aircraft swung rapidly left. The student quickly applied the brakes, and the aircraft came to a stop with the propeller a few centimetres from the truck's diesel tank (Figure 2). The diesel tank was located directly beneath an 8,450 L Avgas tank. The fuel vehicle operator had seen the aircraft taxiing in, and realising a collision was imminent, had pressed the emergency stop button to stop the flow of Avgas through the refuelling hose. He ran around the front of the truck and called to the pilot to shut down the aircraft. He also sought assistance from nearby students to help convey that message. About half a minute later, the student (who later reported being in shock) shut down and then exited the aircraft. The student pilot was not injured; however, the aircraft and fuel vehicle sustained minor damage.

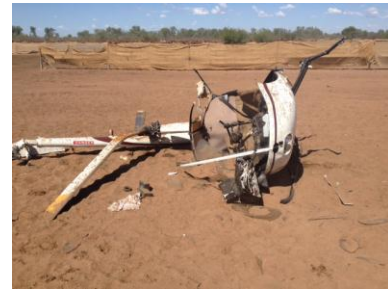
VH-HAY

To arrest the yaw, the pilot immediately closed the throttle, resulting in a rapid rate of descent. In an attempt to lessen the rate of descent, the pilot raised the collective. The helicopter struck the ground heavily, and then rolled onto the right side. The pilot sustained serious injuries and the helicopter was substantially damaged (Figure 1).

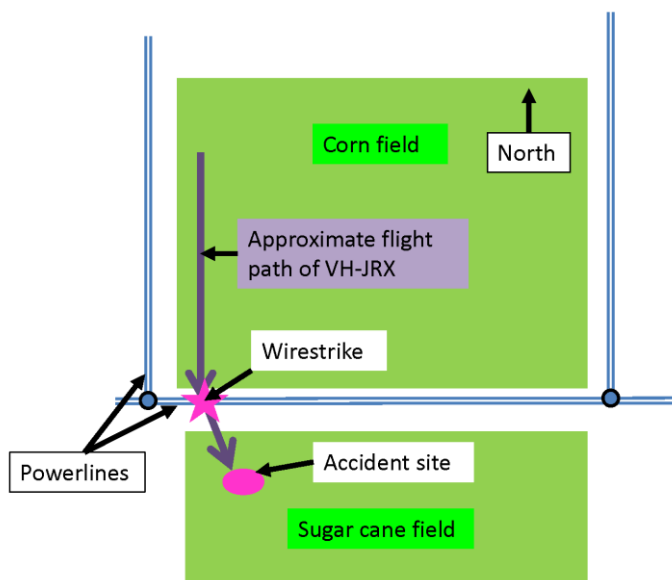
Figure 1: Approximate flight path of VH-JRX

At about 1645, after completing 14 loads of spraying, the pilot commenced the final clean-up run. The helicopter was operating from north to south along the western boundary of the paddock, parallel to the powerlines (Figure 1). The pilot was aware of those powerlines, however when about 5 m from the southern boundary, he sighted the powerlines running perpendicular to the direction of flight. The pilot assessed that it was too late to climb over the powerlines and elected to fly underneath them. The crop was about 6 ft tall and the pilot wanted to ensure the helicopter remained above the crop.

The main rotor blade hub struck the powerlines and the helicopter collided with the ground. The helicopter was substantially damaged (Figure 2) and the pilot sustained minor injuries.
