Stall warning event involving a Raytheon B200, VH-ZCO

Darwin Airport, Northern Territory, 17 May 2015

ATSB Transport Safety Report
Aviation Occurrence Investigation
AO-2015-049
Final –7 October 2015

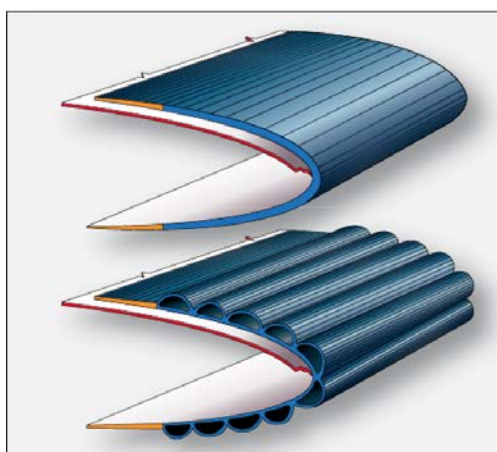
Figure 2: Pneumatic leading edge de-ice boot (representation) in the normal (deflated) condition and the inflated condition

Upper illustration shows leading edge boot held against the leading edge contour (normal in-flight condition). Lower illustration shows leading edge boot in an inflated condition, typically held in that position for a short time only, to remove an accumulation of ice.

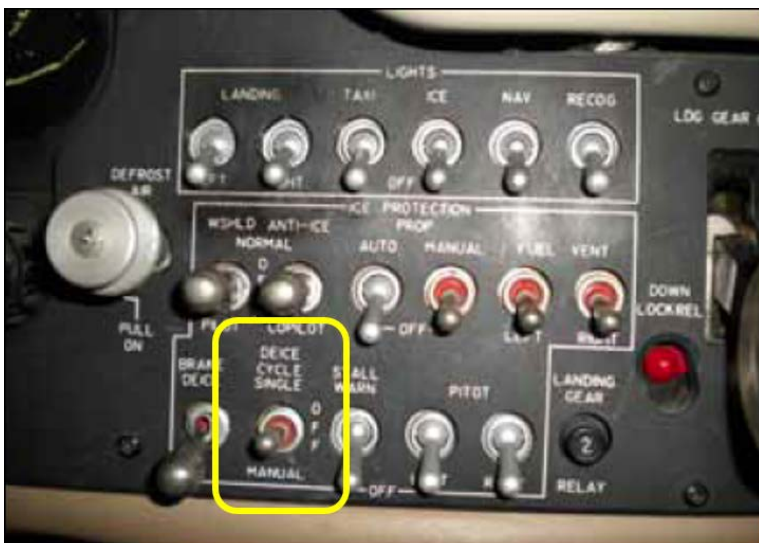
Figure 4: Raytheon B200 ice protection panel (typical) – wing and horizontal stabilizer de-ice control switch highlighted

The wing and horizontal stabiliser de-ice boots are operated by a three-position switch, spring-loaded to the centre OFF position (Figure 4). When the switch is selected to the DEICE CYCLE SINGLE (up) position, the wing boots are inflated for 6 seconds, followed by the horizontal stabiliser boots, which are inflated for 4 seconds to complete the cycle. The switch must be selected up again to commence another cycle. When the switch is selected to the MANUAL (down) position, the wing and horizontal stabiliser boots inflate simultaneously, and remain inflated while the switch is held in the MANUAL position. When the switch is released back to the centre OFF position, the boots deflate.
