Aviation Short Investigations Bulletin

Issue 44

ATSB Transport Safety Report
Aviation Short Investigations
AB-2015-118
Final – 4 November 2015

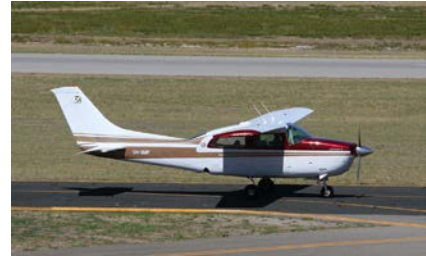
VH-SMP

The pilot reported that when the manual gear extension hand pump was used to pump the gear down, and was pumped until it could not be pumped further, it felt just like when the gear is in the down and locked position.

The owner of the aircraft conducted an investigation into the incident. As part of their investigation, they determined that one of the nose landing gear down lock pins had failed. The pin had failed in the area of the machined groove for the pin retention roll pin (Figure 1). The failed down lock pin migrated out and interfered with the nose landing gear actuator. This movement prevented the nose landing gear down lock mechanism from engaging in the down and locked position (Figure 2). The other down lock pin was serviceable.

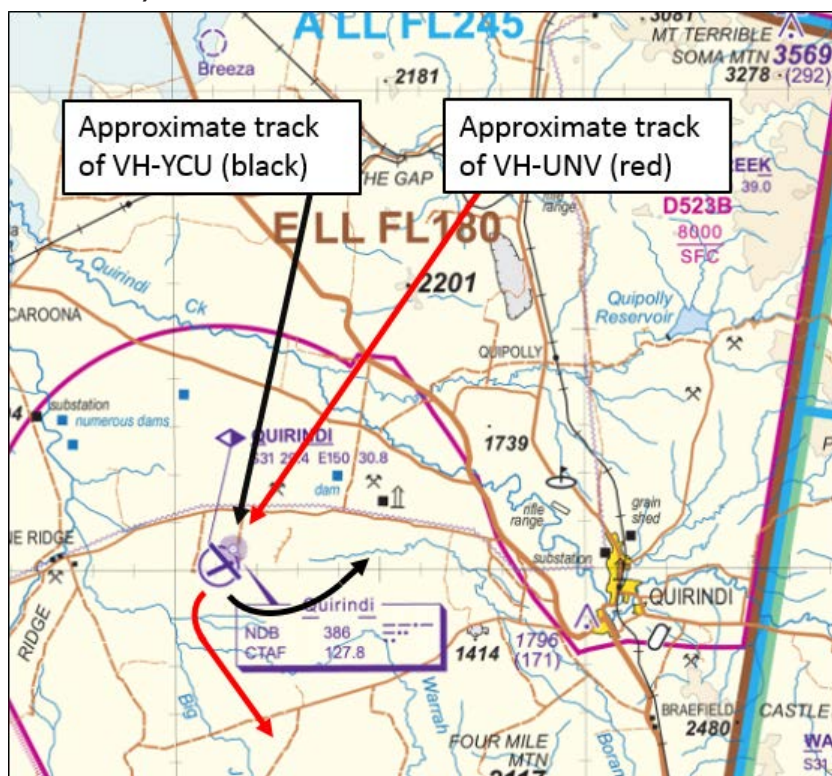
Figure 1: Extract from a visual chart showing the manner in which the tracks of the two aircraft converged as they neared Quirindi, and the general direction of flight of each aircraft after they passed Quirindi (YCU turning to the north-east and UNV turning to the south-east)

Just north of Quirindi, the traffic collision avoidance device fitted to YCU alerted the crew to an aircraft in their vicinity, at a distance of 0.4 NM, at the same altitude. The instructor commenced an intensified lookout and soon sighted UNV. At that moment, UNV was in about the 10 o'clock position⁶ relative to YCU, at the same altitude, on a slightly converging flight path. The instructor in YCU estimated that at the time UNV was sighted, YCU was in approximately the 4 o'clock position relative to UNV.

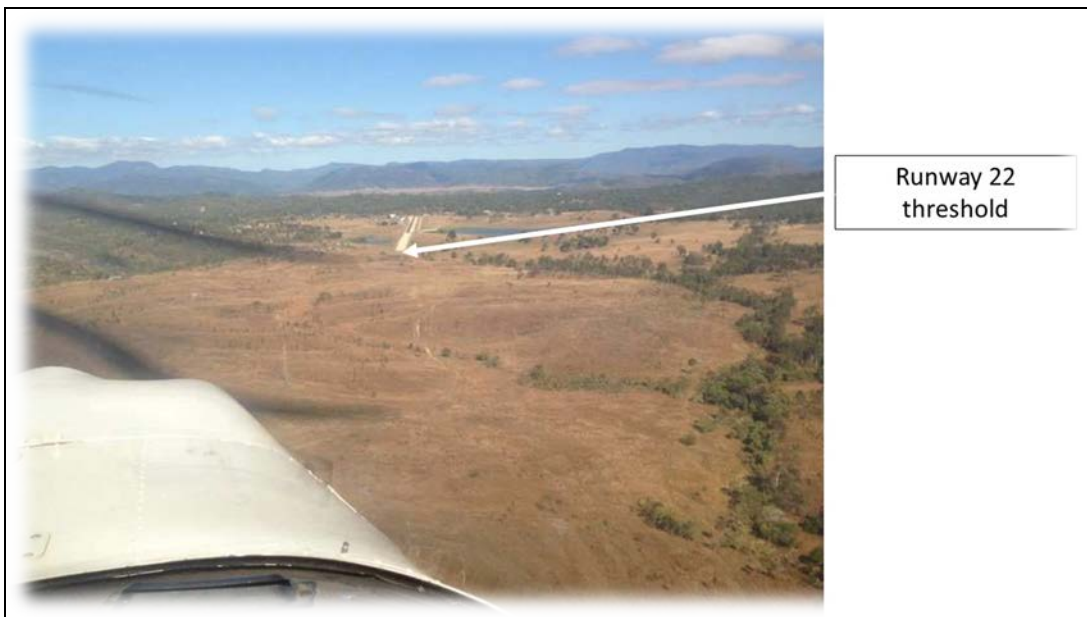
Figure 3: Approach to runway 22 at Lakeside Airpark. Note the unsealed and sealed portion of the runway. Also, note the difficulty in detecting the power lines on approach. Photo taken about a week prior to the accident

In order to maintain sufficient clearance over the two rows of power lines, and still land near the threshold, well before the sealed section of the runway, the pilot planned a steeper approach than normal. The flap was set to 40° (full flap) and the rate of descent increased to about 500-600 feet per minute.

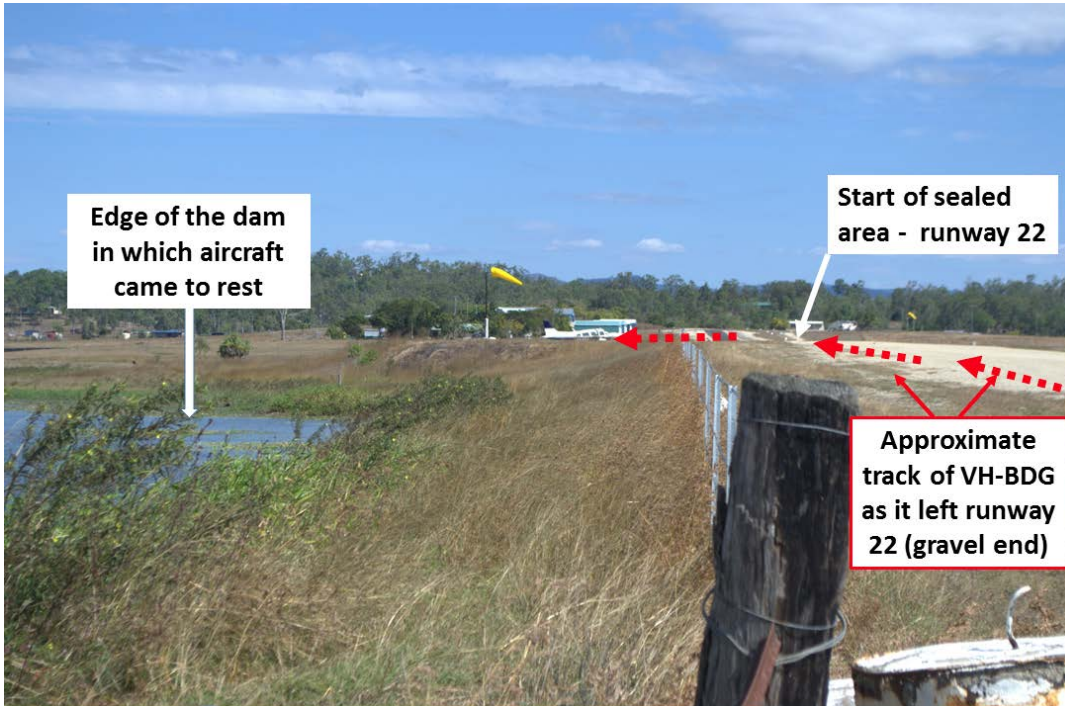
Figure 4: Looking along runway 22 taken a few days after the accident

Once into the grassed area, and with the aircraft most probably airborne, it struck a wire fence (Figure 4) then the raised embankment of the dam, which ran perpendicular to the runway. The pilot reported that the left wing tip struck the water and the aircraft spun around and entered the water. At some point throughout this sequence, the main wheels detached from the aircraft. The pilot reported continuing to battle for control of the aircraft, up until it arrived in the water.

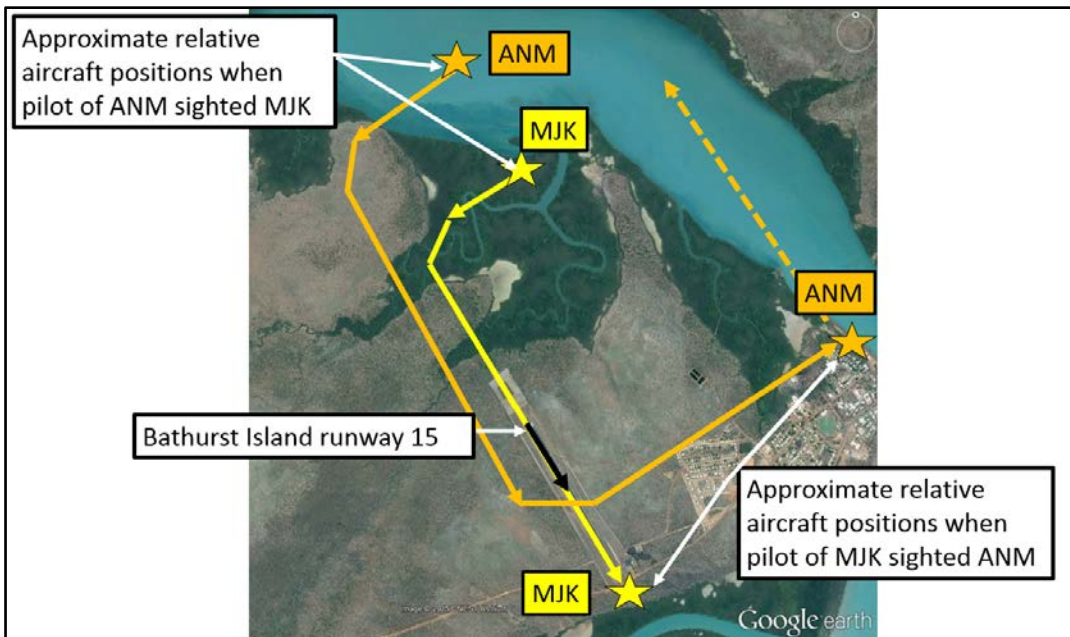
Figure 2: Bathurst Island Airport showing approximate aircraft tracks and relative positions

At about 1210 Central Standard Time (CST), a Cessna 404 aircraft, registered VH-ANM (ANM) and operated by Hardy Aviation, departed from Darwin Airport, Northern Territory, on a scheduled flight to Bathurst Island, with a pilot and five passengers on board. The pilot broadcast when inbound and about 15 NM from Bathurst Island Airport on the common traffic advisory frequency (CTAF) of 126.5 MHz, and did not receive any response. At about 1220, the aircraft joined on the downwind leg of the circuit for runway 15 at 1,000 ft above ground level and broadcast joining the circuit. As the aircraft turned onto base, the pilot sighted MJK also on base, at the same height, closer to the runway and estimated it was about 150 m away (Figure 2).

After the touch-and-go, when upwind of the runway at about 500 ft above ground level, the pilot of MJK sighted ANM. ANM was then to the left, above MJK at 1,000 ft, and turning onto the downwind leg. The pilot of MJK then saw that the radio was selected to frequency 126.6 MHz. The pilot checked their flight plan, noted that the correct frequency was 126.5, and immediately changed the radio to that frequency. The pilot of MJK then broadcast a departure call on the CTAF. The pilot of ANM then contacted the pilot of MJK, who advised that the radio had been on the wrong frequency.

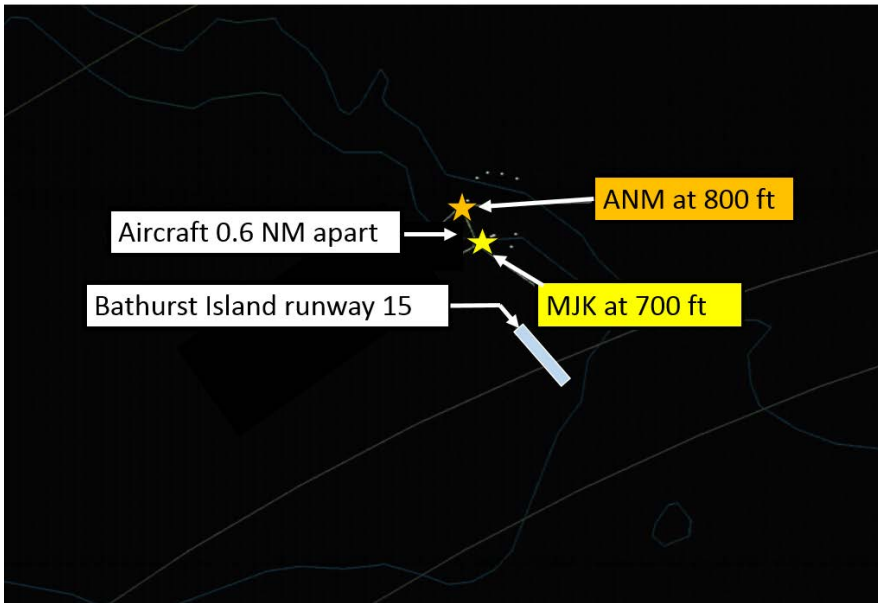
Figure 3: Radar display showing relative aircraft positions

The radar data provided to the ATSB by Darwin air traffic control, indicated the aircraft came within about 100 ft vertically and 0.6 NM at the closest proximity (Figure 3).
