Aviation Short Investigations Bulletin

Issue 36

ATSB Transport Safety Report
Aviation Short Investigations
AB-2014-158
Final – 3 December 2014

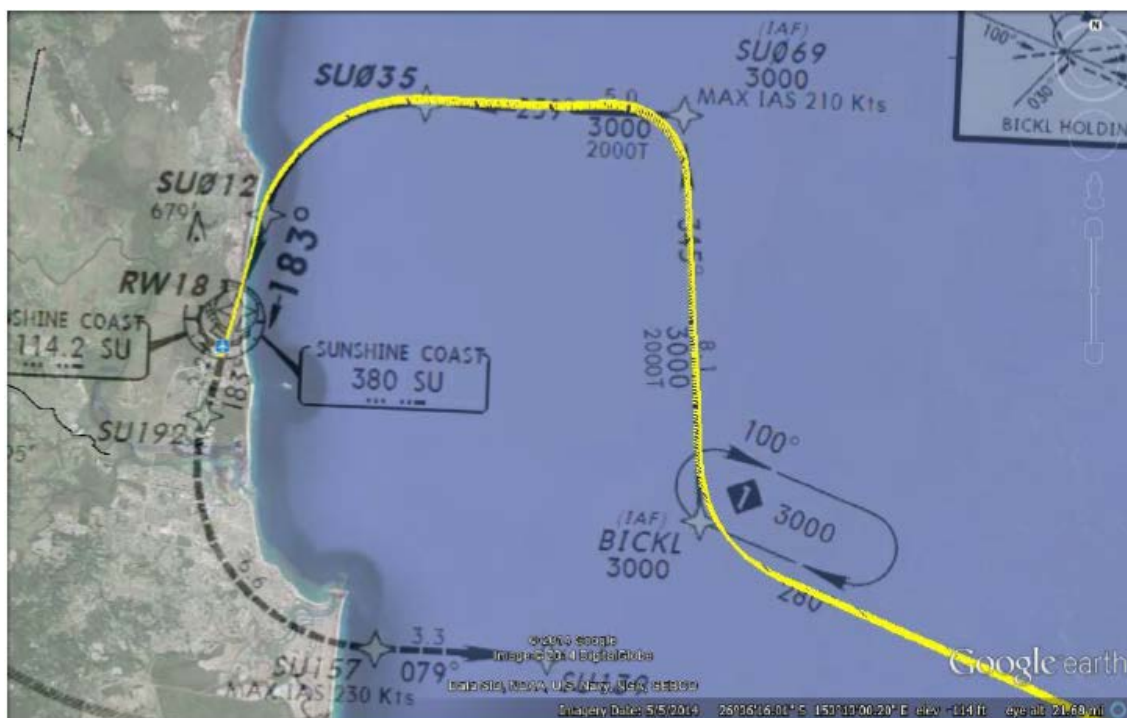
Figure 2: VH-VGJ track via the RNAV-X RWY 18 approach

When approaching waypoint BICKL (Figure 2) and passing about 4,500 ft on descent, VGJ was cleared by Brisbane Centre ATC to leave controlled airspace and advised that there was no relevant instrument flight rules (IFR) traffic. The crew observed some visual flight rules (VFR) aircraft on the traffic collision avoidance system (TCAS)³. Another Jetstar A320 aircraft then broadcast on the Brisbane Centre frequency that they were taxiing at Sunshine Coast Airport and ATC confirmed that the first officer of VGJ had copied that call.

As VGJ passed waypoint SU035 turning onto final approach, the aircraft, which had been in and out of cloud, became clear of cloud at about 2,500 ft. The captain was concerned about the position of helicopters operating in the area and made a direct call to one helicopter pilot requesting their current position and intention. That helicopter reported operating and remaining in ground effect and not near the runway. The first officer then observed that VGJ was about 400 ft above the normal approach profile and alerted the captain. The captain corrected the flight path.

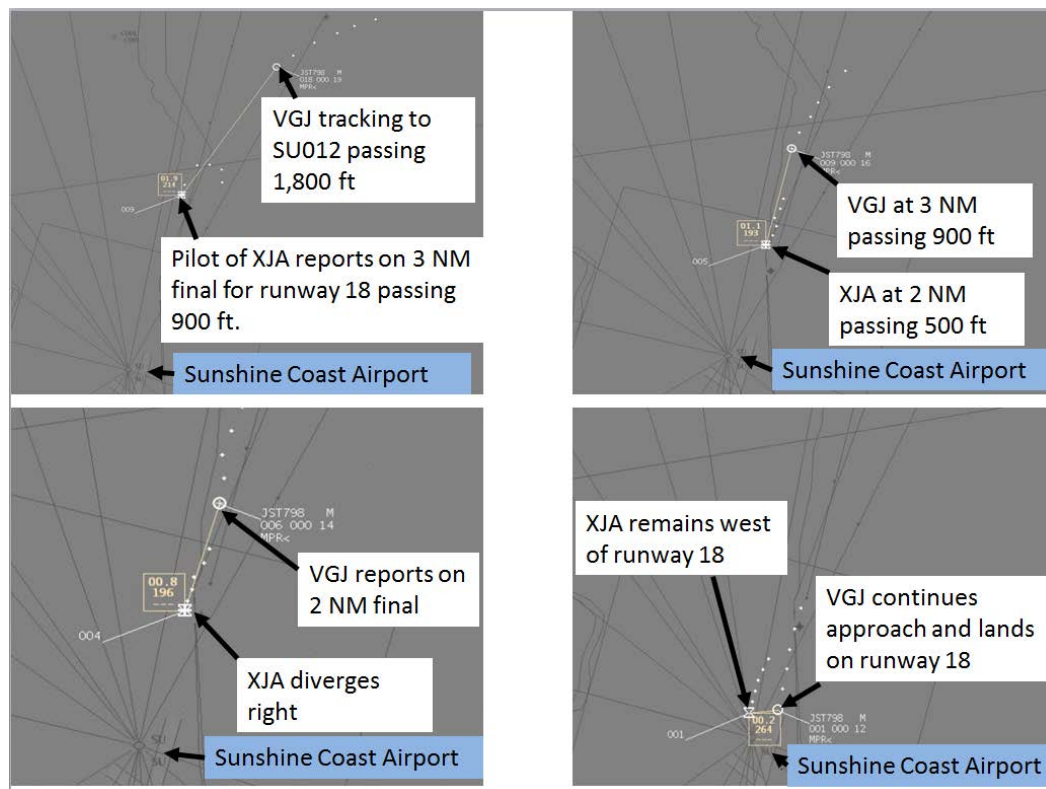
Figure 3: Radar data showing relative positions of VH-VGJ and VH-XJA

Radar data provided to the ATSB by Airservices Australia indicated that the two aircraft passed at an altitude of about 200-300 ft with a lateral separation of about 370 m (Figure 3).

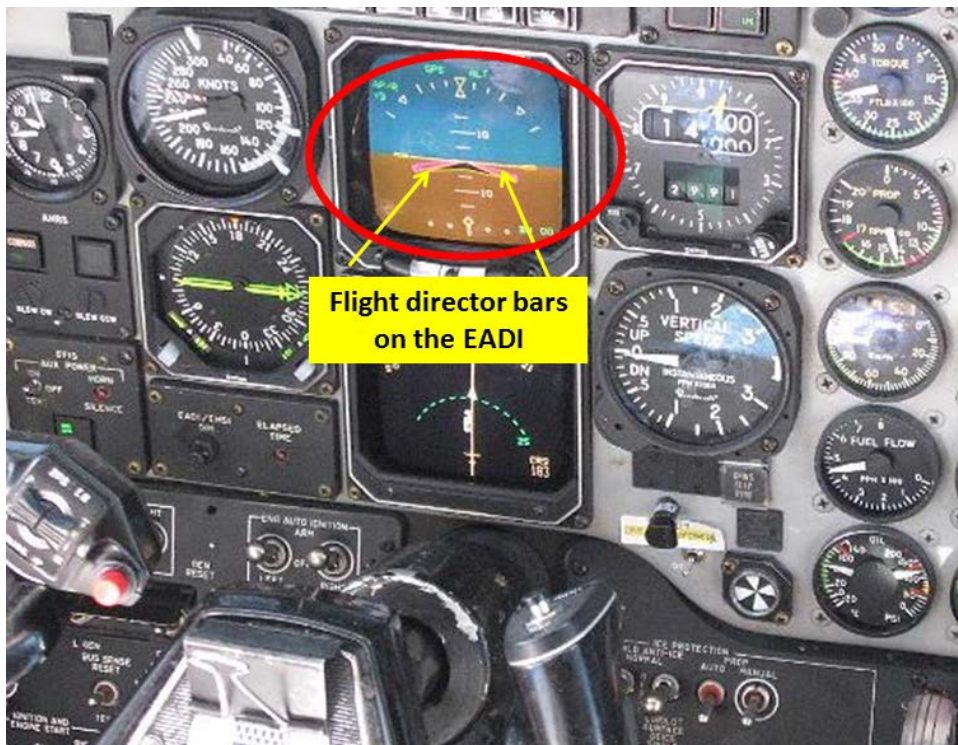
Figure 1: Rockwell Collins Electronic Attitude Director Indicator (EADI)

During the test de-briefing, the CASA officers queried why the flight director (FD) bars on the Rockwell Collins electronic attitude director indicator (EADI) (Figure 1), which the FO was following, were not agreeing with the information presented by the Bendix King KLN90B Global Positioning System (GPS) (Figure 2). The course direction indicator (CDI)³ linked to the GPS, was about half scale deflection out, when the flight director bars were followed. A disconnect between the information given by the FD bars, and that given by the GPS, occurred when the GPS re-scaled⁴ in the latter part of the approach. As the majority of the company flight crew reported not engaging the flight director bars when conducting an RNAV approach, the issue had not been previously identified.

The operator sought clarification from the aircraft flight manual supplements to determine why the discrepancy occurred when the FD's were selected. However the flight manual did not give a clear instruction regarding the use of FD's during an RNAV approach. Other operators utilising the same aircraft type also found a similar lack of information from the flight manual supplements.

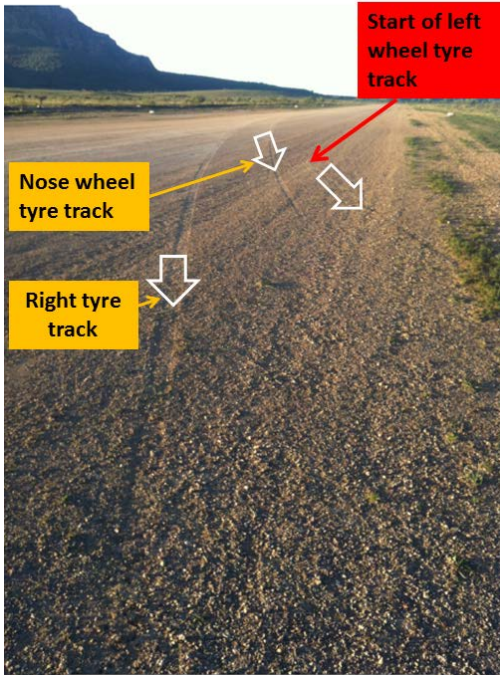
Figure 1: VH-TND tyre tracks runway 21

The aircraft continued toward a 45 cm high levee bank running parallel to the runway. The main wheels struck the levee bank, and the aircraft became airborne in a nose high, tail low attitude. In an attempt to clear a shrub (Figure 2), the pilot raised the nose of the aircraft. The aircraft horizontal stabiliser (Figure 3) struck the main trunk of the shrub about 45 cm above the ground, uprooting it.

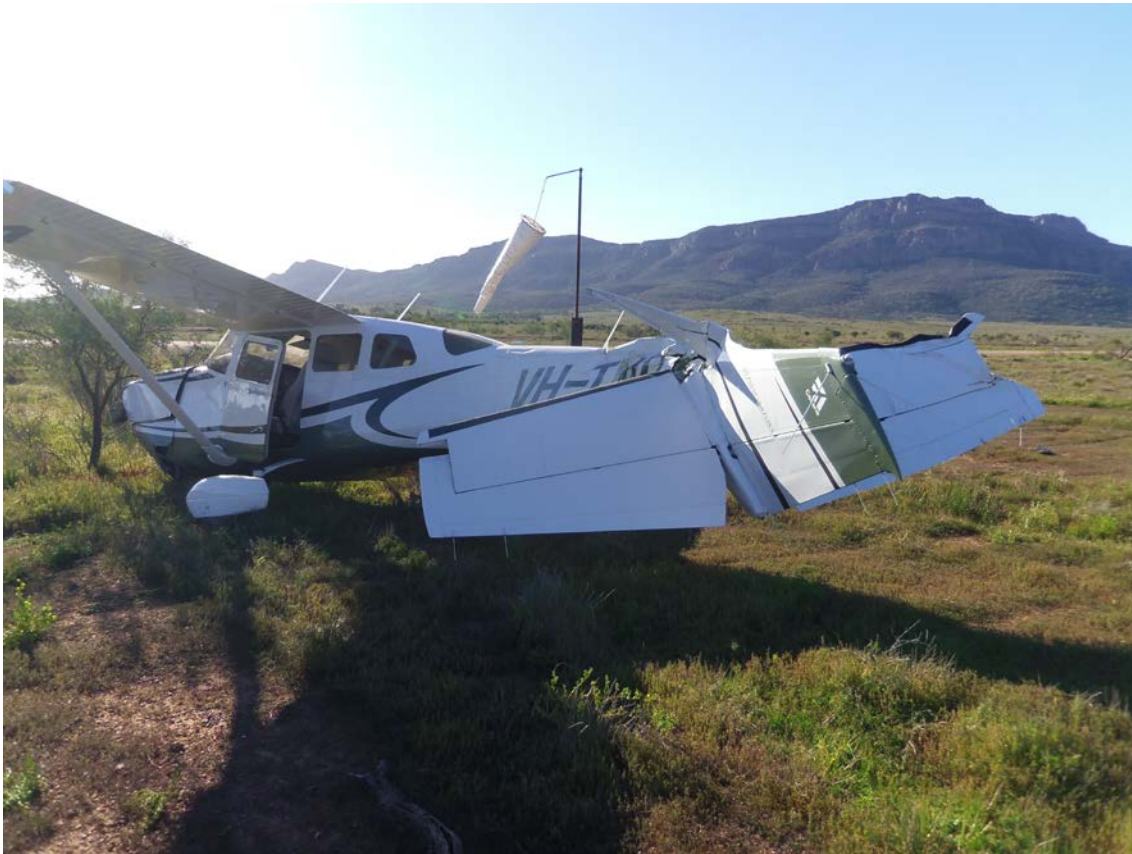
Figure 5: VH-TND near windsock

As TND passed over the windsock, the pilot heard a 'clunk' and the aircraft 'wobbled'. Moments later, the aircraft spun rapidly to the left and collided with the ground (Figure 4). It came to rest about 18 m from the windsock (Figure 5). The pilot shut down the aircraft, and assisted the male passenger from the front left pilot door, then the female passenger from the rear door.

The pilot reported everything with the flight went well up until the aircraft began to veer left. During the go-around, he thought a wheel had struck the windsock. The pilot recalls little else from when the aircraft began to spin, until it came to rest and he was able to shut it down.
