Descent below approach path involving Boeing 777, VH-VPF

Melbourne Airport, Victoria | 15 August 2013

ATSB Transport Safety Report
Aviation Occurrence Investigation
AO-2013-130
Final – 15 July 2015

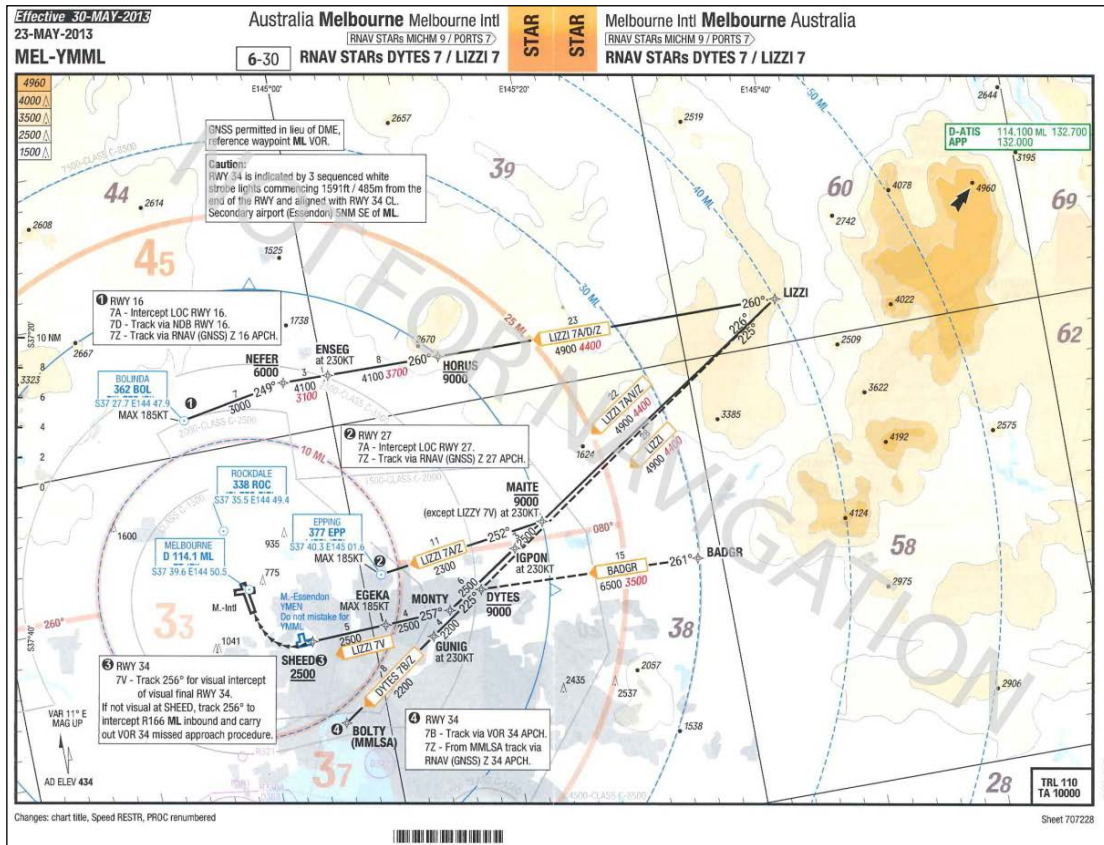
Figure 1: Aeronautical chart for Melbourne LIZZI 7 STAR

The LIZZI 7V STAR commenced at the LIZZI waypoint north-east of Melbourne Airport, and sequenced through the waypoints MAITE, IGPON, MONTY and EGEKA before completing at SHEED (Figure 1). SHEED was located overhead Essendon Airport, to the south-east of Melbourne Airport, and had a minimum altitude requirement of 2,500 ft to prevent conflict with traffic around Essendon Airport. All of these waypoints were stored in the database in the FMS.

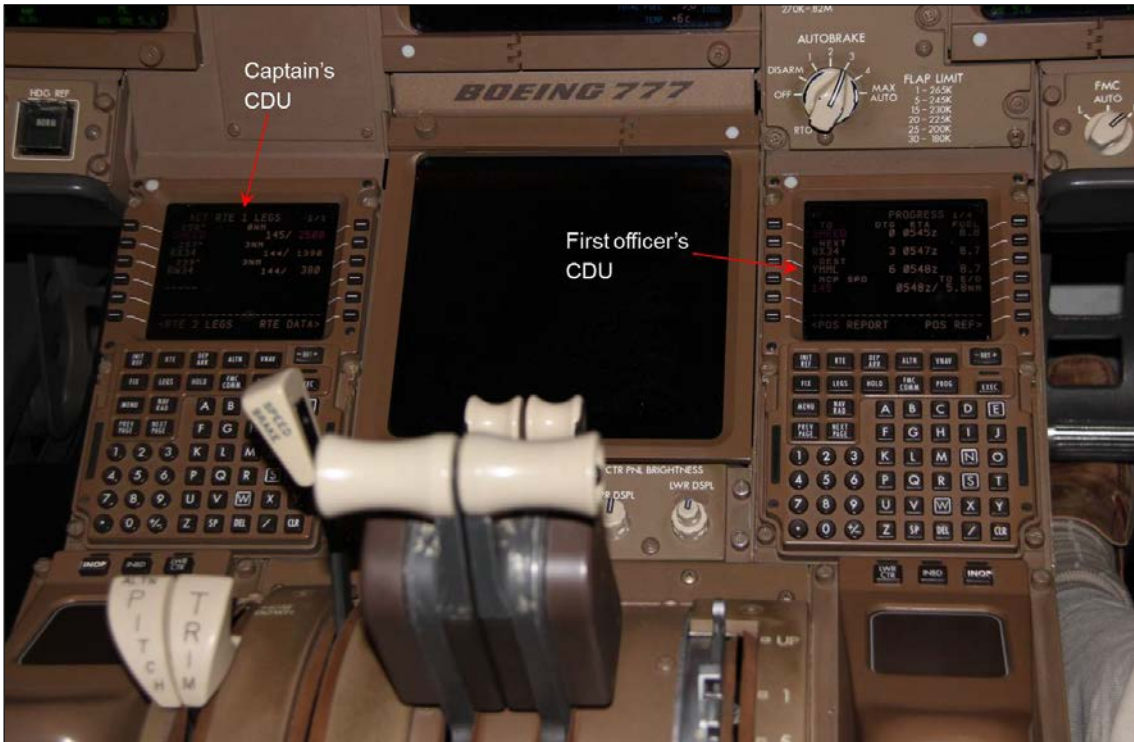
Figure 3: Captain and FO CDUs

The flight crew's primary interface with the FMS is via the control display units (CDUs). Three CDUs are located in the centre pedestal, one each for the captain and FO (Figure 3), and a third at the rear of the pedestal, as a backup. Each CDU contains a screen for presenting FMS information and a keypad to allow the flight crew to navigate through the various pages and enter and modify FMS data. The screen contains a number of lines of information with line selection keys that allow each line to be selected to either enter or modify the data in that line. Data is entered into the CDU via the scratchpad, using the keypad at the bottom of the screen. The scratchpad is also used to present messages to the flight crew in relation to the operation of the FMS (Figure 4).
