Air Safety Investigations

Recently completed investigations

Chieftain investigation leads to safety recommendations

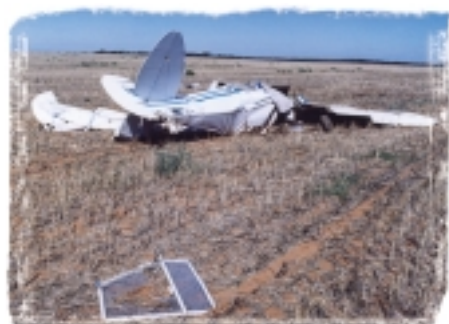
Occurrence Report 199900844

The ATSB has made a number of safety recommendations following a collision between a Piper Pawnee and an Astir CS glider over Waikerie on 2 March 1999 in which two pilots were fatally injured.

The Pawnee was towing a Grob Twin Astir prior to the collision. The pilot of the Grob immediately released the tow when a collision between the two aircraft was imminent.

The recommendations followed the findings that: aerial towing was conducted through areas of gliding activity resulting in traffic conflicts which relied solely on visual acquisition for separation; pilots did not adequately use CTAF procedures for traffic alerting; and the Astir CS pilot's lookout was not effective.

The ATSB recommends that the Gliding Federation of Australia, in conjunction with its member clubs, incorporate the use of radio for effective traffic alerting into standard operating practices as a matter of priority.

It also recommends that the Federation adopt measures to make all aircraft engaged in gliding activities more conspicuous, and that it considers developing procedures that permit segregation of aero towing and gliding activity.
