# Air Safety Investigations

# Got the right fuel system fitting in your balloon?

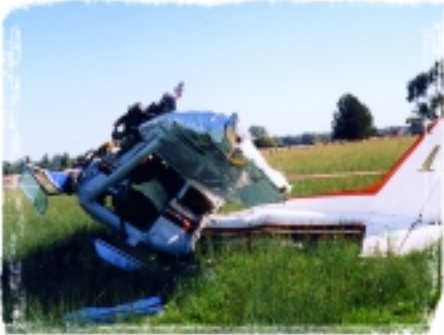
Occurrence Brief 200001153

A pilot and two passengers were seriously injured when their Cessna 172 aircraft impacted the ground after a go-round at Shepparton Aerodrome on 3 April 2000. The pilot died in hospital.

The pilot had attempted to land the aircraft on runway 18. It was estimated during the investigation that the runway crosswind was probably between 7 and 15 KTS and tail wind between 5 and 12 KTS.

The go-round was commenced as the aircraft neared the end of the runway. The aircraft continued south beyond the runway, drifting east with the wind and over the southern boundary fence. It turned left, banking sharply, and tracked eastward at low altitude with its wings rocking and a pronounced nose-high attitude. A number of witnesses observed the nose to suddenly drop and the aircraft adopted a steep nose-down attitude before impacting the ground.

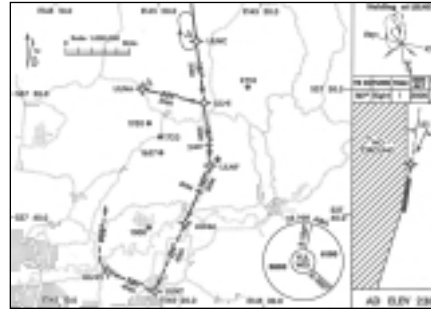
Occurrence Brief 200004914

An incident during an approach at Lilydale ALA last year has highlighted the importance of a pilot's situational awareness and understanding of GNSS (Global Navigation Satellite System) operations through good training.

The pilot had conducted a Global Positioning System (GPS) instrument approach to Lilydale from waypoint Charlie (15 NM north of Lilydale). As the aircraft approached waypoint India (5 NM south of Charlie) the controller advised the pilot that the aircraft was two-and-a-half miles east of Charlie. When the pilot advised passing waypoint India the controller responded that the aircraft was two-and-a-half miles east of Charlie.

The pilot disregarded the controller's information and conducted a missed approach. Soon after the pilot visually established the aircraft's position on the GPS approach track. The pilot continued the approach visually.

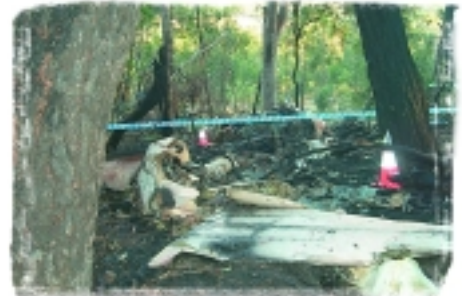
Occurrence Brief 200101729

A pilot and passenger were fatally injured when their Beechcraft Bonanza A36 collided with dense woodland 4 NM to the south-west of Goulburn Aerodrome on 20 April 2001.

The aircraft had departed Swan Hill at approximately 1600. The pilot had left details of the flight at the point of departure and arranged to phone a contact on arrival at Goulburn. At about 1735 a radar trace consistent with the flight path of the aircraft was identified approaching Goulburn from Yass. The aircraft disappeared from radar 7 NM west of Goulburn at 1744 consistent with the flight profile of a planned descent to Goulburn. The pilot did not report to the contact by phone as planned and a search for the aircraft commenced the next morning.

The descent path of the aircraft through the trees indicated a rate of descent in excess of normal controlled flight. Examination of the wreckage found no evidence of any defect in the aircraft or its systems.

The aircraft was not certified for flight in instrument meteorological conditions.
