# Air Safety Investigations

# Safety briefs

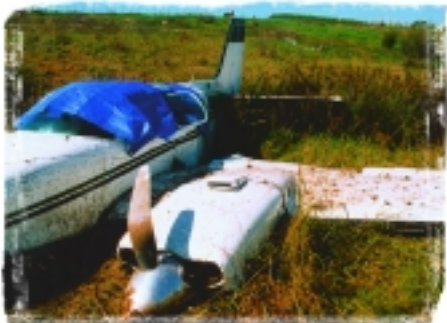
Safety Brief 200000893

Three significant factors were found during the investigation into the forced landing of a Beech Baron on 13 March 2000 in which the pilot suffered severe head and facial injuries.

The pilot was not adequately prepared for an assigned instrument approach in instrument meteorological conditions (IMC); did not change fuel tank selection when the auxiliary tanks were exhausted; and the shoulder harness was not correctly installed.

After turning the left engine failed followed by the right. The aircraft impacted the ground in a grass-covered gully. ■

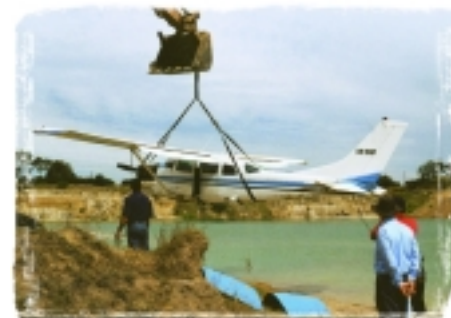
Safety Brief 200000932

A number of factors were considered but no firm conclusion reached in the investigation into the ditching of a Cessna 210 Centurion after take off on 18 March 2000.

The aircraft was successfully ditched in a quarry filled with water when it was unable to climb beyond 100ft after takeoff. The pilot and both passengers exited the aircraft but one passenger drowned.

The aircraft had used more runway than book figures indicated for the conditions during take off, however the pilot did not notice the reduced aircraft performance until the landing gear was retracted shortly after becoming airborne. There was no sudden loss of power.

No faults were found with any of the aircraft's systems, engine, and propeller or in its handling by the very experienced pilot. Even though a defect was found in the fuel selector valve that restricted the flow of fuel to the engine, this would not have resulted in the performance loss that was observed in the accident.

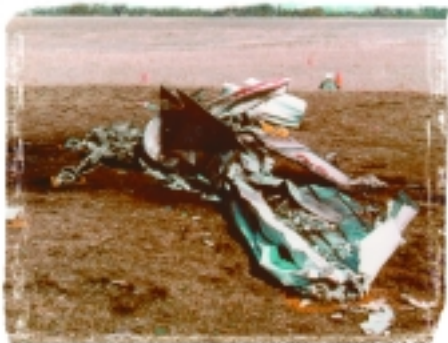
Safety Brief 200004191

Pilot incapacitation leading to a loss of control was a likely factor in the accident involving a Cessna A152 Aerobat on 12 September 2000.

Examination of the accident site revealed that the aircraft impacted the ground in balanced flight at high speed in an attitude of approximately 70 degrees nose down. The engine was producing high power at impact. Examination of the wreckage did not reveal any technical defect that would have contributed to the accident.

The reason for the pilot's loss of control of the aircraft was not conclusively established. Significant factors identified in the investigation were that the pilot suffered from a medical condition that could have adversely affected the ability to fly the aircraft, and the pilot lost control of the aircraft and did not regain control before the aircraft impacted the ground. ■

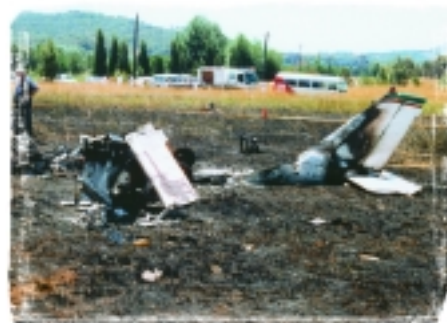
Safety Brief 200100346

A Beech Musketeer stalled during the climb after takeoff on 28 January 2001 and was not recovered before it impacted the ground fatally injuring all four occupants.

Witnesses reported that the aircraft slowly climbed to about 300 ft and then seemed to lose altitude. The aircraft then continued tracking outbound in a shallow climb on runway heading before the right wing dropped. The aircraft then rolled to the right, assumed a steep nose-down attitude and began rotating. After one turn the aircraft impacted the ground in a steep nose-down inverted attitude. The pilot and passengers had arrived at the pilot's home in the early hours of the morning after driving from interstate. The pilot was up at 0630 EST on the day of the accident.

During the investigation no aircraft defects were found and the aircraft was operating within its correct weight and balance limits. It was considered that operating just under maximum gross weight at a density altitude of 3,400ft would have reduced the aircraft's acceleration and climb performance.
