The Australian Air Safety Investigator is a regular eight-page feature in *Flight Safety Australia* produced with editorial independence by the ATSB. It aims to keep the industry informed of the latest findings and issues in air safety from the bureau's perspective.

Panel hooks not engaged

Occurrence: 200101776

The Australian Air Safety Investigator

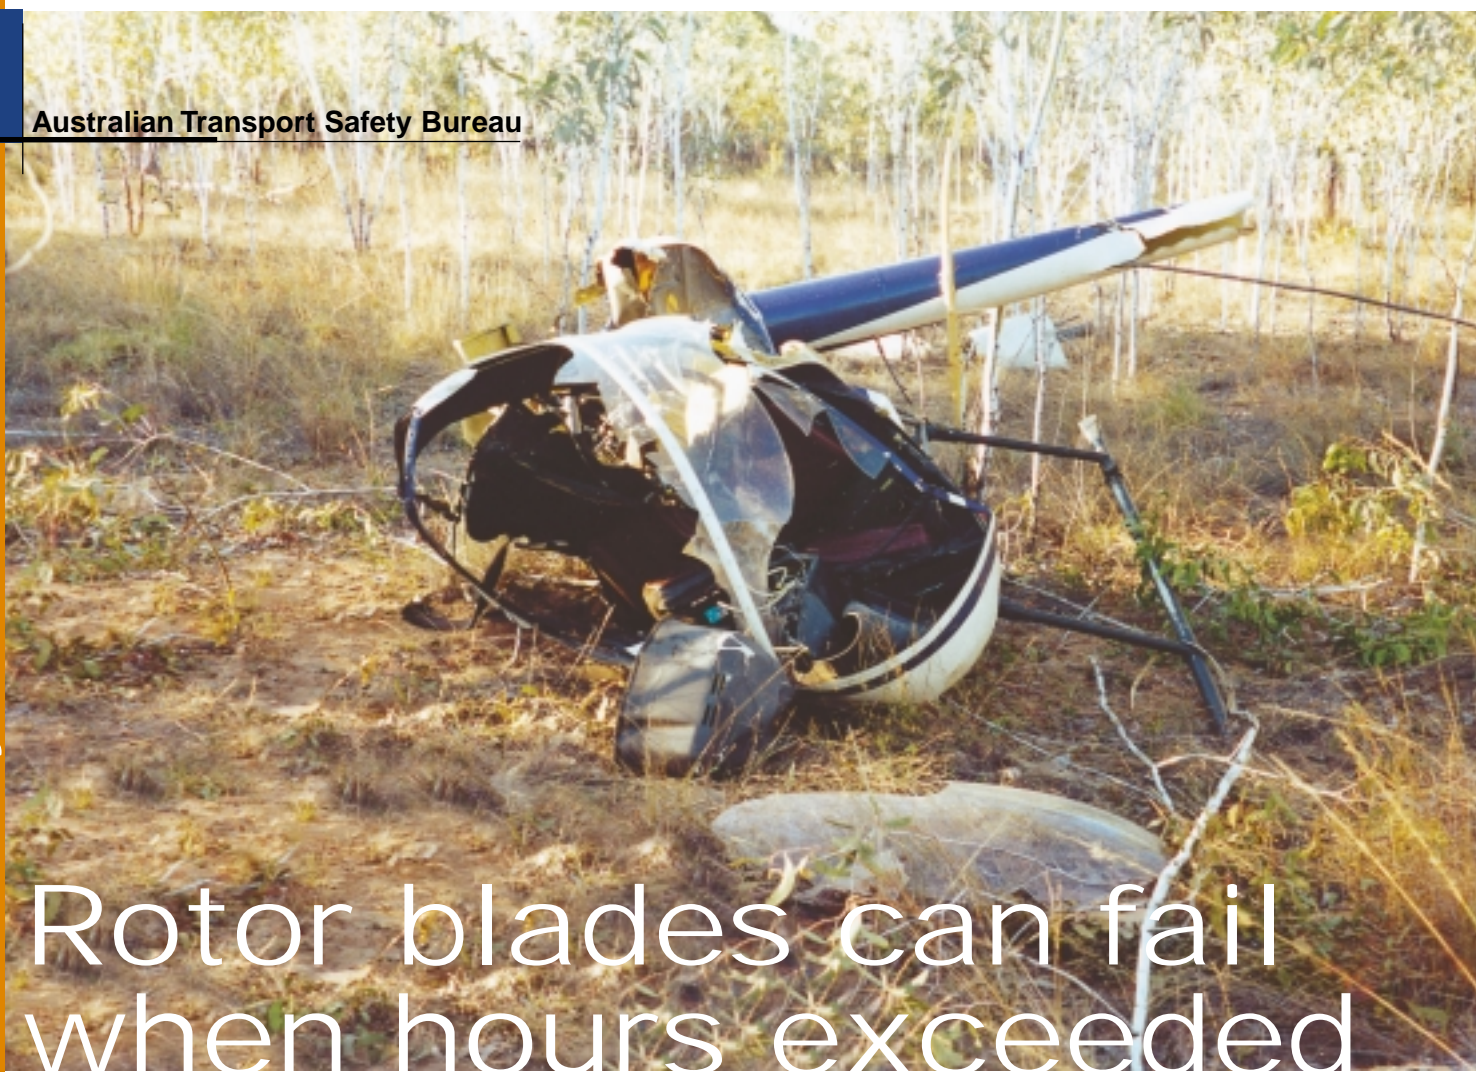
Damage to the aircraft structure, engines and propellers was extensive and indicated a straight and level flight attitude at the time of impact. The aircraft was considered capable of normal flight prior to the accident.

Radar data recorded by Air Traffic Services, and witness reports, indicated that the aircraft was flying straight and level and maintaining a constant airspeed.

Why the pilot continued flight into marginal weather conditions, at an altitude insufficient to ensure terrain clearance, could not be established. ■
