The Australian Air Safety Investigator is a regular eight-page feature in *Flight Safety Australia* produced with editorial independence by the ATSB. It aims to keep the industry informed of the latest findings and issues in air safety from the bureau's perspective.

Recently completed investigations

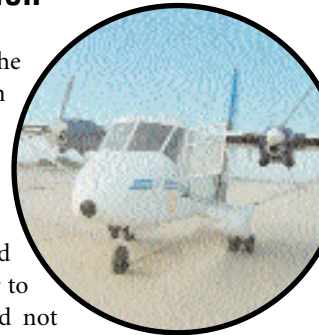
Inspections of the fuel tanks identified that all four fuel quantity transmitters were contaminated by microbiological material. The level of microbiological material in the transmitters was sufficient to affect their accuracy. The aircraft manufacturer recommended that fuel tanks and fuel quantity transmitter units be cleaned every 1,800 hours time in service. On this aircraft, the transmitter units had been cleaned less than 1,000 hours prior to the occurrence.

The evidence indicated that the aircraft's engines failed due to fuel exhaustion. The pilot's method of establishing fuel on board was not robust, with no provision for the possibility of errors in the fuel quantity indicating system. It is possible that the perceived reliability and accuracy of the Caravan fuel quantity indicating system influenced the extent of the pilot's reliance on fuel gauge indications. The company operations manual requirement for preflight fuel quantity assessment was deficient in that it did not adequately address the individual fuel system characteristics of the different aircraft types in the company fleet.

On 11 January 2002, the company issued a memo modifying fuel management requirements. The company also reviewed and rewrote company training documentation and wrote to the aircraft manufacturer regarding the time interval between fuel tank inspections.

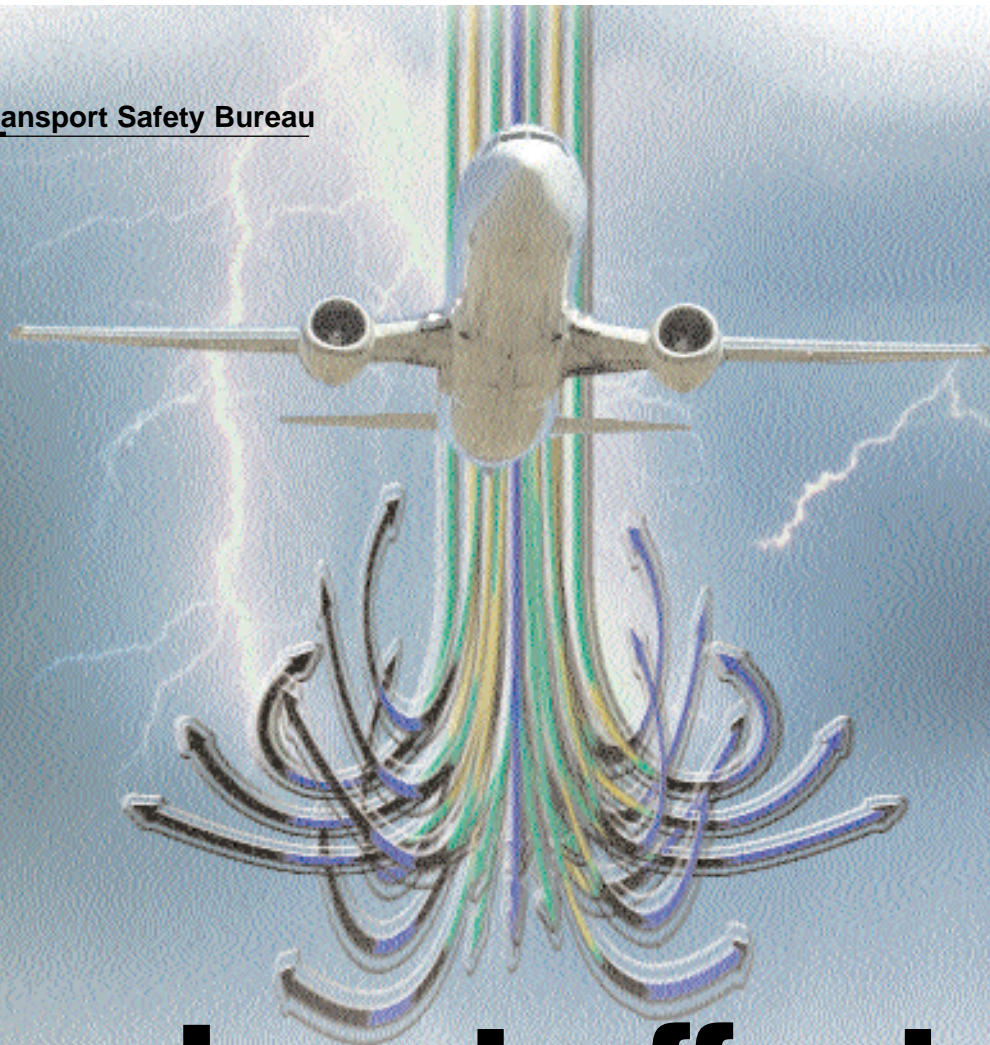
ON 18 January 2001, a Boeing 737 aircraft, encountered microburst windshear at 0729 EST while conducting a go-around from runway 19 at Brisbane aerodrome during an intense thunderstorm. Heavy rain and hail accompanied the thunderstorm, and 8.8 mm of rain was recorded at the aerodrome between 0725 and 0730 which was equivalent to a rainfall rate of 105.6 mm per hour.

The recorded flight data from the aircraft's flight data recorder was examined during the occurrence investigation, and revealed that the aircraft experienced increasing headwind conditions during the go-around, which were then followed by decreasing headwind conditions. Those conditions were typical of a microburst windshear encounter. In the 30-second interval between 0728:25 and 0728:55, the aircraft encountered a steadily increasing headwind from 16 kts to 26 kts.

Microbursts are associated with convective activity, and comprise intense local downdrafts with divergent surface flows. Their horizontal extent is usually about 5 km or less, and their lifetime only a few minutes. Horizontal and vertical windshear produced by microbursts can present significant hazards to departing and arriving aircraft.
