Australian Transport Safety Bureau

The Australian Air Sa

Safety **briefs**

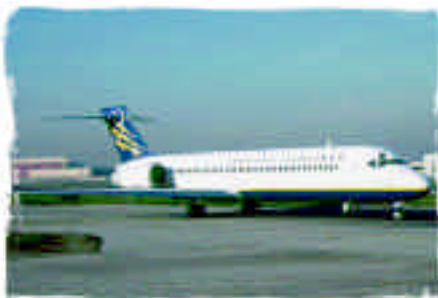
Occurrence 200204444

The crew of the Boeing 717-200 aircraft reported that during the climb from Launceston airport, while passing 7,000 ft above sea level, the right engine sustained an uncommanded in-flight shutdown. A R ENG RPM LO alert was observed followed by a RH SYS FAIL advisory. The crew reported that they did not see any caution advisories prior to the shutdown. The ENGINE FAIL/SHUTDOWN checklist was actioned and the crew completed a

single engine landing. Following the event, the operator's maintenance personnel interrogated the multi-function control display unit and carried out a right engine electronic engine controller fault review check. Several fault codes were noted in the on board computer memory which related to electronic faults listed for a FADEC SYSTEM FAULT [full-authority digital engine control] and EEC BOX FAULT [electronic engine controller]. After conferring with the engine manufacturer, the EEC and the fuel-metering unit (FMU) were removed for further testing. After replacement of those units, normal engine performance returned. ■
