Aviation Short Investigations Bulletin

Issue 43

AB-2015-097

Final – 7 October 2015

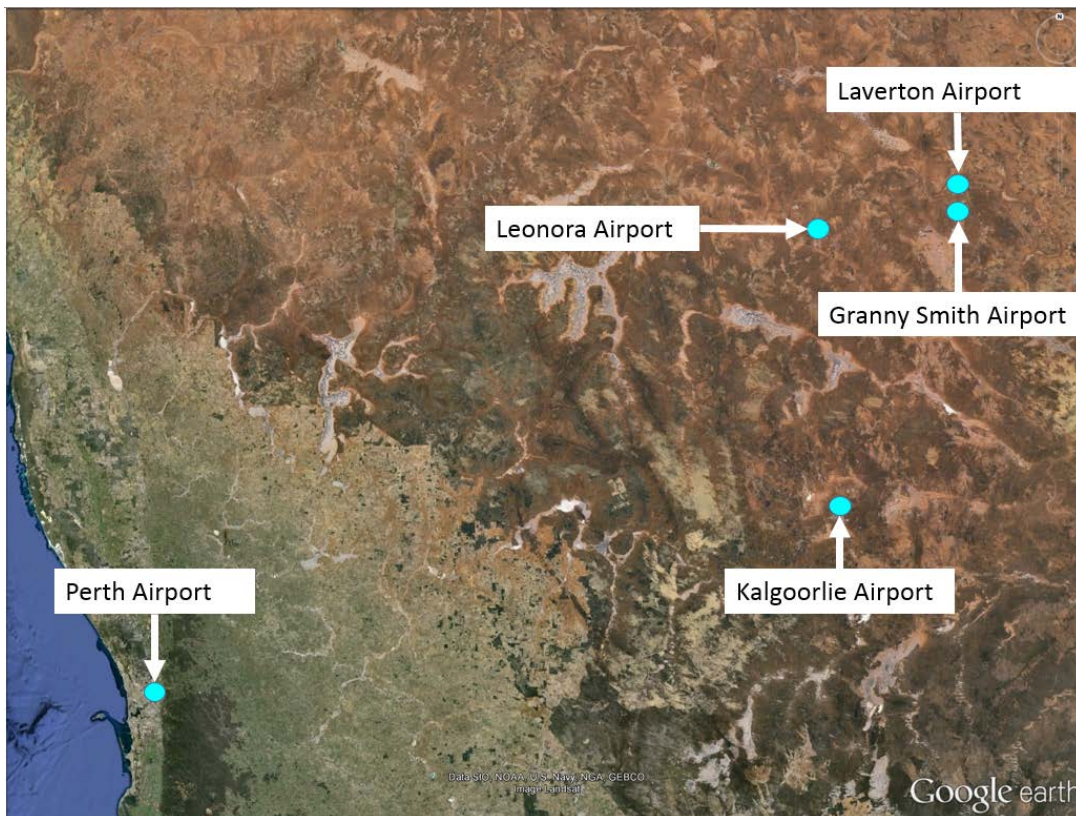
Figure 1: Selected aerodromes in Western Australia

On 23 June 2015, at about 0420 Western Standard Time (WST), the captain and first officer of an Avro 146 aircraft, registered VH-NJW, and operated by National Jet Express, signed on to conduct a scheduled return flight from Perth to Granny Smith Airport, Western Australia (Figure 1). The flight crew reviewed the weather forecast, including the aerodrome forecast (TAF)¹ for Leonora, which was the closest available TAF to Granny Smith. The TAF indicated broken² cloud 1,000 ft above ground level (AGL). The weather report (METAR) current at Leonora at that time indicated nil cloud detected (NCD). The forecast also included cloud at 1,500 ft AGL clearing at 0900 WST. Based on the weather forecast, the crew were required to plan for an alternate aerodrome,³ and the captain planned sufficient fuel to return to Perth if they were unable to land at Granny Smith.

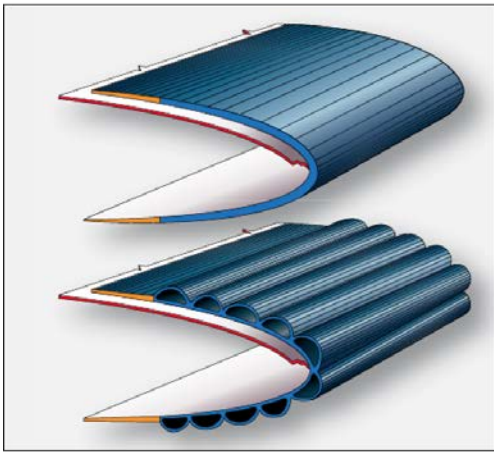
Figure 2: Pneumatic leading edge de-ice boot (representation) in the normal (deflated) condition and the inflated condition

Upper illustration shows leading edge boot held against the leading edge contour (normal in-flight condition). Lower illustration shows leading edge boot in an inflated condition, typically held in that position for a short time only, to remove an accumulation of ice.

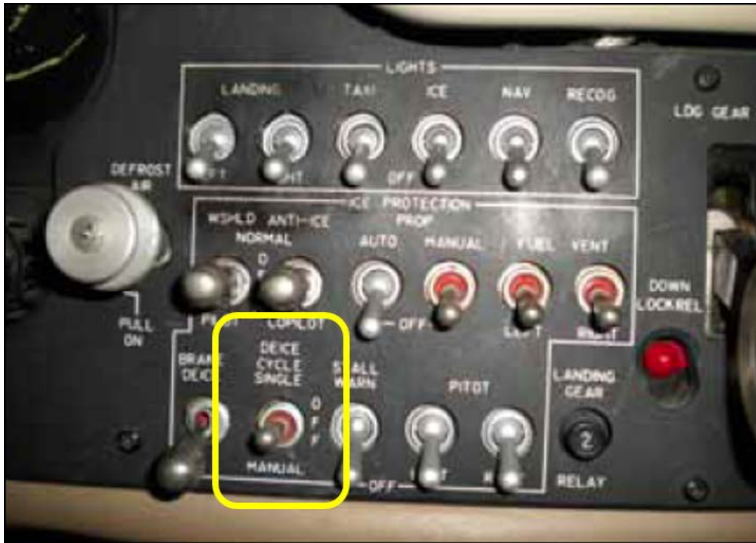
Figure 4: Raytheon B200 ice protection panel (typical) – wing and horizontal stabilizer de-ice control switch highlighted

The wing and horizontal stabiliser de-ice boots are operated by a three-position switch, spring-loaded to the centre OFF position (Figure 4). When the switch is selected to the DEICE CYCLE SINGLE (up) position, the wing boots are inflated for 6 seconds, followed by the horizontal stabiliser boots, which are inflated for 4 seconds to complete the cycle. The switch must be selected up again to commence another cycle. When the switch is selected to the MANUAL (down) position, the wing and horizontal stabiliser boots inflate simultaneously, and remain inflated while the switch is held in the MANUAL position. When the switch is released back to the centre OFF position, the boots deflate.

Apart from a visual inspection of the de-ice boots, there are no direct indications of the status of the boots available to the pilot. Aircraft pneumatic system gauges provide an indirect indication of boot function by indicating a momentary reduction in pneumatic pressure (and momentary needle movement on the gyro suction gauge) as pressure is redirected, but there is nothing that directly alerts the pilot to an inflated boot condition.

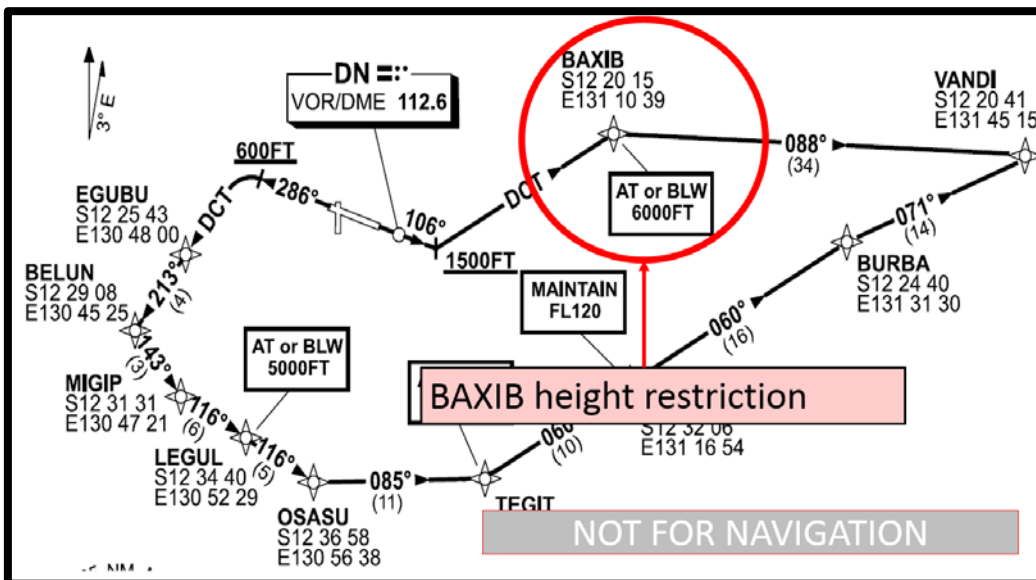
Figure 1: Extract of VANDI ONE SID

On 10 June 2015, the pilot of a Cessna 441 aircraft, registered VH-JLT (JLT), conducted pre-flight preparations for a charter flight from Darwin to Oenpelli, Northern Territory with 6 passengers. The pilot planned to track direct to Oenpelli, but on requesting an airways clearance, was advised by the clearance delivery controller that there was a requirement to plan via the VANDI ONE standard instrument departure (SID) (Figure 1). The pilot then reviewed the SID chart and noted the left turn on departure and the height limit of 6,000 ft at waypoint BAXIB. The pilot wrote '6,000' on the navigation log. As part of the airways clearance issued to JLT, the pilot was initially issued a clearance to climb to 3,000 ft. The pilot entered '3000' into the aircraft's altitude alerter.

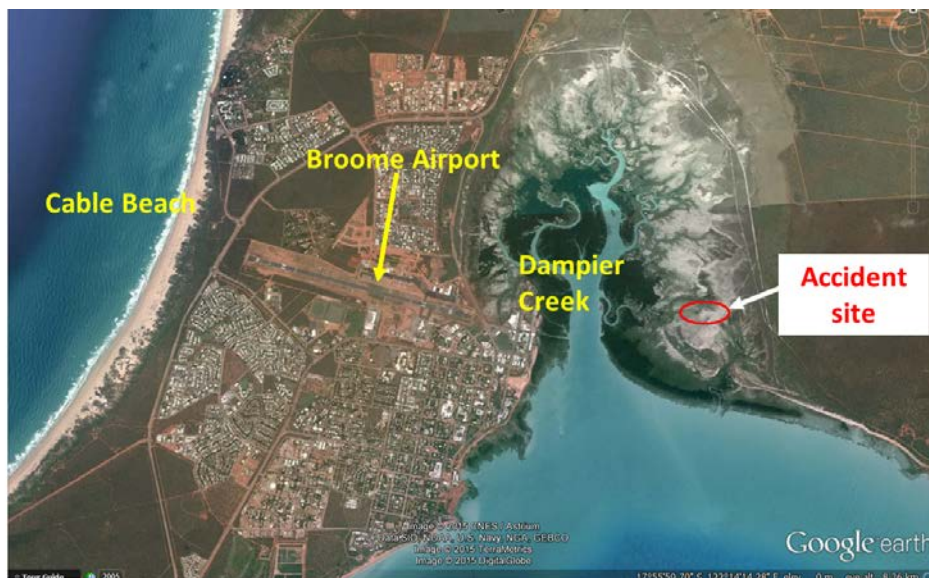
Figure 1: Broome Airport and accident site

At about 15 NM from Broome, the pilot observed the start of a thick layer of fog below the aircraft. Arriving overhead Broome Airport at about 0622 Western Standard Time (WST), with the right fuel tank selected, the pilot initially surveyed the area from about 1,000 ft above ground level. However, as there were no breaks in the fog, the pilot descended the aircraft to about 650 ft. The pilot kept the aircraft in visual conditions while circling the airport and Cable Beach areas (Figure 1) occasionally flying at a lower level to take a closer look for possible breaks. With the right fuel tank still selected, the pilot's search continued for about forty-five minutes.

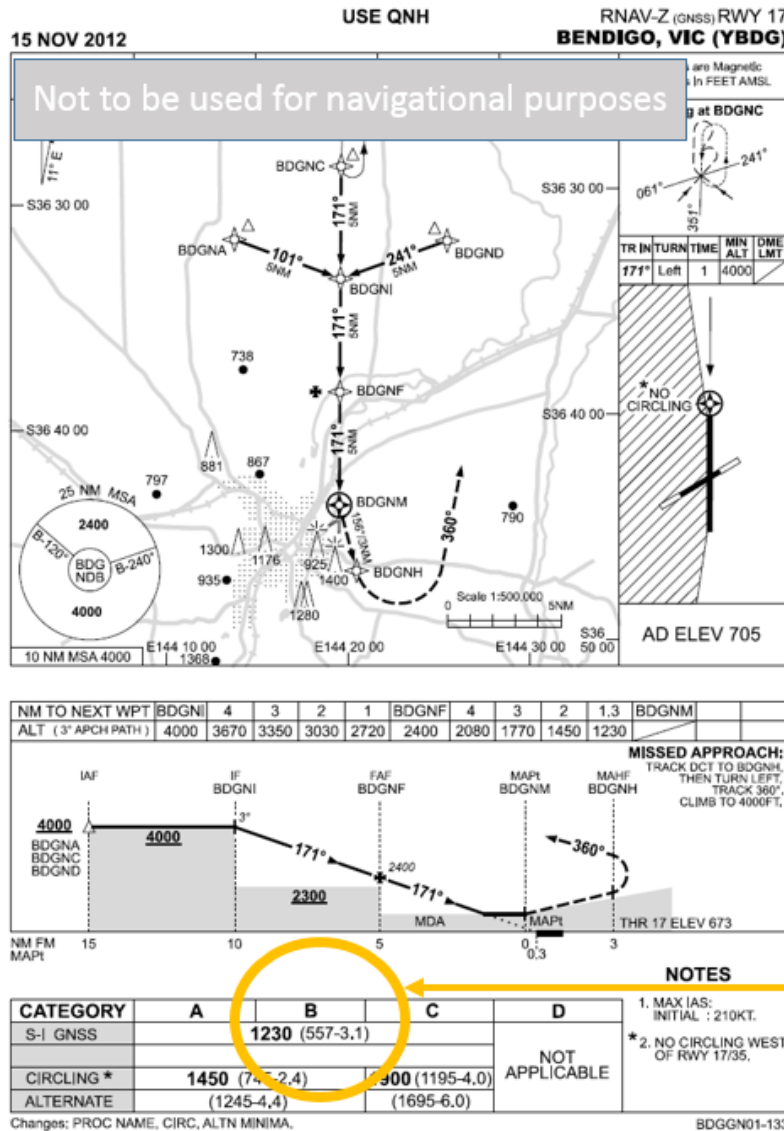
Figure 1: RNAV-Z (GNSS) approach for runway 17 Bendigo

After arriving at the final approach fix 'BDGNF', the autopilot disengaged and the pilot took over manual control of the aircraft. No vertical profile guidance was available to the pilot from the navigation system. They reported being in heavy rain, and that visibility through the windscreen was obscured by the contamination. The pilot could see the runway lights through the contaminated windscreen and rain, but reported difficulty in identifying the exact location of the ground. The aircraft was clear of cloud, but in rain, and the pilot estimated the visibility to be about 2 km. The flight data indicated that the aircraft's rate of descent in this section of the approach reached about 1,200 ft per minute.

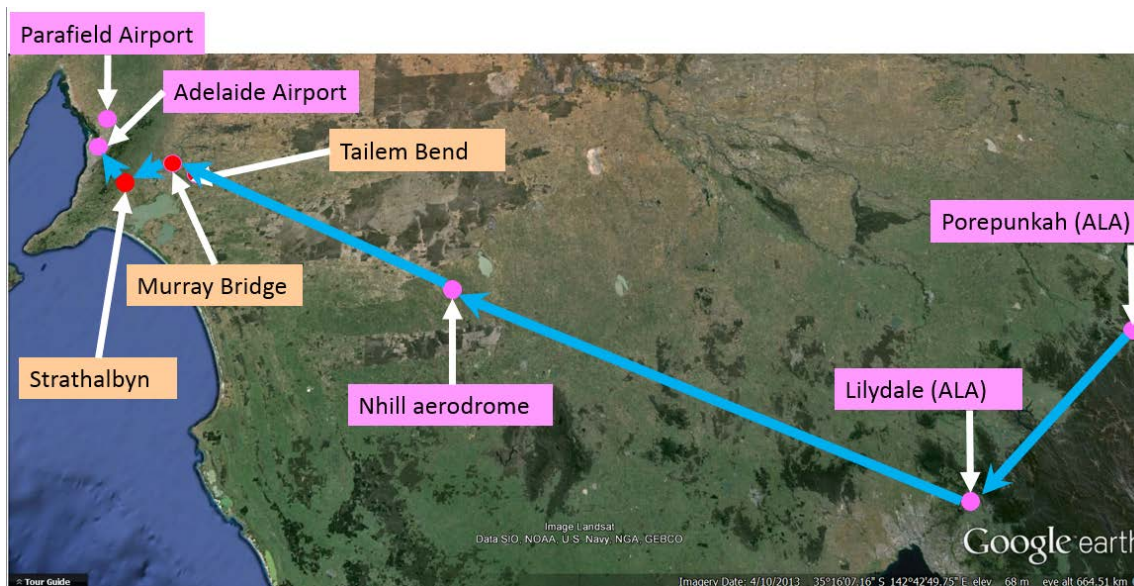
Figure 1: Approximate aircraft track from Porepunkah to Lilydale and Adelaide

On 10 July 2015, the pilot of a Piper PA-28 aircraft, registered VH-MHI (MHI), conducted a flight from Porepunkah to Lilydale, Victoria (Figure 1). In Lilydale, the pilot refuelled the aircraft, filling the tanks to full (189 L). Then the aircraft departed for Parafield, South Australia at about 1400 Eastern Standard Time (EST), with the pilot and two passengers on board.

As the aircraft passed overhead Nhill, Victoria, the pilot assessed the fuel status. The fuel gauges indicated about 100 L of fuel remaining, which the pilot reported was in agreement with the expected fuel consumption rate. The pilot calculated that based on 90 minutes flight time remaining, 60 L of fuel was required, plus 30 L fixed reserve. Therefore, the pilot assessed that sufficient fuel remained to complete the planned flight, and elected to continue towards Parafield.

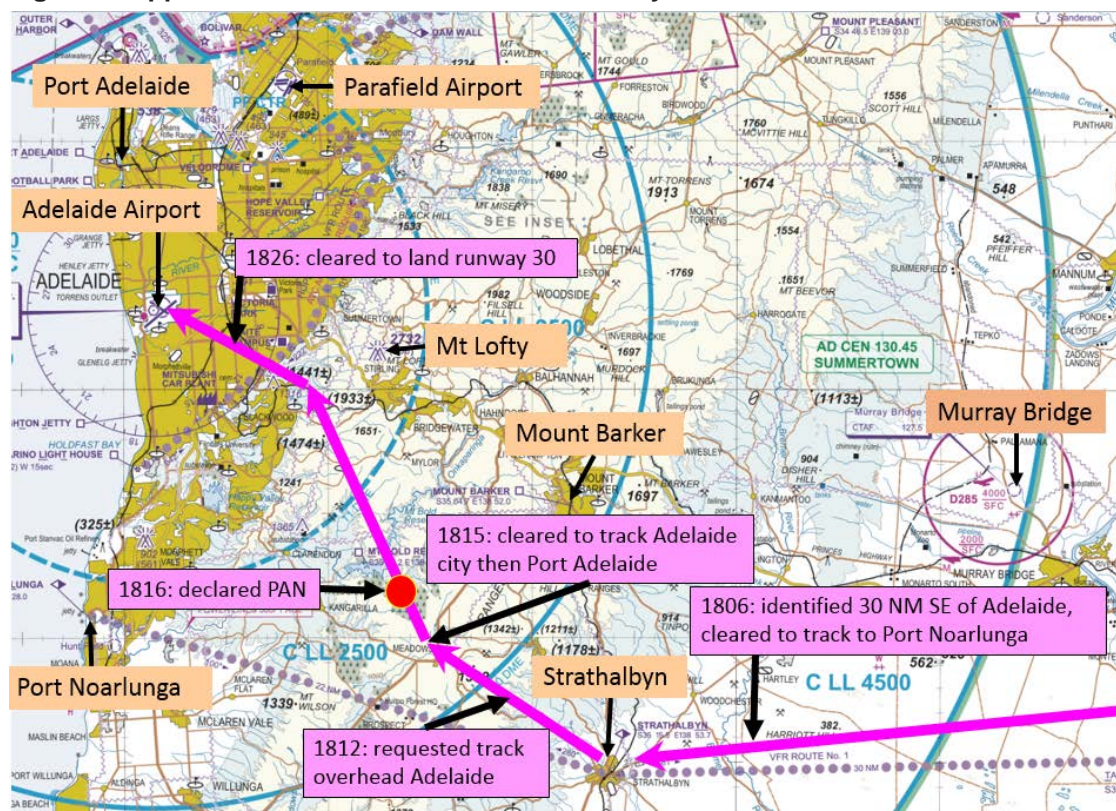
Figure 2: Approximate aircraft track from Strathalbyn to Adelaide

The pilot then switched the transponder off for about one minute, before switching it back on. At about 1803, the Adelaide Centre controller told the pilot that the Tower controller at Parafield Airport had advised that they were unable to see Mt Lofty from Parafield due to cloud. The pilot advised the controller that the aircraft was then approaching Strathalbyn and the weather appeared to be clear towards Adelaide (Figure 2). The controller then stated that the aircraft was now visible on the radar display.

At about 1805, the pilot again reported to ATC that they were approaching Strathalbyn at 4,500 ft and the controller advised the pilot to standby for a clearance. About 1 minute later, the controller identified the aircraft on the radar display, about 30 NM south-east of Adelaide and cleared the pilot to track to Port Noarlunga, then expect to track up the coast to Port Adelaide and on to Parafield.
