Australian Government
Australian Transport Safety Bureau

In-flight break-up involving de Havilland DH82A Tiger Moth, VH-TSG

300 m east of South Stradbroke Island, Queensland | 16 December 2013

ATSB Transport Safety Report
Aviation Occurrence Investigation
AO-2013-226
Final – 21 January 2016

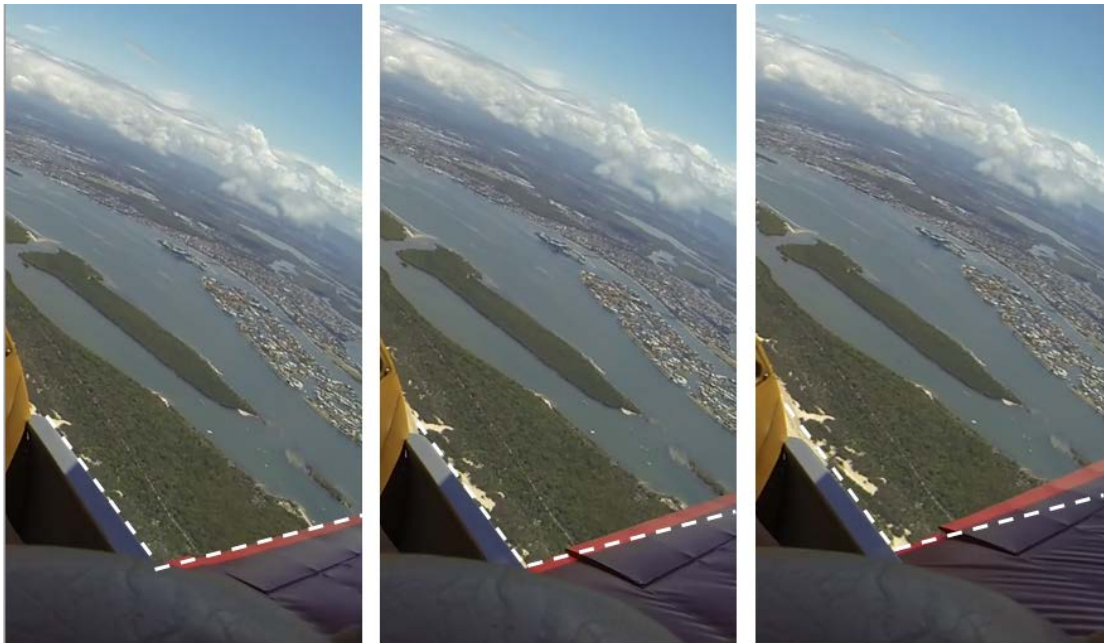
Figure 12: +0.032 sec

Figure 10 is the final picture of the aircraft's wing in what would be considered a normal state. A white dashed line was added to Figures 10, 11 and 12 to highlight the rearward movement of the wing trailing edge from its original position. The first notable indications of an abnormality were the ripples on the left lower wing's upper fabric skin (Figure 10). The rippling amplifies and moves outboard through Figures 11 to 13.

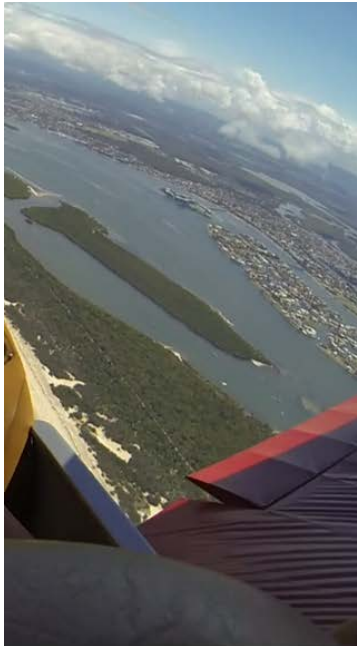
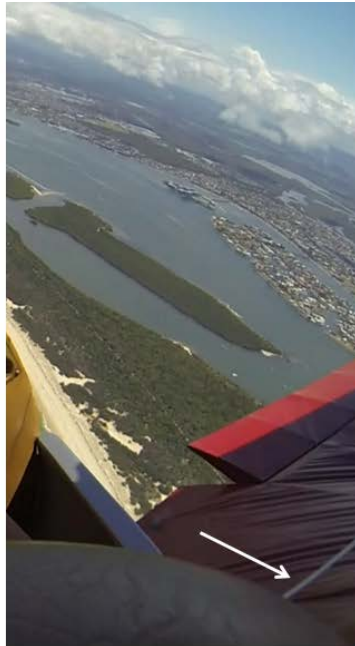
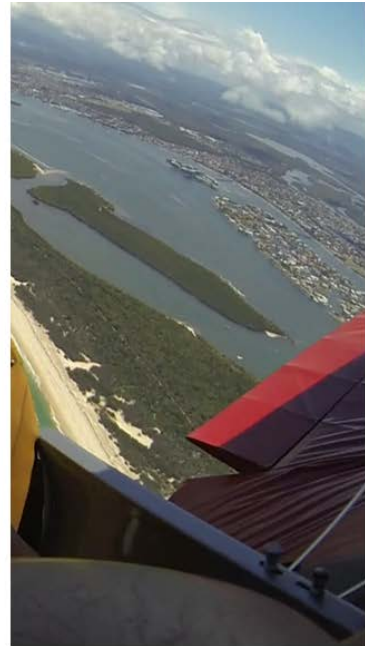
Figure 14 shows the rear of the two flying wires coming into view, indicated by the white arrow. Wing twisting also becomes apparent from this point. Figure 15 shows the front flying wire and the wing walk area also coming into view. Both flying wires are attached to the front spar inboard end and the wing walk area is also located in that area. Visibility of these features indicates movement of the inboard leading edge upwards by a considerable amount. Further, wing skin creases and wing shape indicate that the wing structure was significantly disrupted at this point.

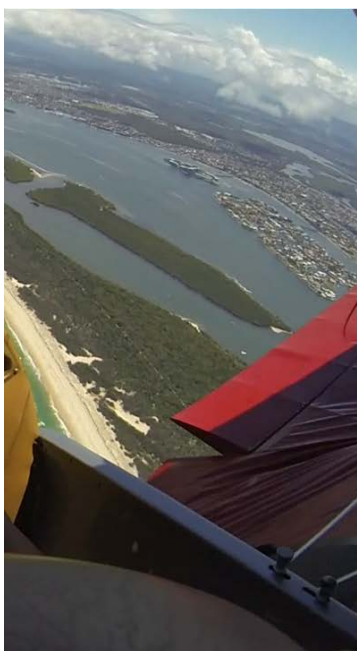
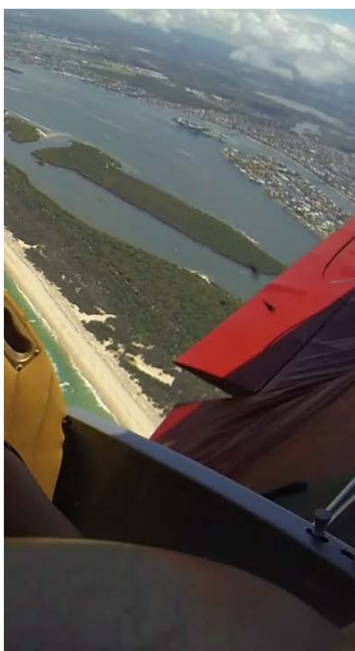
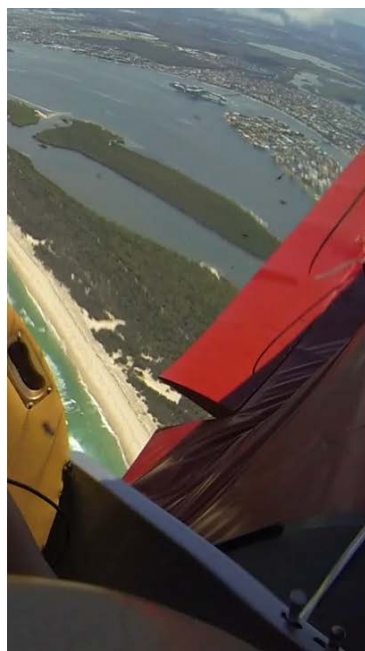
Figures 16, 17 and 18 show the end of the raised section of wing walk continuing into view. It also shows the mid-section of the wing rising, which indicates further wing structural disruption.

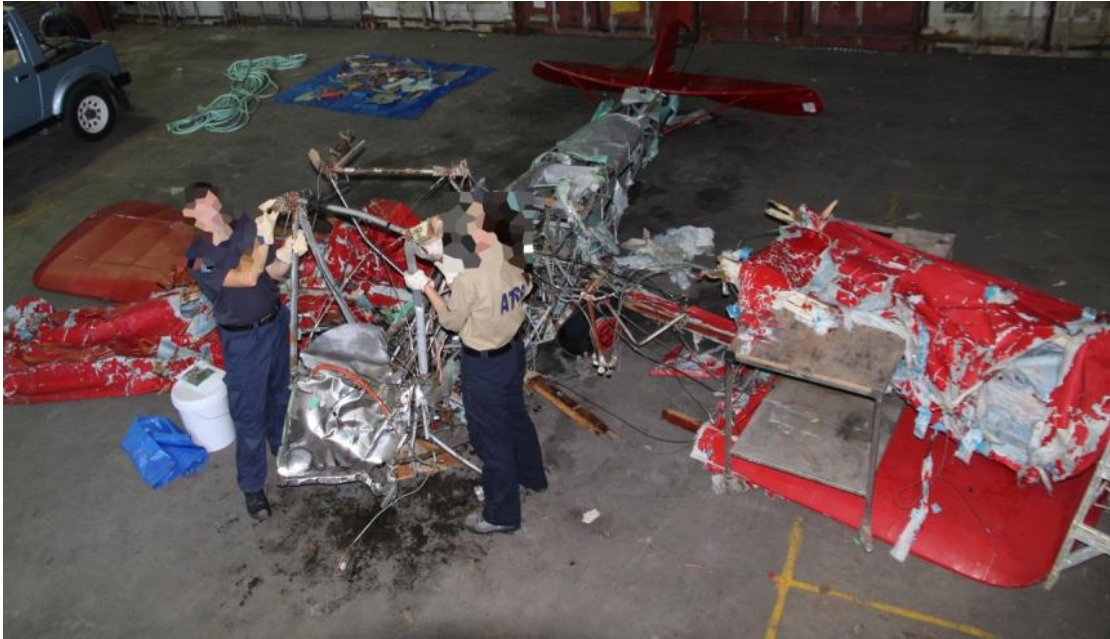
Figure 21: Wreckage reconstruction

The fuselage structure and flight control systems were inspected with no pre-impact defects identified. The fuselage and wings were reconstructed to assist with determining the aircraft break-up sequence (Figure 21).

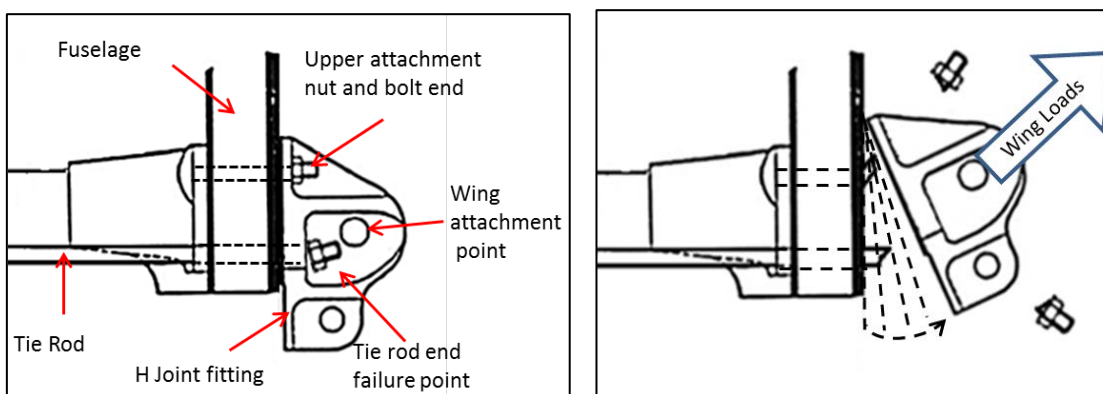
With the fracture of the two tie rods on the left side, the two upper attachment bolts and nuts were the only remaining attachment hardware securing the Joint H fitting to the left side of the fuselage. The flight loads from the left wings acted on the Joint H fitting at the left lower wing attachment point, below the remaining attachment hardware. The upper attachment hardware was not designed for, and not capable of sustaining the loads applied by the wings in the absence of the tie rods. The upper attachment bolts failed in overstress. The left Joint H fitting and left lower wing forward attachment point then detached from the fuselage (Figure 31).

Figure 31: Wing attachment fitting showing the effect of the tie rod failures, followed by the upper attachment bolt failures and leading to wing fitting separation

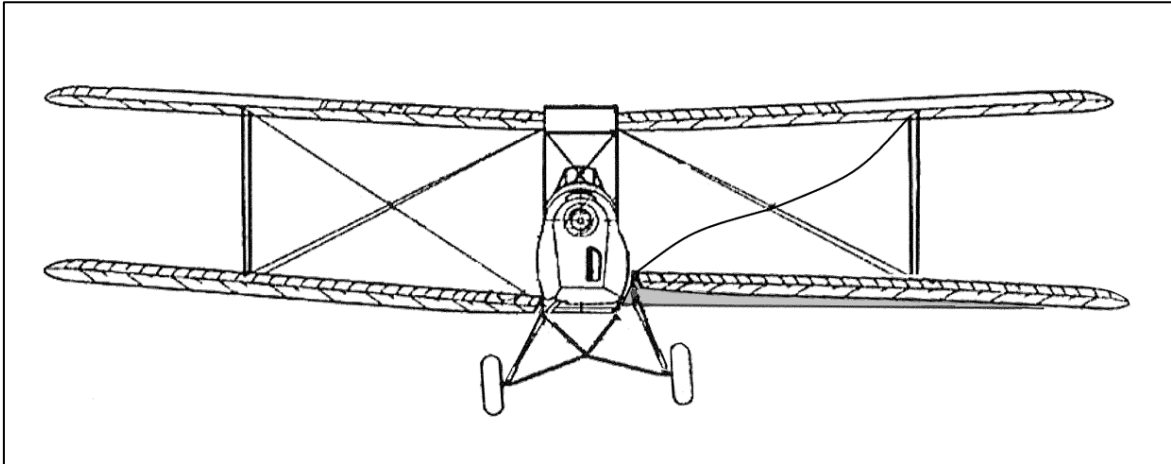
When the wing attachment fitting separated, it allowed the fitting to move upwards until the movement was restrained by the landing gear. The left lower wing was still partially supported by the rear attachment fitting and the interplane struts, resulting in the inboard leading edge moving upwards, increasing the incidence of the inboard lower left wing (Figure 32).

Figure 32: Initiation of the left wings failure (looking aft)

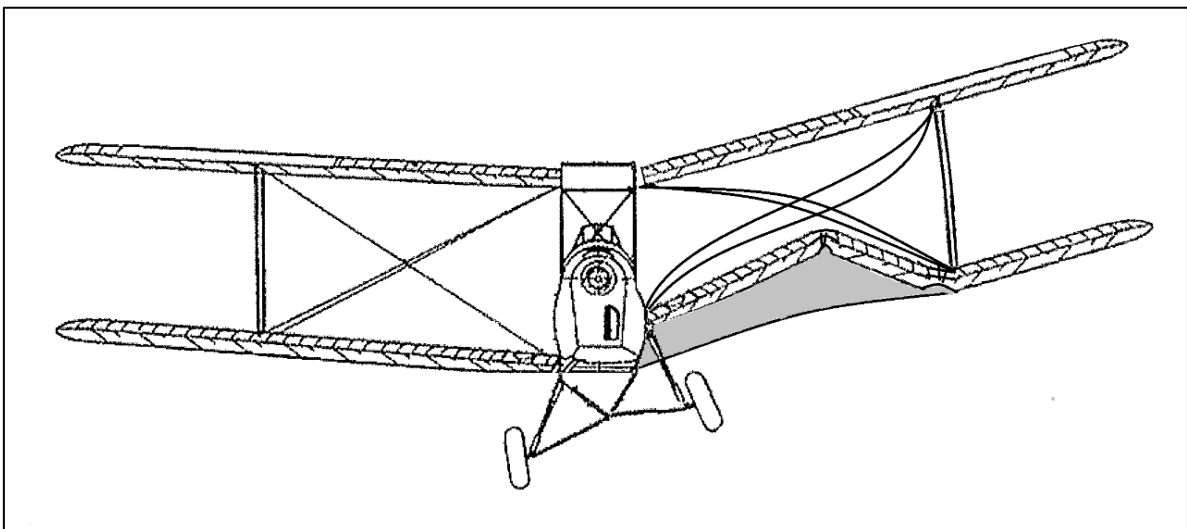
The increase in the incidence of the left lower wing increased the aerodynamic loads generated by that wing. Those loads continued to increase until the left lower wing front spar failed due to bending between the wing attachment fitting and the interplane struts (Figure 33).

The failure of the tie rods resulted in a loss of structural integrity of the lower and upper left wings, leading to the in-flight break-up of the aircraft.

Figure 33: Left wing structural collapse

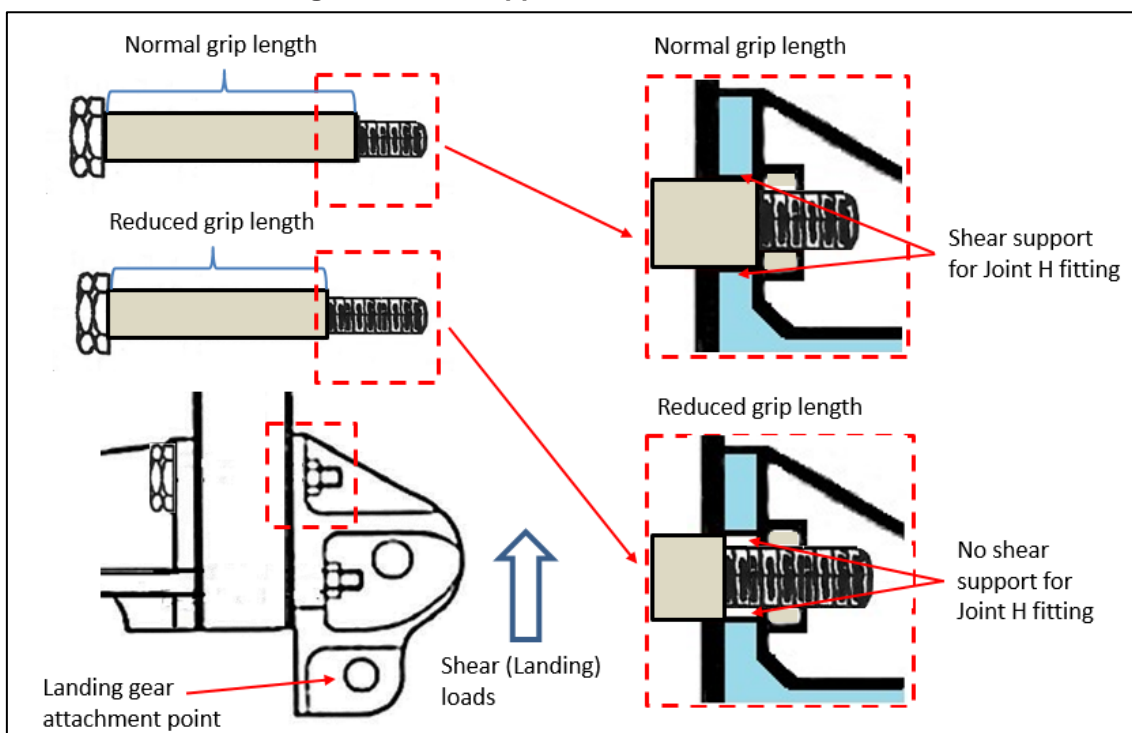
Assembly with undersized bolts had the potential to cause excessive shear loads to be imparted into the tie rods because of in-flight or landing loads (Figure 34). The ATSB was not able to determine the effect that this may have had on the fatigue life of the tie rods, but was likely to have been detrimental.

Figure 34: Joint H fitting bolts showing different grip lengths and the effect that had on Joint H attachment fitting shear load support

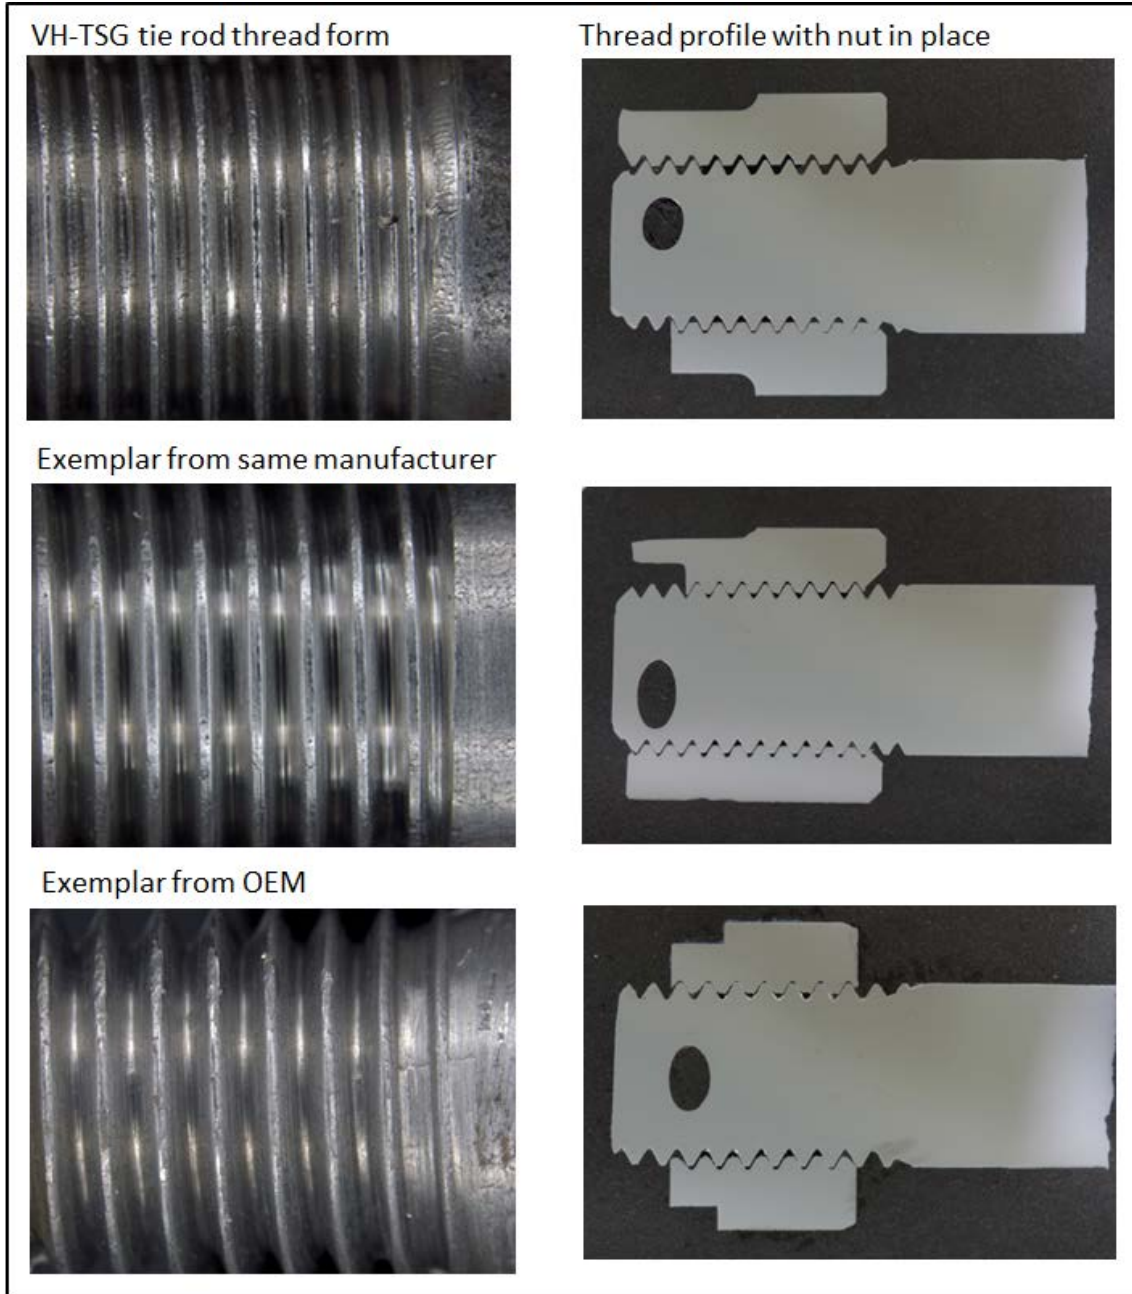
Figure A6: JRA-776 tie rod thread comparison

Examination of the tie rods with their associated nuts found that the thread fit was also variable, with VH-TSG's nuts noticeably looser when engaged. The three rods were sectioned and polished with the nuts in situ to illustrate this difference.⁴⁹ The effect of a loose thread fit on fatigue endurance of the components was not determined.

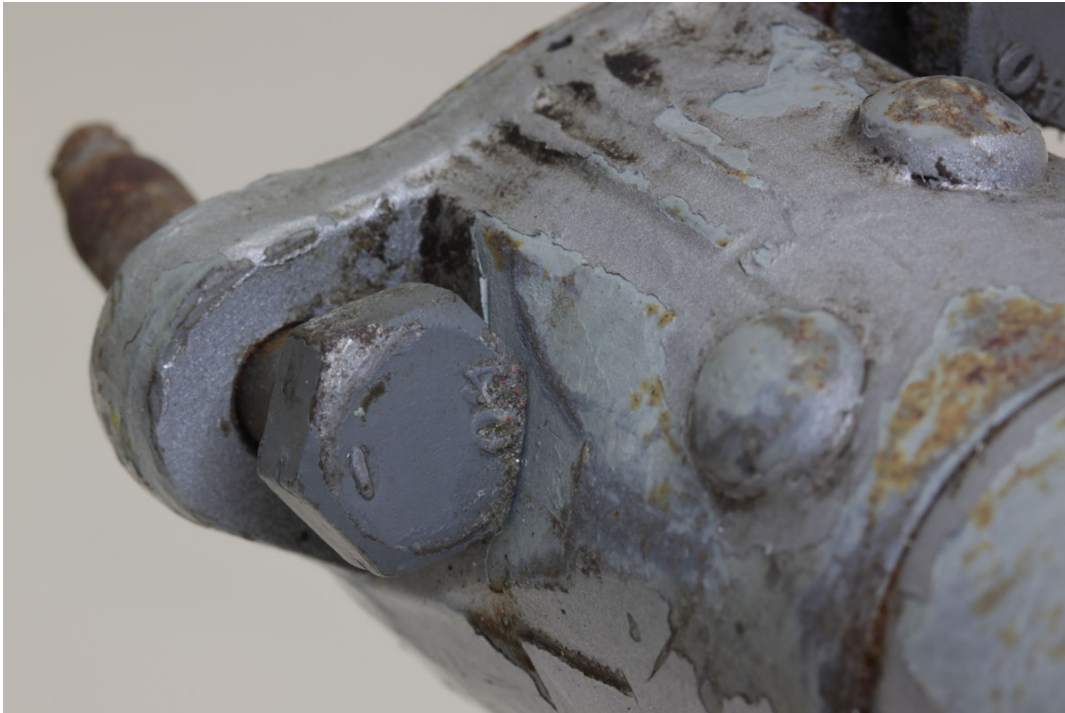
Figure A9: Bolt on right side showing head markings
