Aviation Short Investigations Bulletin

Issue 28

ATSB Transport Safety Report
Aviation Short Investigations
AB-2014-037
Final – 27 March 2014

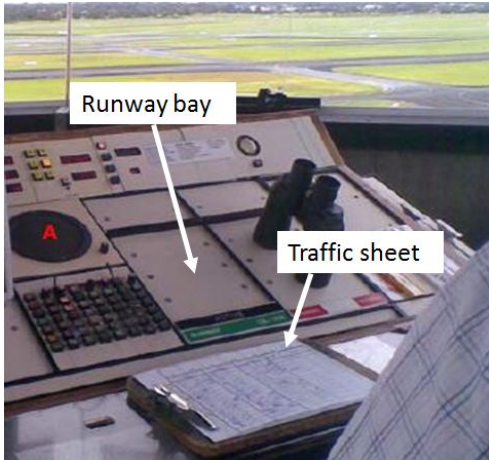
Figure 2: Aerodrome controller – east console

in use. He was seated between ADCE and SMC, from where he was able to sight the aerodrome. ADCE had the runway strip for runway 17L on the runway bay on the console (Figures 2 and 3).

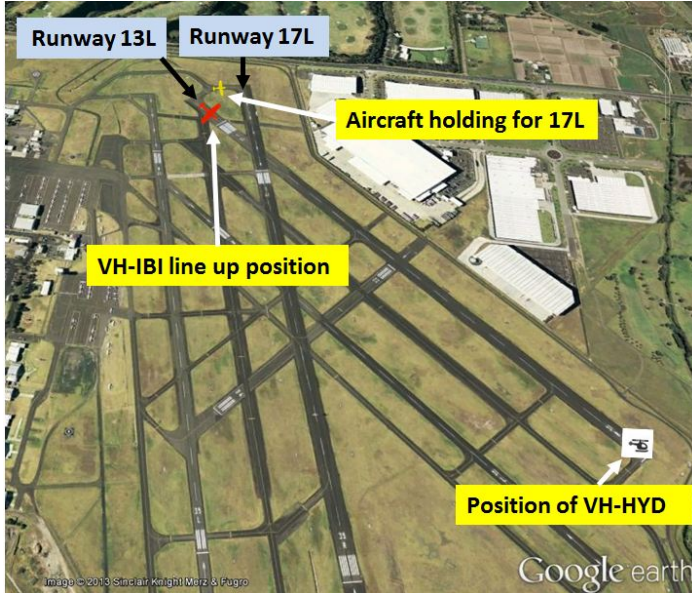
Figure 7: Aircraft positions

At this time, the helicopter, HYD, was on the runway 31 Right threshold at the far end of runway 13L, however ADCE did not see the helicopter when conducting a scan of the runway prior to clearing IBI for take-off. ADCE reported that the 'Helicopters' strip on the console was not effective in alerting the controller to the presence of the helicopter (Figure 7).

At about 0918, ADCE cleared IBI for take-off from runway 13L. The pilot of IBI sighted the helicopter ahead, on the runway centreline, when about two-thirds of the way along the runway. As the aircraft had already exceeded the minimum rotate speed, the pilot continued the take-off, increased the aircraft's angle of climb, and IBI passed about 100-200 ft above HYD.
