Derailment of Sydney Trains Passenger Train 602M

near Edgecliff station, Sydney, NSW | 15 January 2014

ATSB Transport Safety Report
Rail Occurrence Investigation
RO-2014-001
Final – 3 December 2015

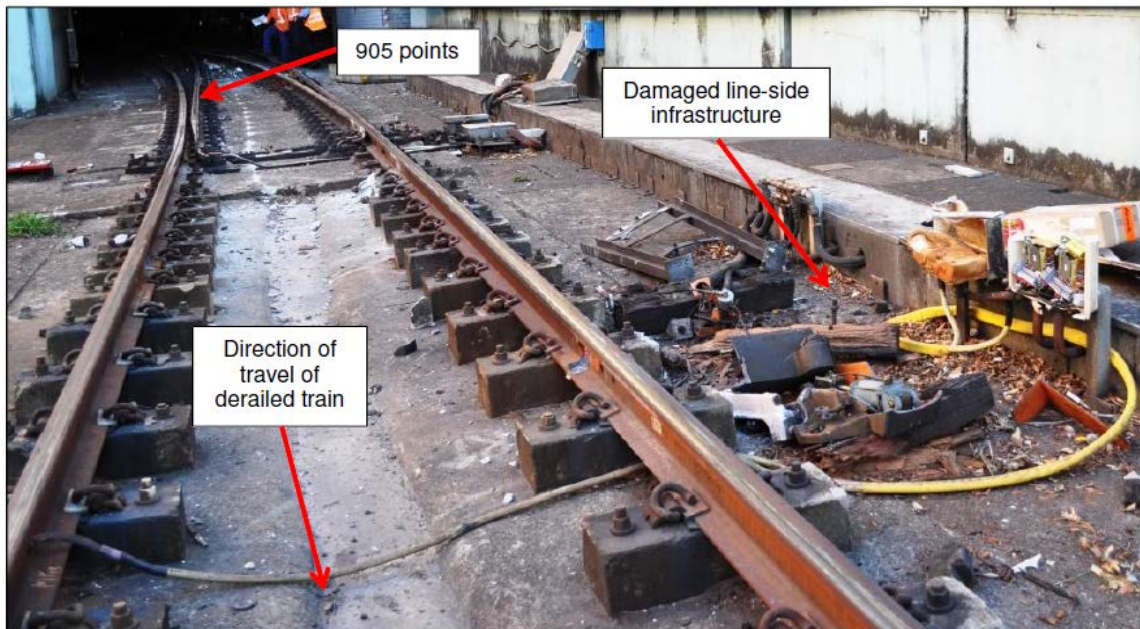
Figure 9: View of Up track between Edgecliff and the derailed train’s location

Unlike conventional track, at the point of derailment, the rails were secured to polymer concrete half sleepers which were in turn fixed to and supported by concrete slabs (Figure 9). In the Sydney Trains’ network, using either concrete or wooden half sleepers, is peculiar to parts of the ESR and Sydney underground railway.

At Edgecliff, the Up ESR ran alongside platform 1 of Edgecliff station and curved to the right. After a transition, the curve was constant at a radius of 402 m and a superelevation of 65 mm. At the derailment site there was a known wide gauge of 27.5 mm. That is, the distance between the rails was 1462.5 mm rather than the standard gauge of 1435 mm. No other defects were noted.

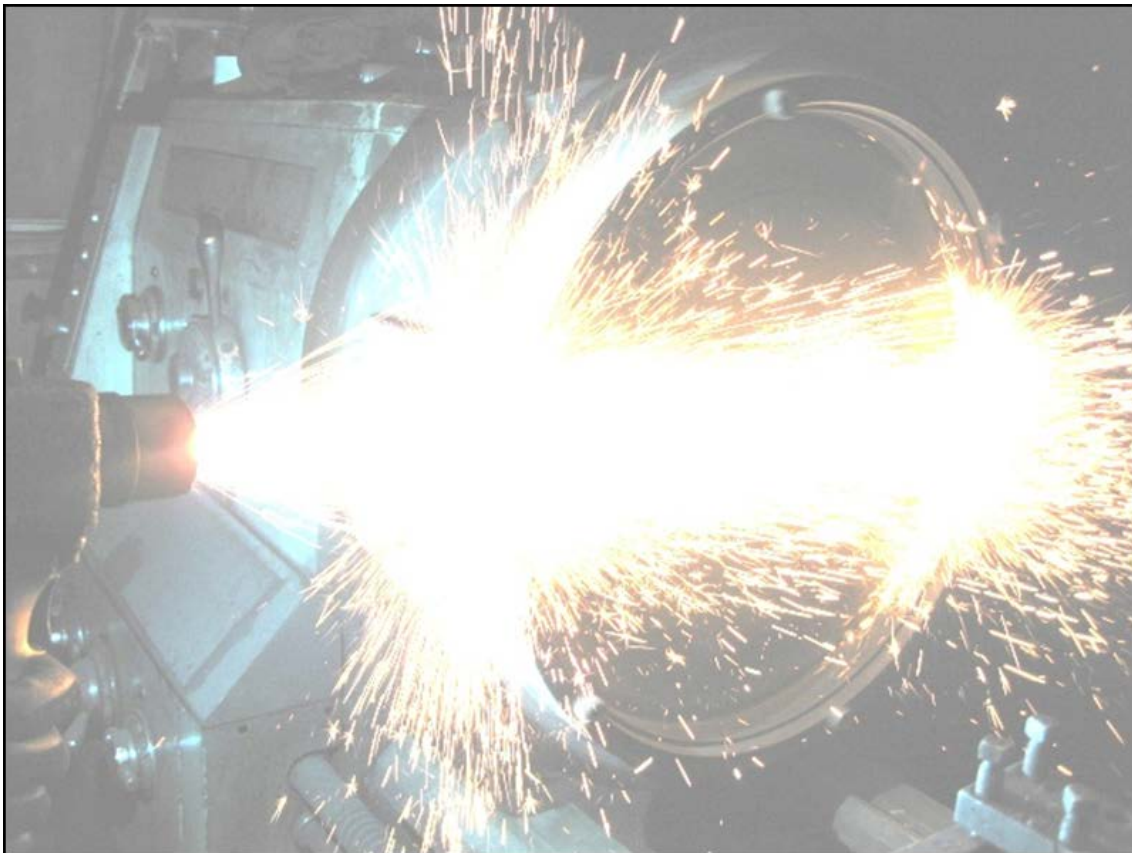
Figure 18: Example of metal spraying process

Thermal Metal Spraying requires machining of the parent metal on a lathe such that a depth of at least 0.5 mm new material can be achieved. The machining produces a grooved surface with a pitch of between 0.25 mm and 0.35 mm and a depth of 0.5 mm. The job is then pre-heated to between 100°C and 140°C and a bonding coat (depth 0.1 to 0.15 mm) of nickel/molybdenum/aluminium alloy is applied. This is closely followed by the application of 420 grade stainless steel. Application is by using twin electric arcs to heat the wire fed material such that it can be sprayed onto the surface to be repaired (Figure 18). Build up and adhesion of the material is a mechanical rather than fusion process: the material is not heated to a molten state but, being both heated and given velocity, has the malleability and kinetic energy to flatten as it hits the repair, joining with and building up the surface progressively as the job is rotated, at approximately 80 RPM on the lathe. Once material has been built up to a depth such that the diameter is 2 mm oversize, it is ground to produce the final surface finish and specified dimension.

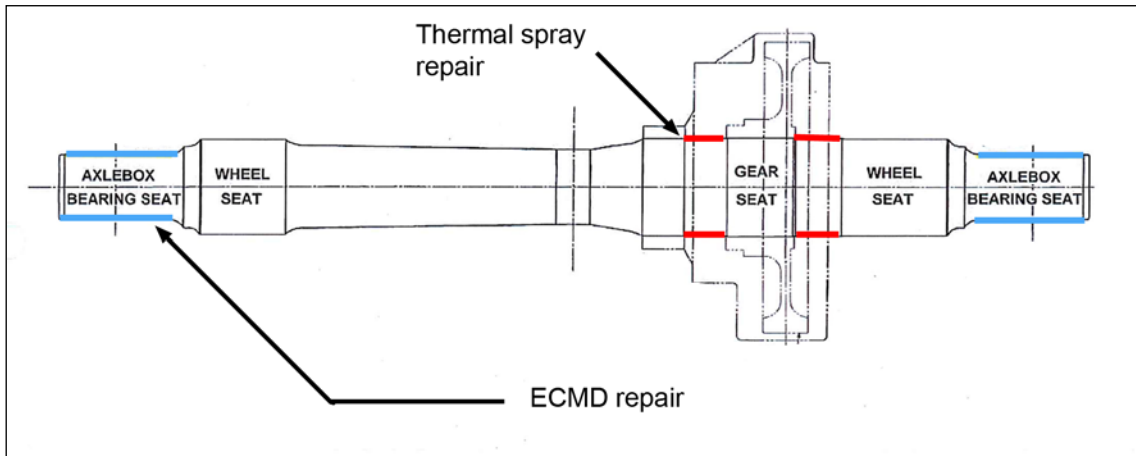
Figure 10: Repair locations on Tangara axles – repair around the gearbox is not normally performed

The company that conducted the axle repair work reported that the axles were initially prepared by machining of the axle surface, followed by the spray application of an intermediate bond layer of nickel/molybdenum/aluminium, later followed with a thicker deposited layer of an iron-chromium alloy steel. The metal surface layer was applied to the axle in the region of the low speed gear seat, via a twin-arc process; the alloy was softened and then deposited in droplet form onto the axle using a high velocity gas jet (**Figure 10**).

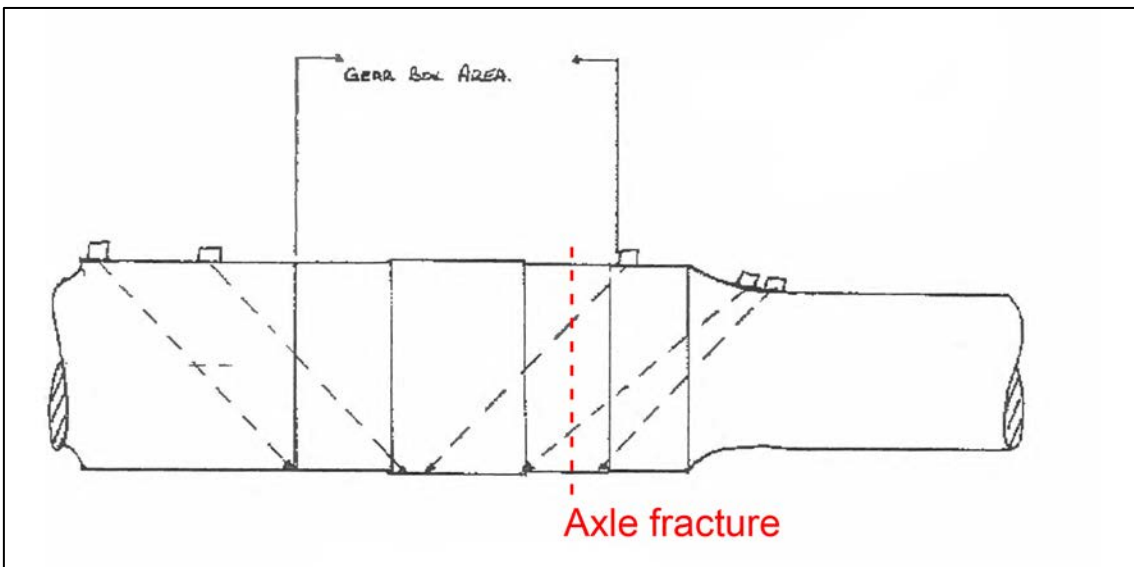
Figure 11: Scanning for cracks with the gearbox in-situ: ultrasonic inspection probe scann1g positions

It was not possible for the magnetic particle testing to detect for cracks in the region inboard of the gearbox housing with the gearbox remaining assembled to the axle. With the gearbox in place, the operator used an ultrasonic inspection procedure, *Gear Area Ultrasonic Examination P-3000-UT-0071* that was designed to detect for cracks under the bearings, oil flingers and the low speed gear region. The inspection was accomplished using a 45-degree angled flaw detector at a number of positions along the axle (**Figure 11**).

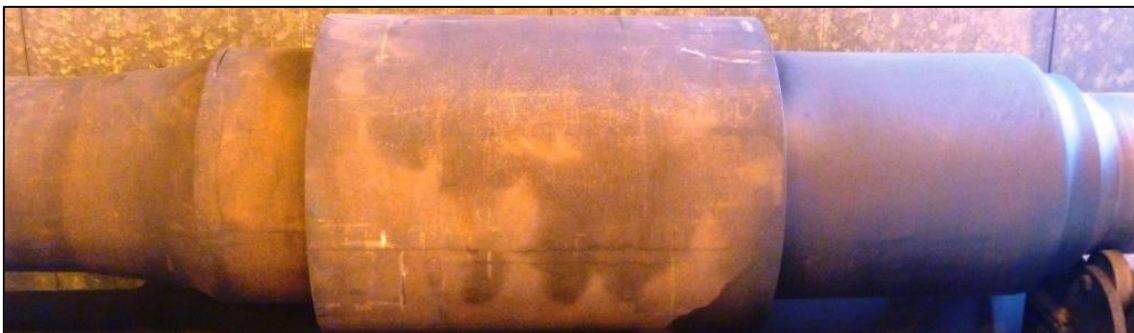
Figure 12: Tangara axle ultrasonic testing reference standard

In order to calibrate the ultrasonic test equipment, an axle reference standard was utilized by the technicians prior to testing. The reference standard comprised a length of Tangara axle coupled with a steel sleeve (simulating the low speed gear) that had been shrink-fitted over the axle surface (**Figure 12**). Underneath the sleeve, artificial defects in the form of 2 mm deep circumferential grooves had been machined into the axle and they were used to assist in the calibration of the equipment.
