Australian Government
Australian Transport Safety Bureau

Collision between V/Line train 8280 and MTM train 6502

Altona, Victoria | 22 August 2014

ATSB Transport Safety Report
Rail Occurrence Investigation
RO-2014-016
Final – 6 July 2016

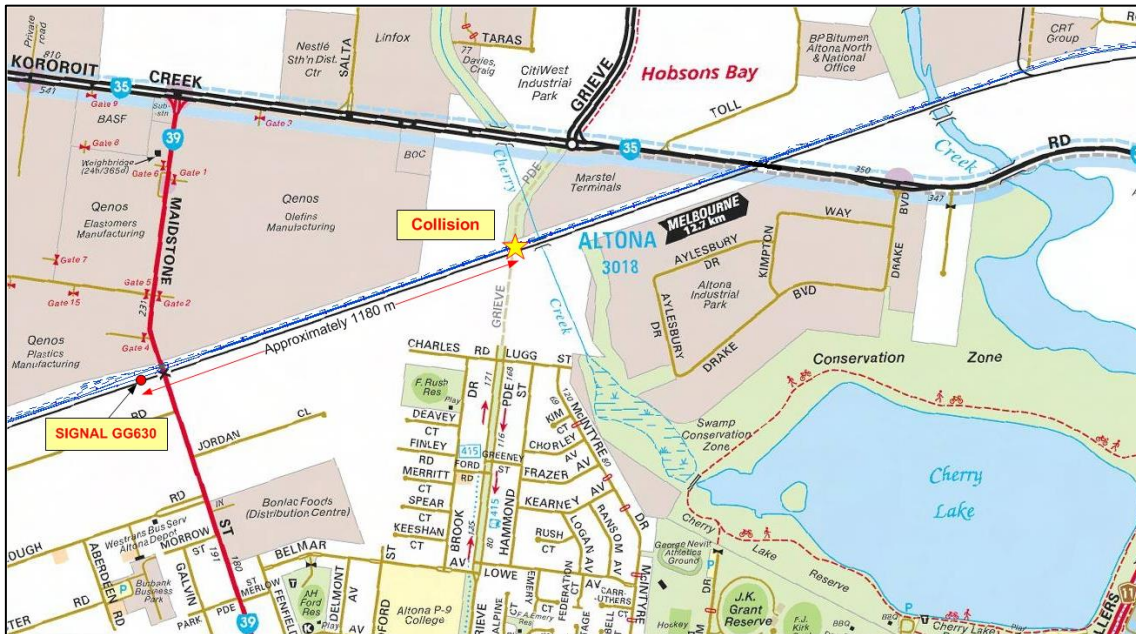
Figure 6: Location of collision

The collision occurred on the MTM rail network between the Maidstone Street and Kororoit Creek Road level crossings in Altona, Victoria (Figure 6). Altona is approximately 22 km from Flinders Street Station, Melbourne.

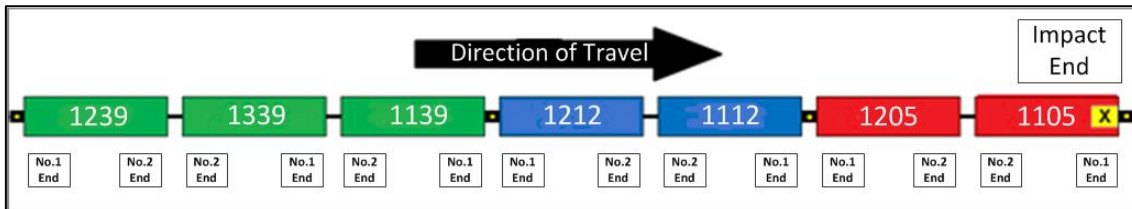
Figure 9: Train 8280 DMU configuration

The V/Line train 8280 was a VLocity Diesel Multiple Unit consisting of VL05 (units 1105 and 1205), VL12 (units 1112 and 1212) and VL39 (units 1139, 1339 and 1239).

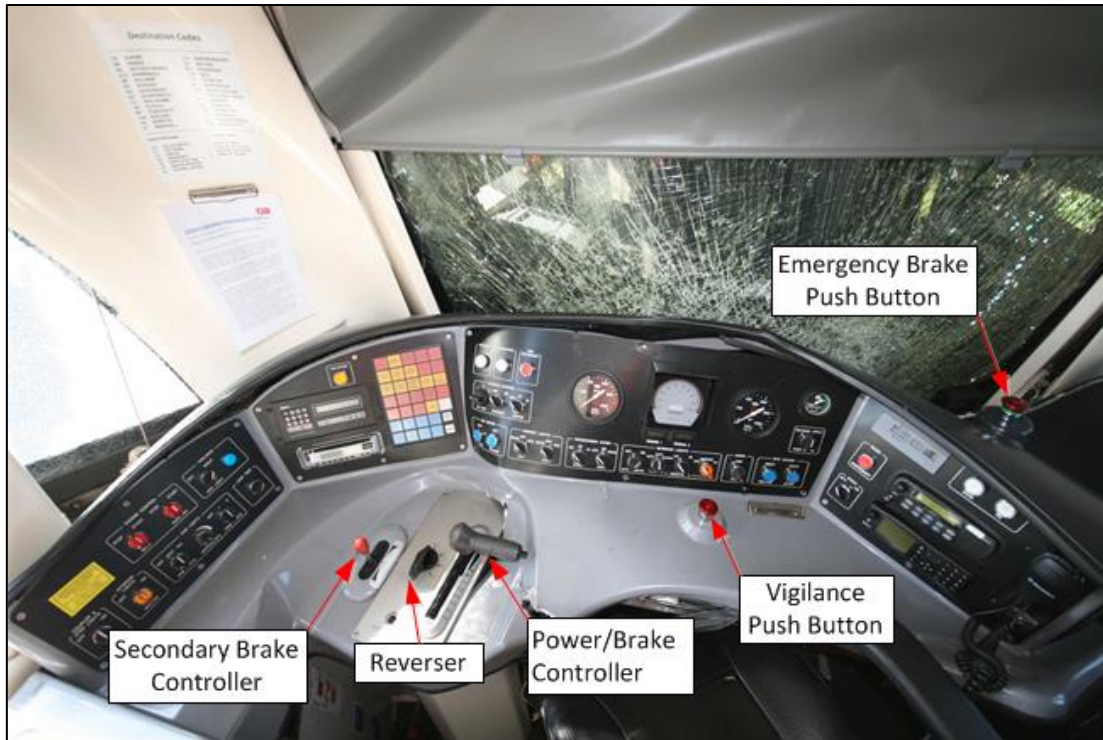
Figure 10 - Driver control console showing the main controls

The driving control console of the VLocity is a wrap-around style instrument panel (Figure 10). The cab windows provide good visibility for the train driver. The Reverser is a four-position switch that is moved between Off, Forward, Neutral and Reverse positions. The Power/Brake Controller

(PBC) is used to control traction power and brake effort. The PBC operates in power mode when pulled back from the centre 'off' position and in the brake mode when pushed forward from the centre position. There are six power notches that dictate the tractive effort. In brake mode, the controller moves seamlessly between minimum and full service braking. The Secondary Brake Controller (SBC) is used in the event of a brake control unit failure and braking effort becomes unavailable through the PBC. The SBC directly controls the brake pipe pressure to independently apply and release the brakes. Emergency braking can also be achieved by activating the emergency brake pushbutton located on the control console.
