# Runway excursion involving Cessna 550, VH-FGK

Lismore Airport, New South Wales | 25 September 2015

**ATSB Transport Safety Report**  
Aviation Occurrence Investigation  
AO-2015-114  
Final – 25 July 2016

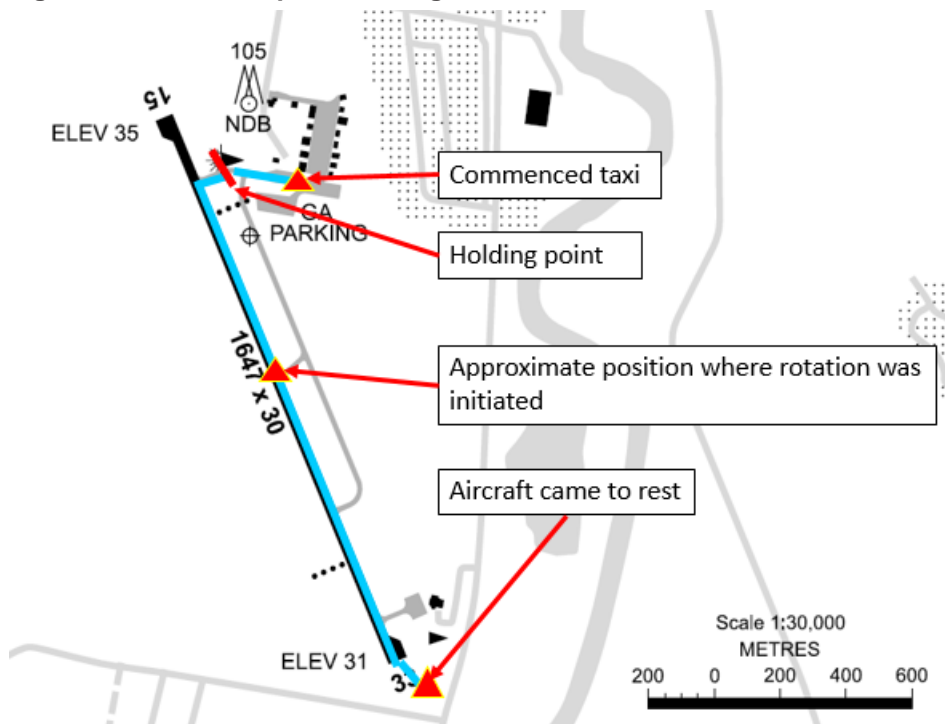
**Figure 1: Lismore Airport showing aircraft track**

The captain taxied the aircraft onto the runway, and turned left onto the runway centreline to commence the take-off run from the intersection (Figure 1). While rolling along the runway, the captain advanced the thrust levers to the approximate take-off setting. The captain then called ‘set thrust’, and the copilot set the thrust levers to the more precise position needed to achieve the planned engine thrust for the take-off.

Runway 15 at Lismore had an available take-off length of 1,647 m (5,403 ft). The runway sloped down by 0.1 per cent. The aircraft was taxied onto the runway at the northern taxiway intersection, about 152 m (500 ft) beyond the runway threshold (Figure 1). Although the take-off was commenced from the intersection, an additional 152 m of runway was available to the crew for the take-off.

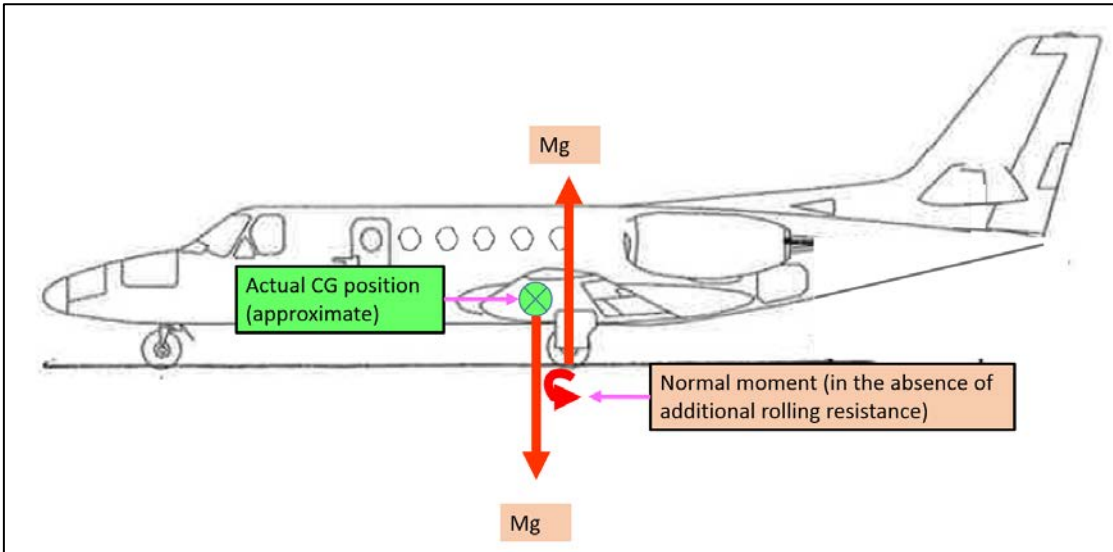
**Figure A-5: Representation of normal nose-down moment and centre of gravity (in the absence of additional rolling resistance)**

The nose-down moment due to the additional rolling resistance, depicted in Figure A-4, is equivalent to the nose-down moment due to the vertical force ( $Mg$ ) through a more forward centre of gravity position (Figure A-6). So that  $0.13 Mg * 5.35 \text{ (ft)} * 12 \text{ (inches per foot)} = Mg * x$ , where  $x$  is the effective forward movement of the CG. Therefore,  $x$  is 8.35 inches, which is 10.3% MAC.
