Aviation Short Investigations Bulletin

Issue 50

ATSB Transport Safety Report
Aviation Short Investigations
AB-2016-088
Final – 25 August 2016

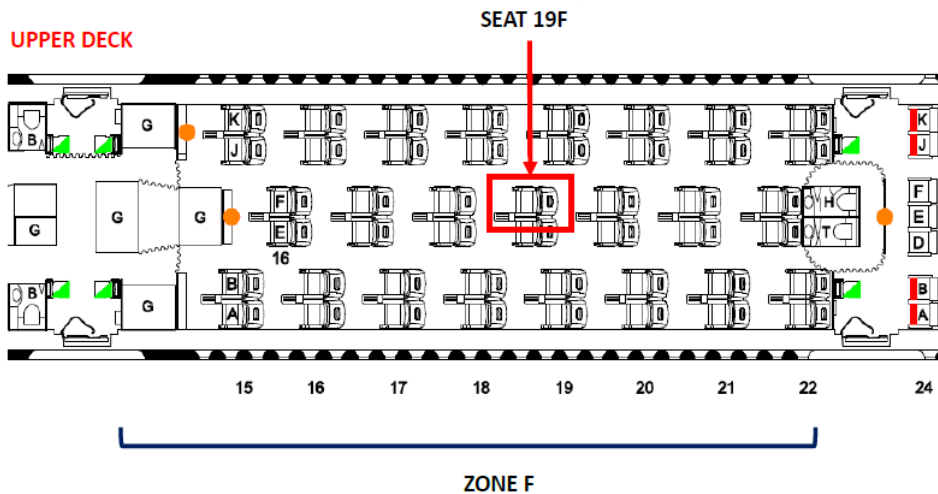
Figure 2: Cabin diagram showing the seat from where the smoke emanated

The cabin crew located the source of the smoke at seat 19F, in Zone F, on the upper deck (Figure 1). The crew removed the seat cushions and covers from seat 19F while the CSM turned off the power to the centre column of the seats. When the seat was further dismantled, the crew found a crushed personal electronic device (PED) wedged tightly in the seat mechanism. The cabin crew assessed that the crushed PED contained a lithium battery.

By that time, the PED was no longer emitting smoke, however, a strong acrid smell remained in the cabin. The crew then manoeuvred the seat and freed the PED (Figure 2). The crew placed the PED in a jug of water, which was then put in a metal box and monitored for the remainder of the flight.

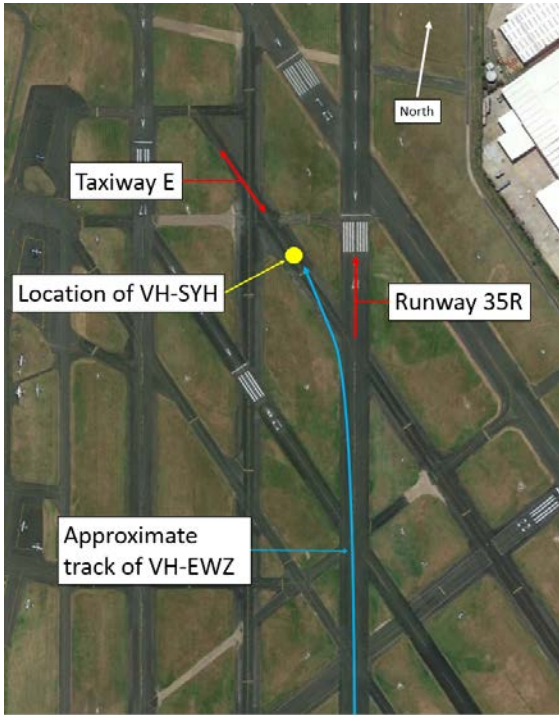
Figure 1: Moorabbin Airport showing location of collision

The underside of the left wing of EWZ contacted the top of the right wing of SYH (Figure 2). EWZ came to a stop on the grass to the left of runway 35R. Both aircraft sustained minor damage and the pilots were uninjured (Figure 3).

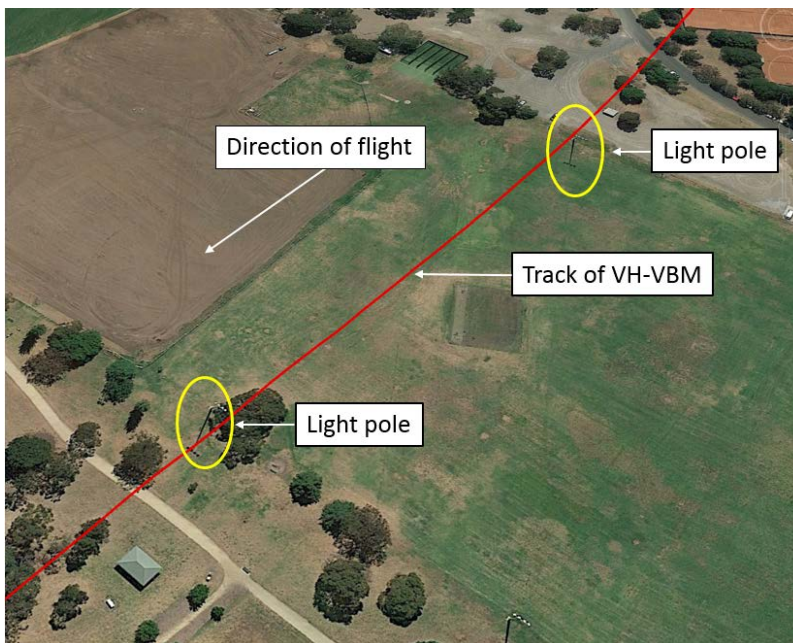
Figure 2: Dendy Park showing light poles

At about 0800, the balloon in company with VBM landed safely at Dendy Park. The wind speed was about 10 kt as VBM approached Dendy Park. As the balloon descended to land, the pilot sighted a light pole directly in the balloon's path (Figure 2). The pilot then lit the balloon's burners to climb over the pole, however, a second light pole stood directly in the balloon's path on the far side of the available landing area. Due to the balloon's height and the wind, the pilot assessed that the balloon may collide with the second pole if the pilot attempted a landing and therefore elected not to land in the park.
