# Aviation Short Investigations Bulletin

Issue 46

**ATSB Transport Safety Report**  
Aviation Short Investigations  
AB-2015-148  
Final – 28 January 2016

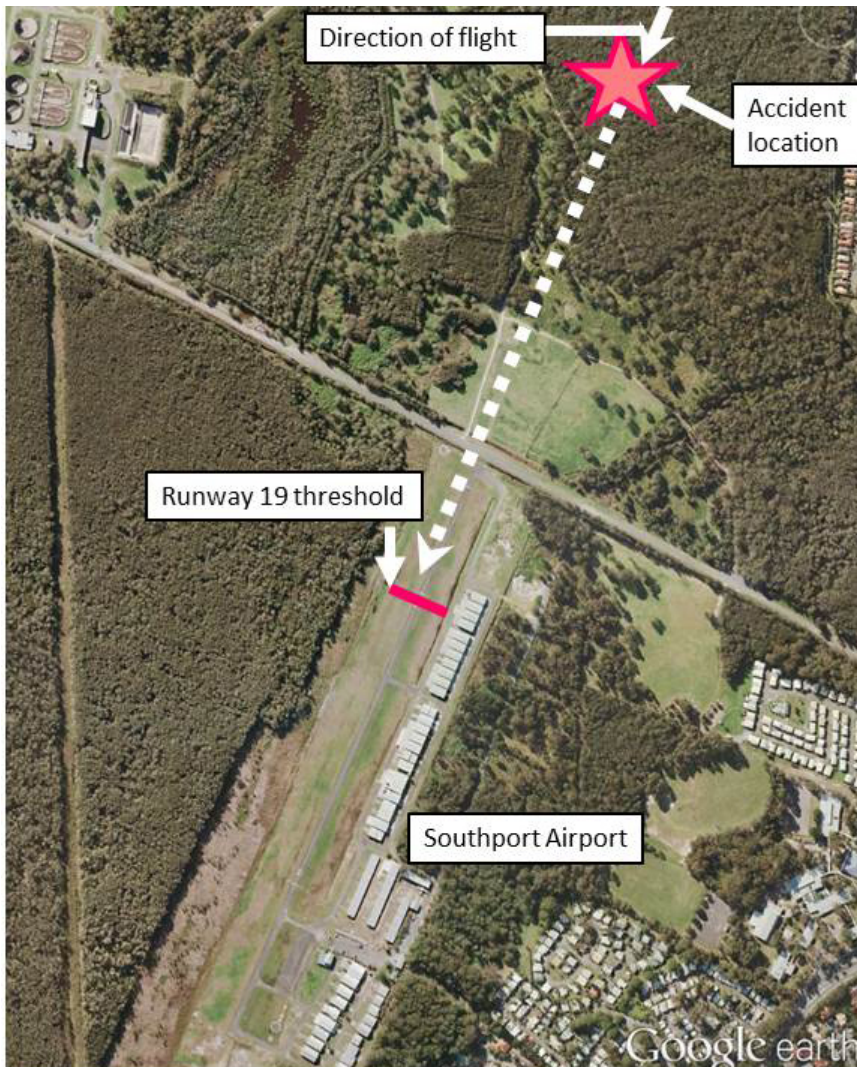
**Figure 1: Southport Airport and accident location**

About 800 m from the runway threshold, at about 150 ft above ground level, the aircraft's engine stopped. The pilot broadcast a Mayday<sup>1</sup> and conducted a forced landing (Figure 1). The aircraft collided with trees, resulting in substantial damage and the pilot was not injured (Figure 2).

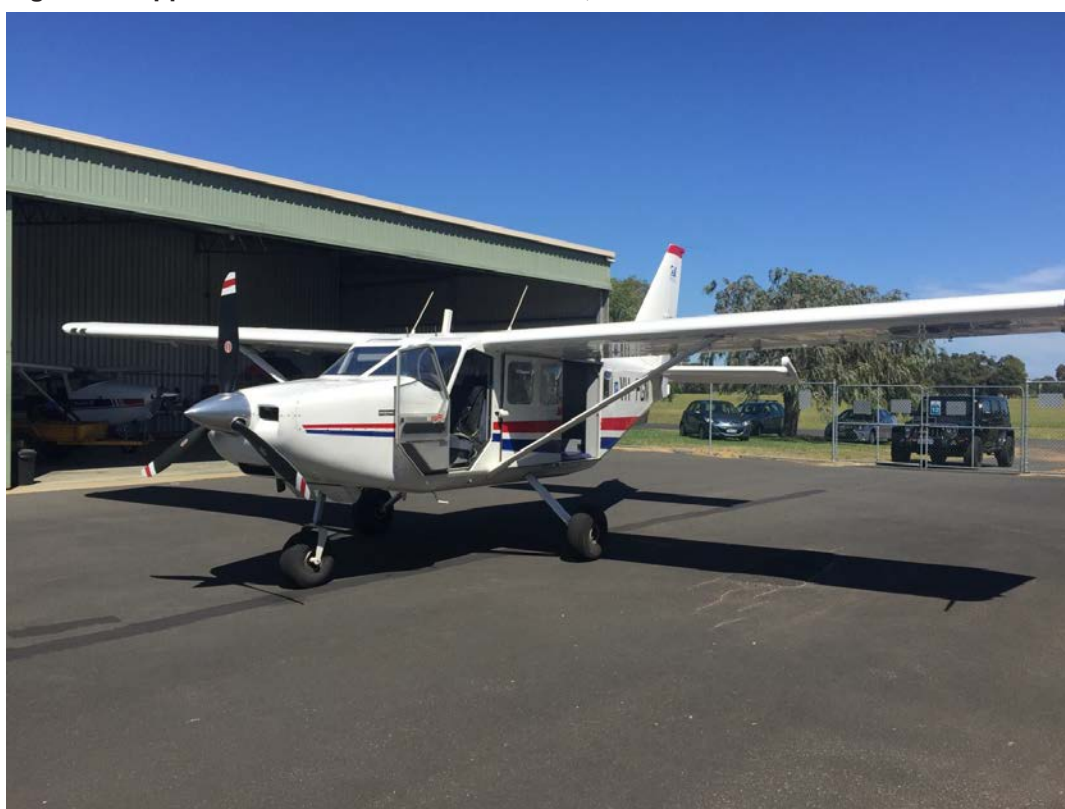
**Figure 1: Gippsland Aeronautics GA-8 aircraft, VH-FGN**

At about 1500 Western Standard Time (WST), FGN took off from Busselton Airport with a pilot and seven parachutists on board. As the aircraft climbed through about 2,000 ft, the pilot observed a decrease in the engine manifold pressure. The manifold pressure was still in the green arc, or normal operating range, but indicating about 30 inches. The normal manifold pressure during the climb was about 38 inches. The fuel flow also increased from about 120 L/hr to 154 L/hr. As the aircraft was tracking south towards forested terrain, the pilot elected to turn back towards the aerodrome, and continue the climb, in case the engine issue worsened. The pilot conducted the standard engine checks, but the engine continued to produce only partial power. The pilot broadcast a Mayday<sup>1</sup> on the Melbourne Centre air traffic control (ATC) frequency.
