# Aviation Short Investigations Bulletin

Issue 53

**ATSB Transport Safety Report**  
Aviation Short Investigations  
AB-2016-121  
Final – 14 October 2016

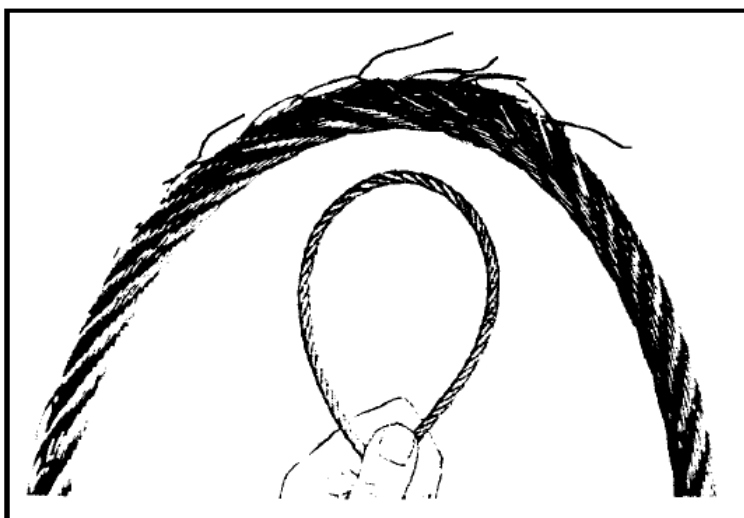
**Figure 5: Cable inspection technique**

United States Federal Aviation Administration [Advisory Circular 43-13-1B chapter 7](#), section 8, paragraph 7.149 states that: ‘deterioration, such as corrosion, is not easily seen, therefore, control cables should be removed periodically for a more detailed inspection and any cable with a broken strand in a critical fatigue area<sup>6</sup> must be replaced.’ See Figure 5 below.

- Paragraph 7.149i states that: ‘**Areas especially conducive** to cable corrosion are battery compartments...etc.; where a concentration of corrosive fumes, vapours, and liquids can accumulate.’
- Paragraph 7.152 states that where control cables pass over pulleys: ‘Provide corrosion protection for these cable sections by lubricating with a light coat of grease or general purpose, low-temperature oil.’
