Derailment of freight train 9T92

Near Julia Creek, Queensland | 27 December 2015

ATSB Transport Safety Report
Rail Occurrence Investigation
RO-2015-028
Final – 9 December 2016

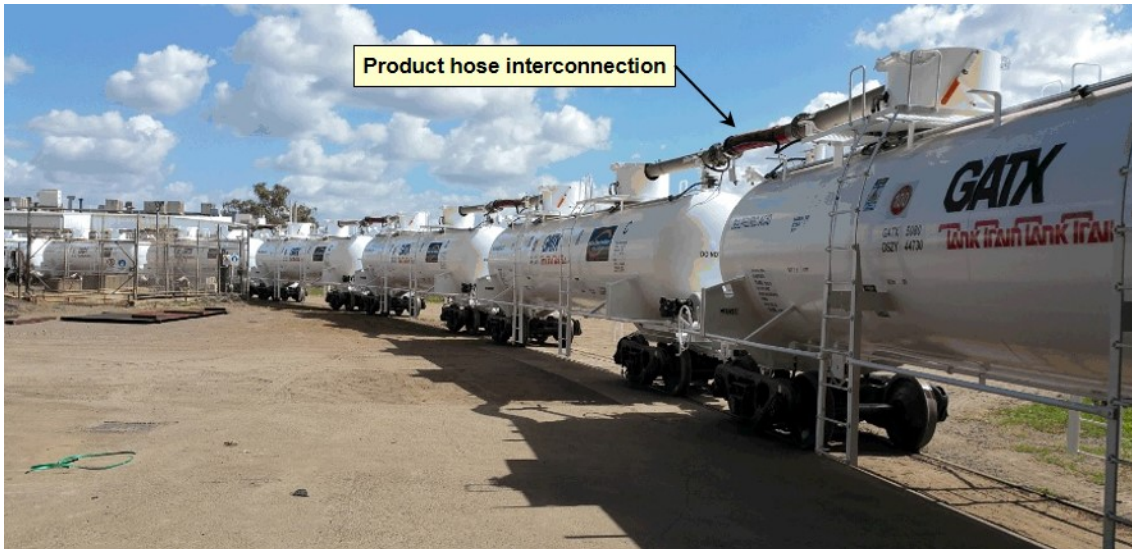
Figure 5: GATX tank wagons

Image of a GATX tanker wagons coupled in a string and the product hoses interconnecting each vessel. Source: Incitec Pivot

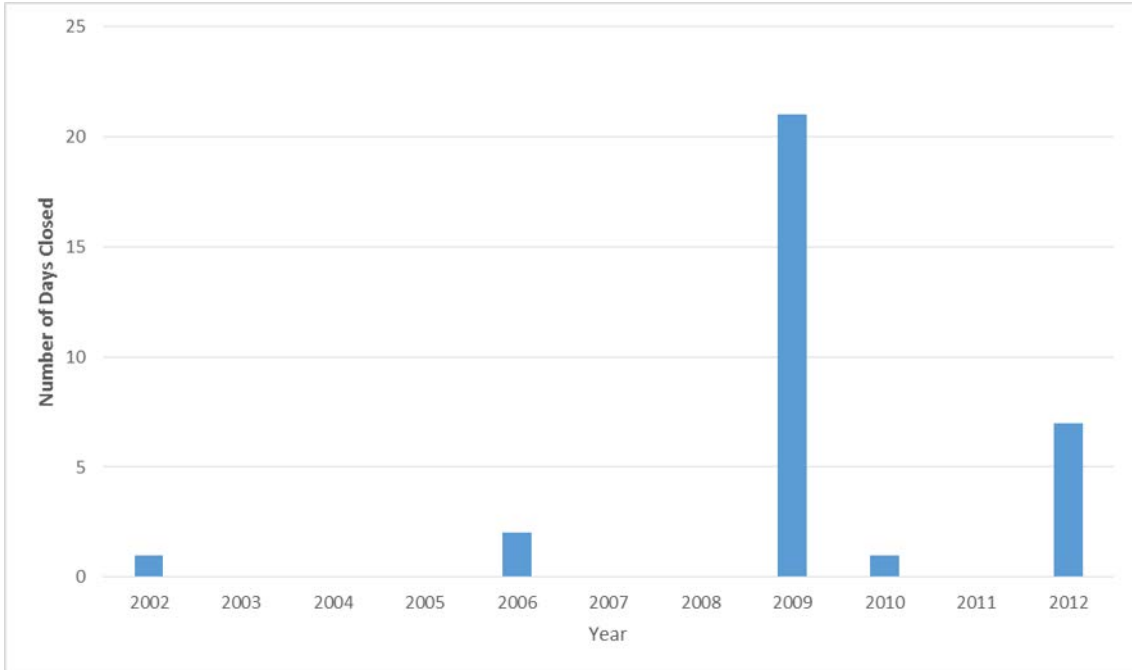
Figure 10: Flinders Highway road closures per year between Richmond and Julia Creek

Illustration of the number of days each year that rainfall runoff inundated the Flinders Highway at locations between Richmond and Julia Creek, resulting the closure of the highway to road traffic. The 2009 year shows a significantly larger number of days closed, which aligns with severe flood events in the region (due to active monsoon trout that developed into tropical cyclones Charlotte and Ellie). Source: Queensland Department of Transport and Main Roads data, plotted by ATSB

The Richmond to Julia Creek segment contained the Alick, Spellary, Horse and Julia Creek waterways. The TMR flood study found that this segment of the highway had an overall 0.5-year ARI (86.47% AEP) flood immunity, with the Alick Creek crossing overtopping on frequent occasions.

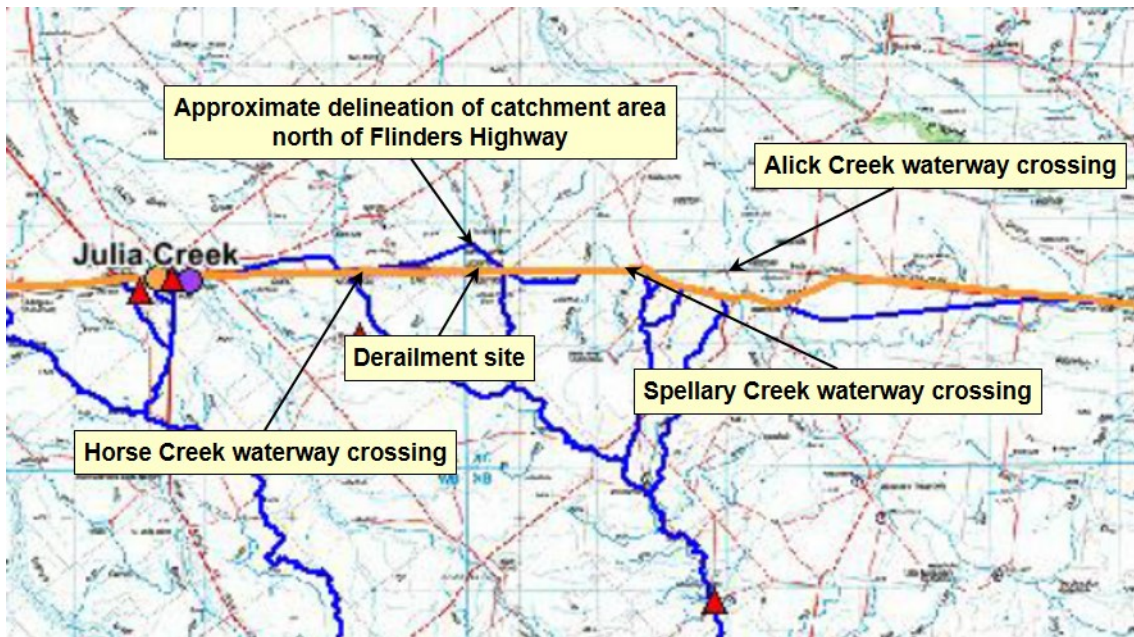
Figure 11: Catchment Delineation Julia Creek area

Extract from Flinders Highway Flood Study Catchment Delineation – Richmond to Cloncurry. Image illustrates catchment area to the north and south of the Flinders Highway at the derailment site. Source: Queensland Department of Transport and Main Roads

The catchment land area to the north was a relatively flat plain with sparse vegetation. As much of central Queensland was in drought following below average rainfall since 2013, the catchment area was largely devoid of vegetative cover. This likely affected the amount of rainwater infiltration into the soil, subsequently increasing the overland flow of runoff from the catchment north of the highway and railway following a rain event (Figure 12).

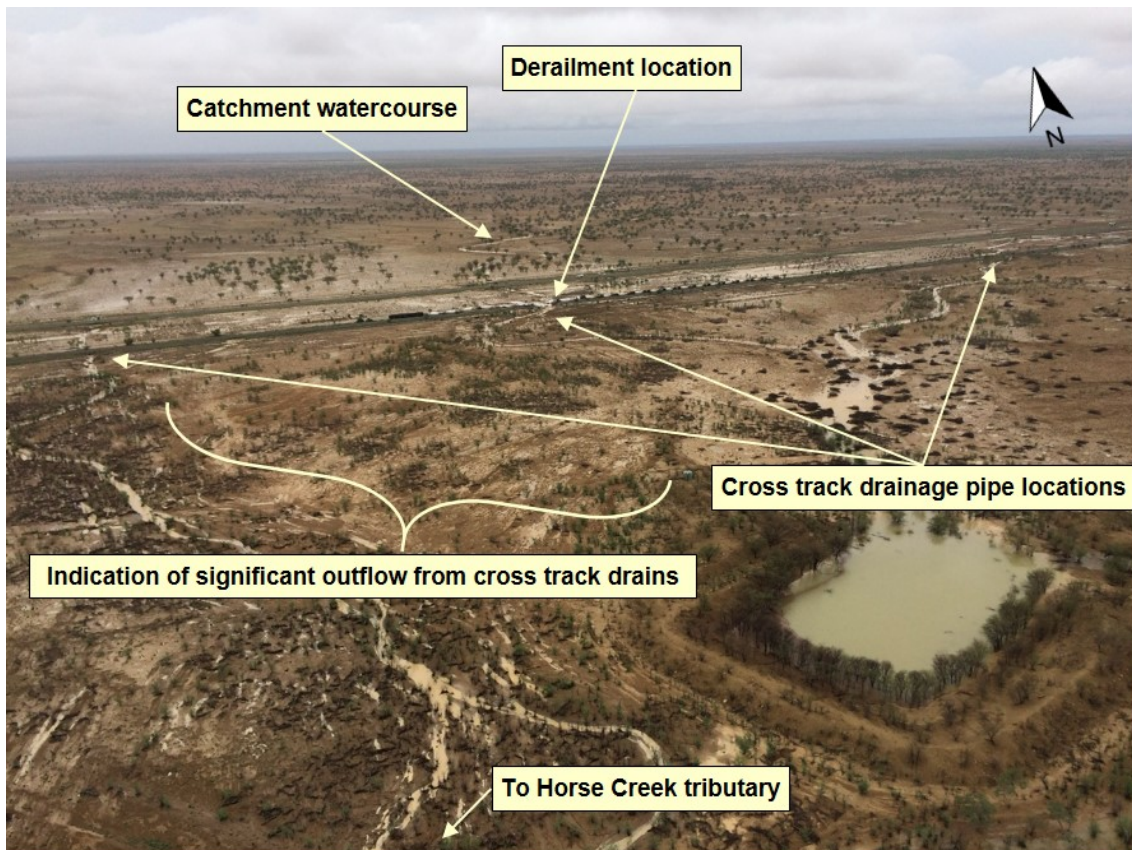
Figure 12: Northward view of catchment area and watercourses

The location of the under track drainage pipes was at the point of lowest elevation of the surrounding ground surface in the immediate area. As the construction of the track formation generally followed the elevation of the ground surface through that area, it was likely that the location of the derailment also corresponded to the lowest longitudinal vertical alignment of the track formation.

Northward view of the catchment area and associated water courses that cross the Flinders Highway and the Mount Isa railway. The view shows the path of floodwater outflow from the cross track drains adjacent the derailment site. Source: Queensland Police

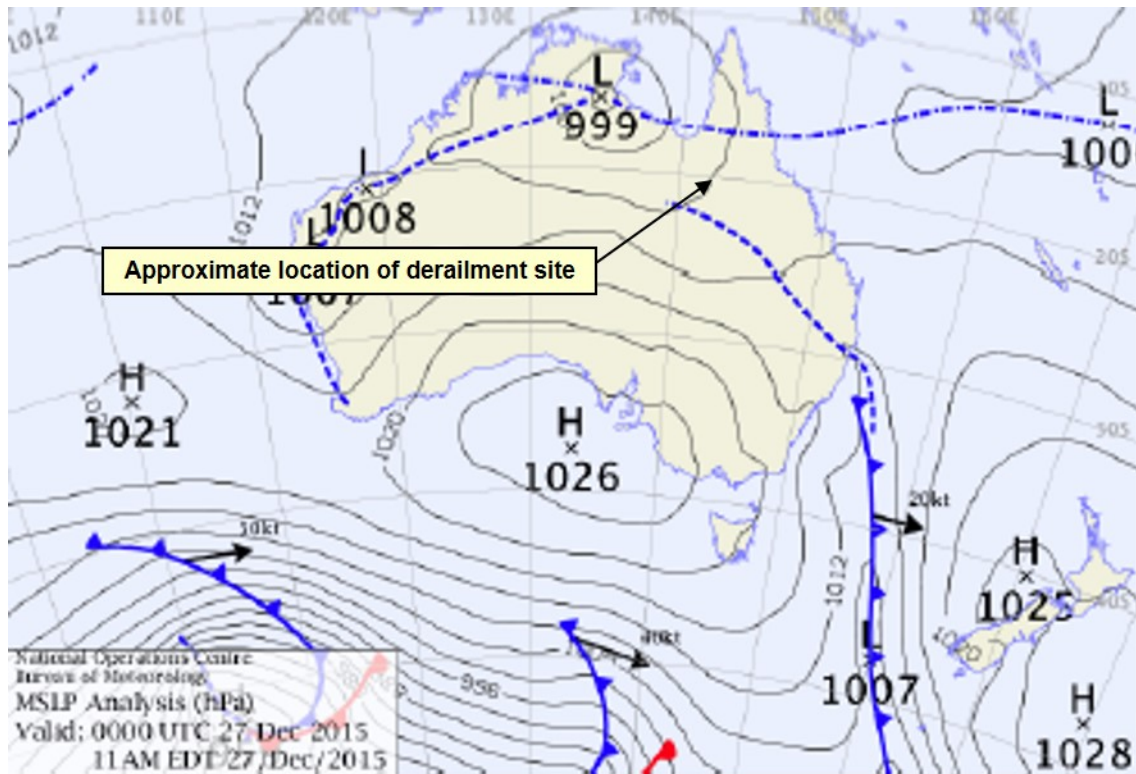
Figure 14: Mean sea level weather chart at 1100 on Sunday 27 December 2015

Image shows the approximate location of the derailment site relative to the path of the tropical low-pressure system tacking eastward across the Gulf of Carpentaria and the trough from the cold front extending into inland north-western Queensland. Source: Bureau of Meteorology

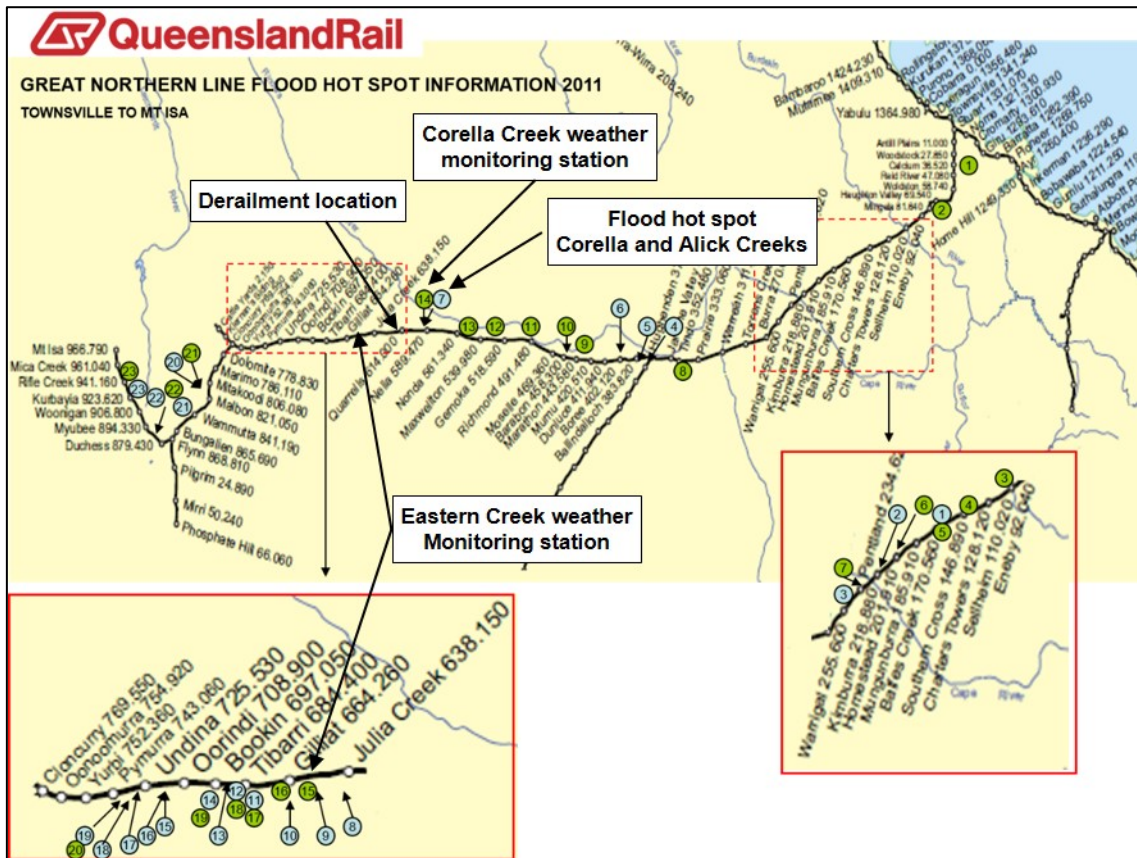
Figure 15: Great Northern Line flood hot spot information

Between Richmond and Julia Creek, the hot spot information identified one flooding hot spot located between the 590 and 601 km points that encompassed the Corella and Alick Creeks. There was no record of a flooding event at the derailment site since the early 1980s, after which QR installed the three additional 600 mm drains. QR did not consider this location to be a flooding hot spot.

Map showing locations of weather monitoring stations and identified flood hotspot areas. Weather stations indicated by green markers. Areas identified as prone to flooding identified by blue markers. Source: Queensland Rail

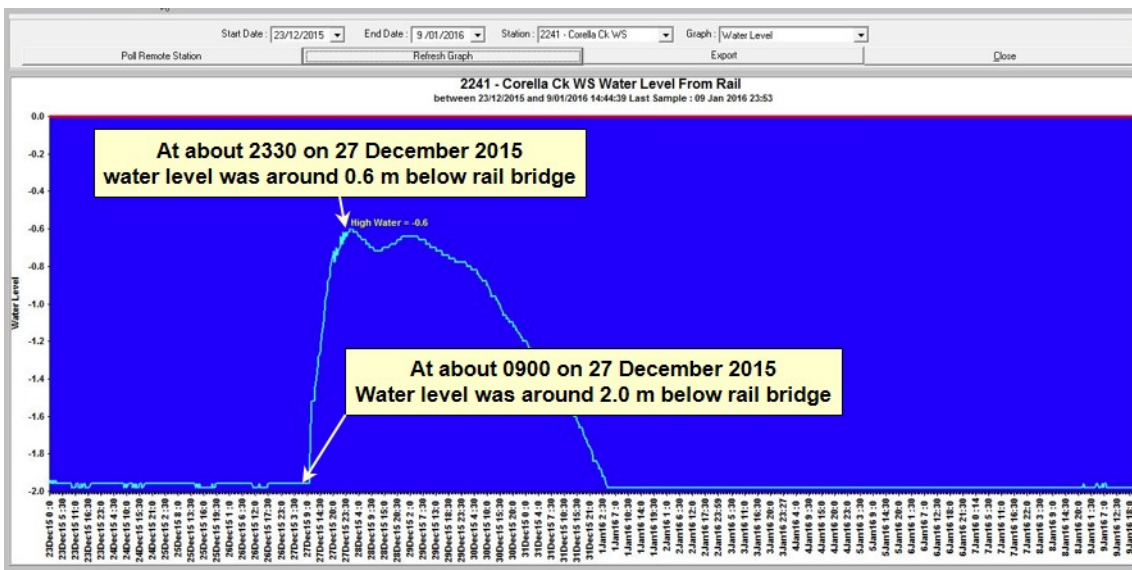
Figure 16: Corella Creek graph of measured water level under rail

Graph of data from the Corella Creek weather station illustrating of rise in water level under the rail bridge at that location. After the passage to train 9T92, the water level rose about 1.4 metres over the next 14 hours to a level around 0.6 m below the rail level. Source: Queensland Rail

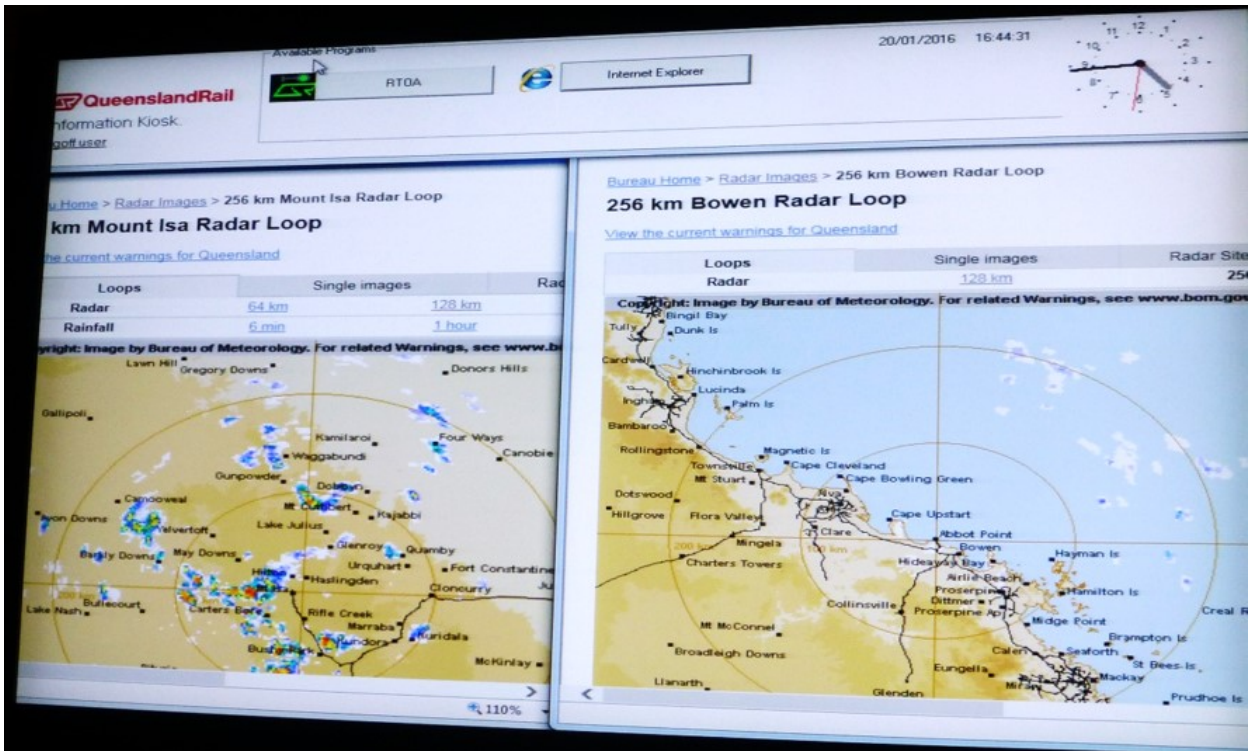
Figure 17: Monitor at Townsville Control Centre displaying BoM radar images

Image of displayed BoM radar loops available to the QR staff at the Townsville Train Control centre. The screens displayed provide an overview of the area containing the Great Northern Rai line. The image does not represent the radar loop at the time of the derailment of train 9T92. Source: ATSB

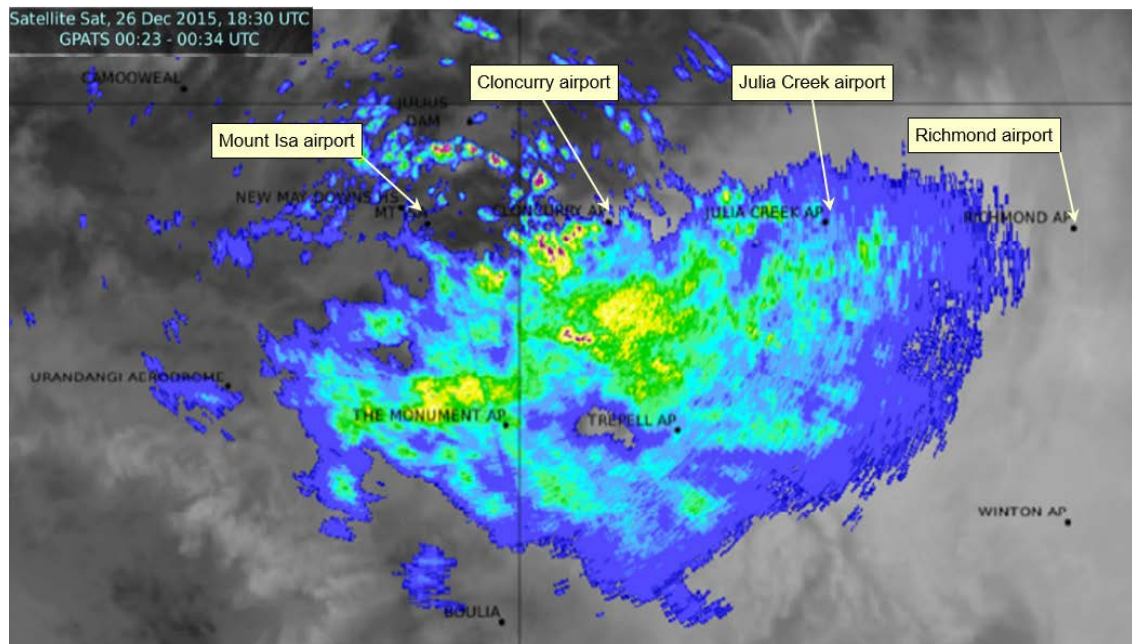
Figure 18: Combined satellite and radar reflectivity imagery over north-western Queensland at 0430

The information indicated a considerable amount of moisture and instability in the tropical atmosphere and the presence of heavy cloud cover and an intense cluster of thunderstorms in a rough line south of Cloncurry in the west to south of Julia Creek in the east (Figure 18). For several hours from about 0130 on Sunday 27 December thunderstorms and rainfall in the general area of the derailment appeared to be at a peak

Image depicts cloud cover at 1830UTC Saturday 26 December 2015. This equates to 0430 AEST on Sunday 27 December 2015, about 5 hours before the derailment of 9T92. Colour on image blue through green/yellow to red indicate increasing rain rate from light toward Heavy. Source: Australian Bureau of Meteorology

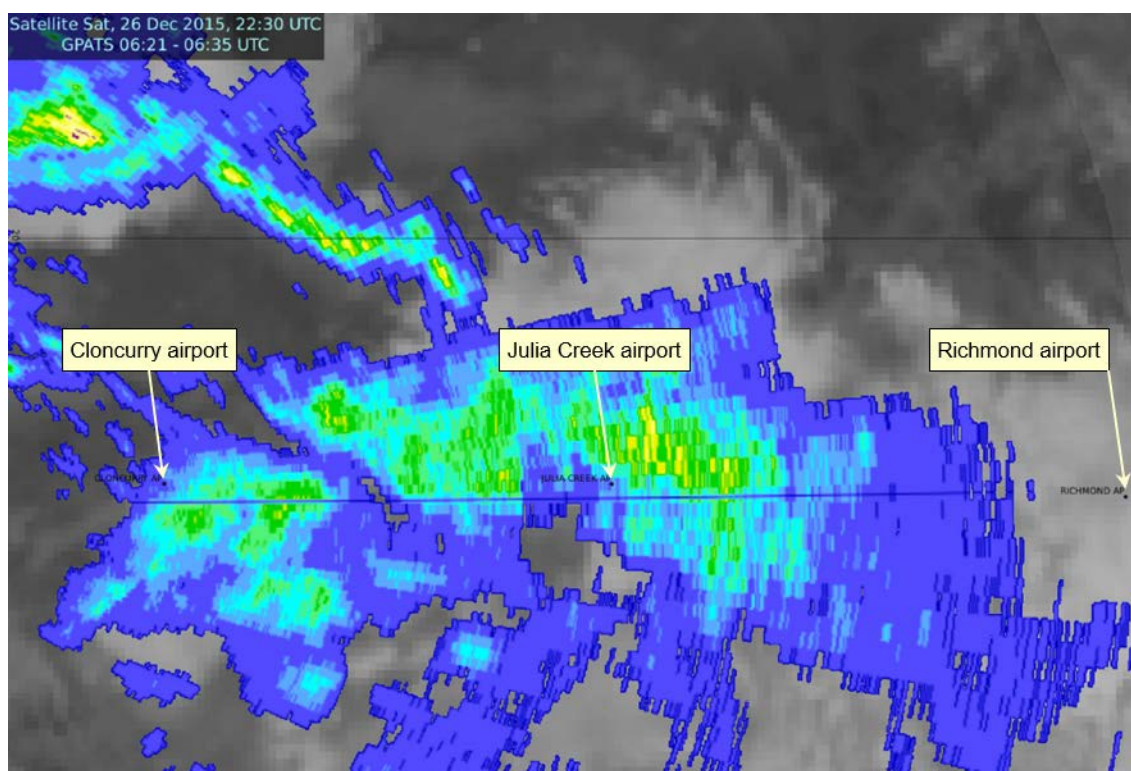
Figure 19: Combined satellite and radar reflectivity imagery over north-western Queensland at 0830

By about 0730 on Sunday morning, the intense storms appeared to have weakened considerably, though areas of rain and showers persisted about the Julia Creek area for the remainder of the morning – most notably to the east of Julia Creek between 0800 and 0930 prior to the passage of 9T92 through Quarrels (Figure 19).

Image depicts cloud cover at 2230UTC Saturday 26 December 2015. This equates to 0830 AEST on Sunday 27 December 2015, about one hour before the derailment of 9T92. Colour on image blue through green to yellow indicate increasing rain rate from light toward moderate. Source: Australian Bureau of Meteorology

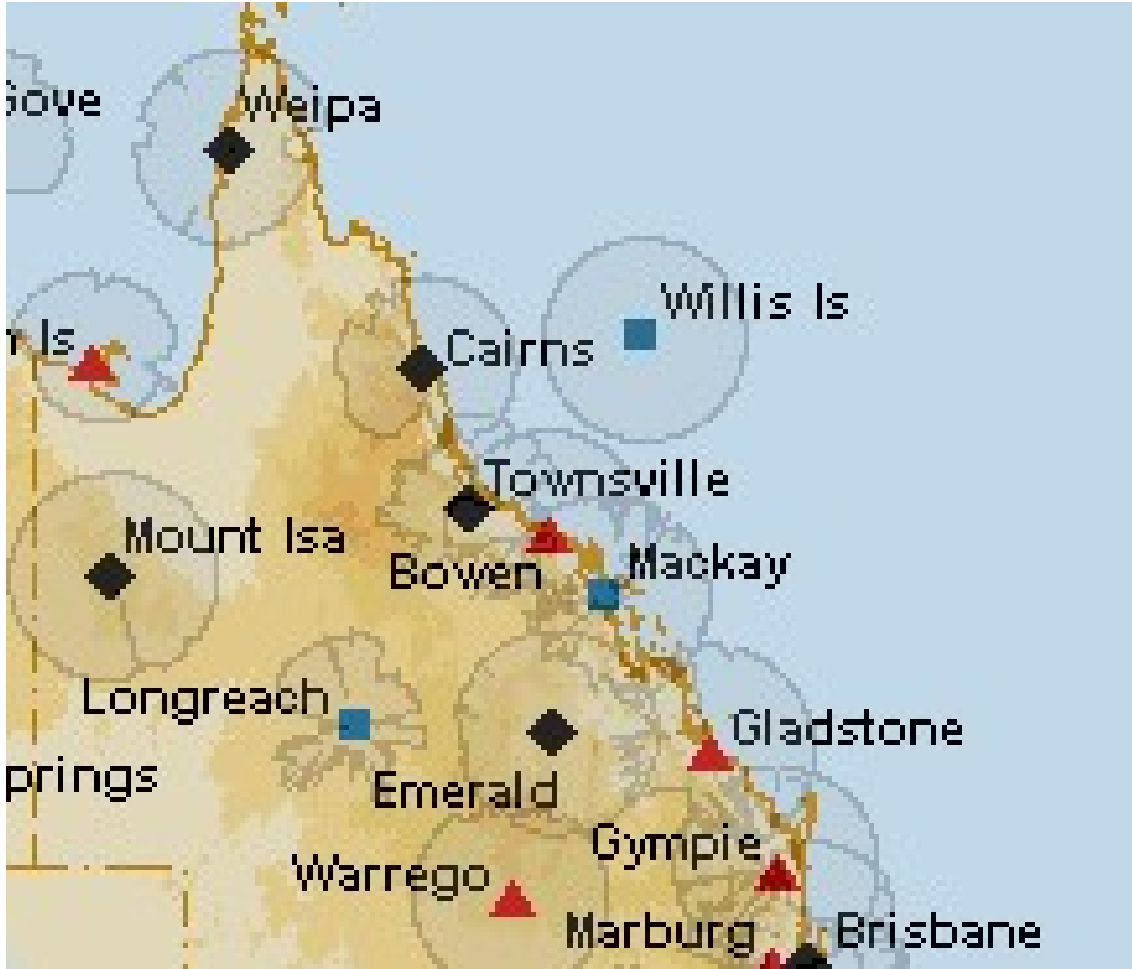
Figure 20: BoM radar optimal coverage areas - Queensland

An over reliance on the individual interpretation of radar images to obtain predictive information could result in the underestimation/inconsistency in assessment of likely hazard posed by weather present along the railway.

Image shows the optimal coverage areas surrounding BoM weather radar installations in Queensland. Queensland Rail references images from the Mount Isa and Bowen weather radars to identify weather conditions that may affect the Mount Isa railway. Source: Bureau of Meteorology

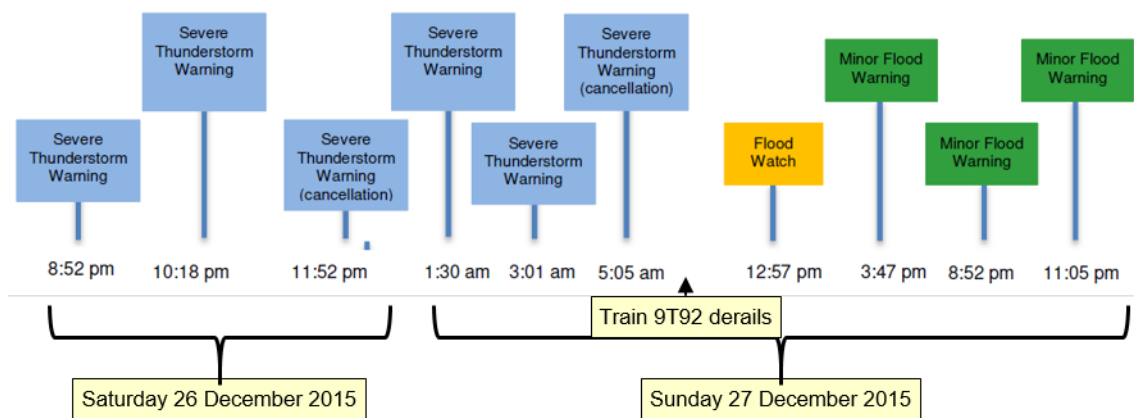
Figure 21: Timeline of weather warnings issued on 26 and 27 December 2015 for the Julia Creek area.

Image depicts the time line for the issuance and cancellation of severe thunderstorm warning, which included the warning of potential flash flooding. An advice for the cancellation of severe weather warnings occurred about 4 hours before train 9T92 encountered the washout and derailed. Source: Bureau of Meteorology, annotations by ATSB

Around the time of the cancellation of the Severe Thunderstorm Warnings (0505) train 9T92 was approaching the passing loop at Marathon, about 170 km from the derailment site. There was no Severe Weather Alert, Severe Thunderstorm or Flood Warning current for the Julia Creek area at the time 9T92 derailed.

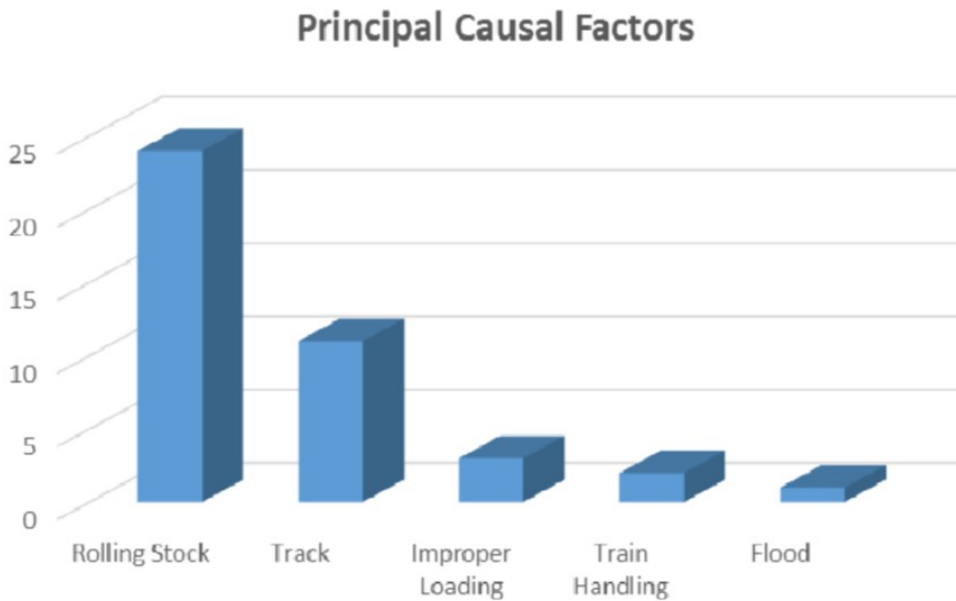
Figure 22: Mount Isa line derailment principal causal factors

The rail regulation unit assessed each derailment to identify the principal causal factor identifying rolling stock and track related defects as the majority contributors (Figure 22). Flooding was the causal factor identified against one main line derailment.

Graph illustrating relative incidence for each identified causal factor to a main line derailment. Source: The State of Queensland (Department of Transport and Main Roads)

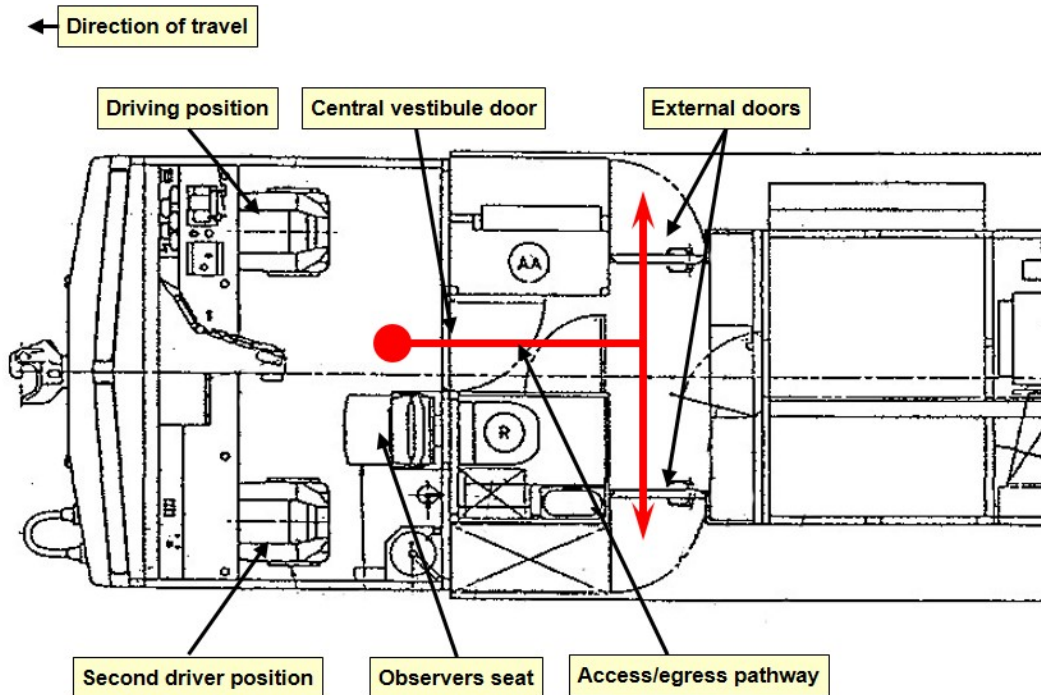
Figure 25: 2800 class locomotive cab access/egress schematic

The locomotive was a 2800 class locomotive, which had an enclosed cab. Access and egress to the cab was via two external doors into a central vestibule, then a central door into the rear of the cab (Figure 25). This access was also the primary emergency escape path. The supplemental escape path through side windows was available after sliding open the window, or using an emergency smash glass hammer to break out the side window.

Diagram of 2800 class locomotive emergency egress path (in red) through centre vestibule and rear side doors. Source: Queensland Rail Annotated by ATSB.
