Aviation Short Investigations Bulletin

Issue 55

ATSB Transport Safety Report
Aviation Short Investigations
AB-2016-161
Final – 14 December 2016

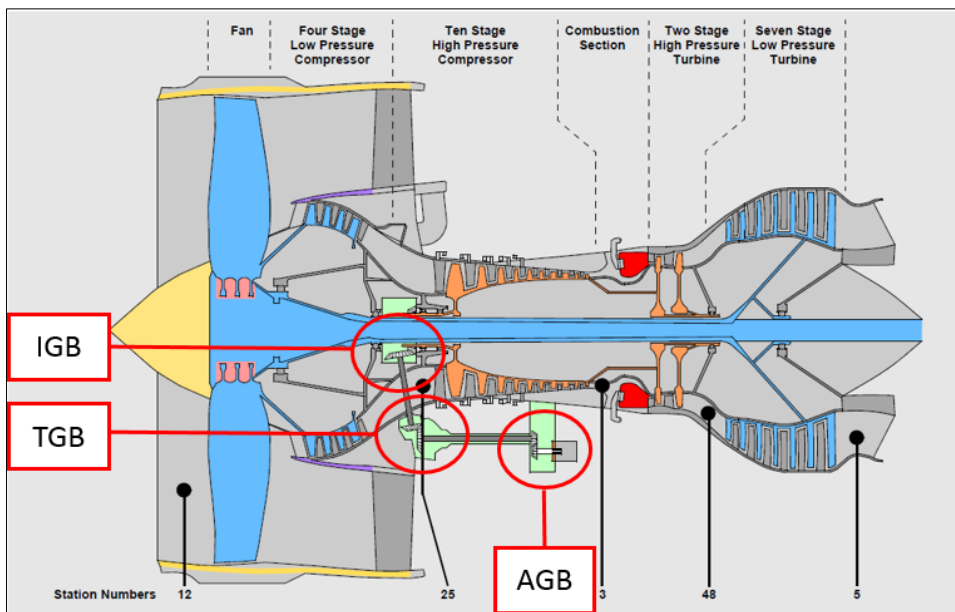
Figure 1: Engine driven gearboxes

Engine rotation is transmitted to an inlet gearbox (IGB) with a radial driveshaft, which connects to a transfer gearbox (TGB). The TGB transmits the engine speed to the AGB via a horizontal driveshaft (Figure 1). The AGB drives the accessories necessary for engine operation and other aircraft services, such as the generators for the aircraft electrical system. The engine oil system provides lubrication, cooling and removes debris from the gearboxes.

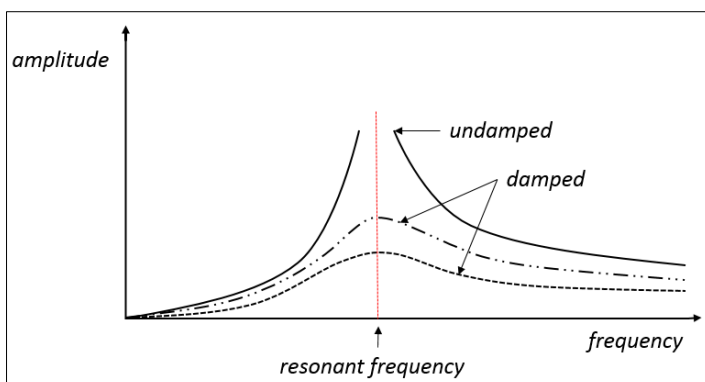
Figure 4: Resonant frequency for damped and undamped vibration

All machinery have a natural frequency of vibration. If a particular abnormality in the machinery generates a forced vibration, which vibrates in-phase and at the same frequency as the natural frequency of vibration, then the energy will magnify. The frequency at which this occurs is known as the resonant frequency (Figure 4). If there is insufficient damping present at the resonant frequency, then the amplitude of the vibrations will increase with each cycle. Excessive movement of components with high energy can cause a catastrophic failure of the machinery.

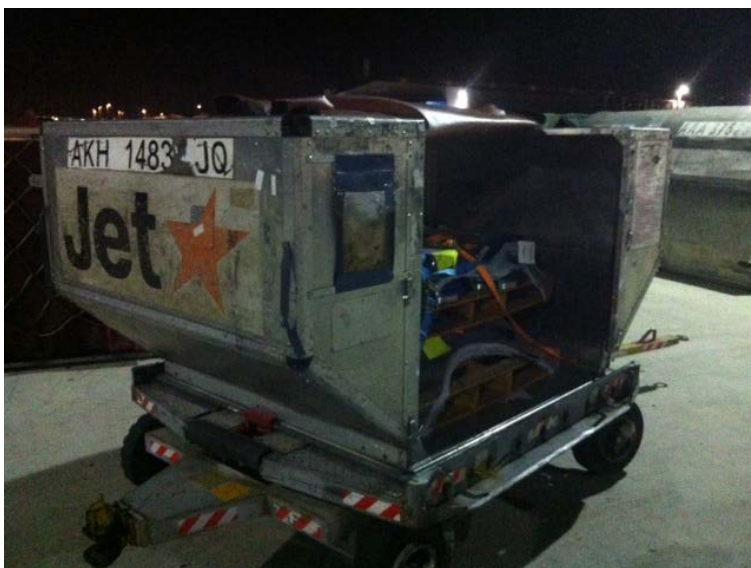
Figure 1: Container AKH 1483 JQ

The leading hand assigned to loading the aircraft had received the deadload weight statement¹ (DWS) for the cargo from the cargo terminal operator (CTO), and printed out a copy to refer to while loading the aircraft. The DWS listed three containers of freight, which the leading hand reported was usually loaded onto the aircraft before the passenger bags. The CTO had previously delivered the three containers to the loading bay from their facility. The leading hand checked the containers with those listed on the DWS – crosschecking the container numbers and the flight details, and confirming that the sum of the weight of the three containers corresponded to the total gross weight on the DWS. Two of the three listed containers were correct, however, the third was listed on the DWS with number 4183 and a gross weight of 240 kg, while the container on the bay was number 1483 (Figure 1), which was subsequently found to have had a gross weight of 900 kg.

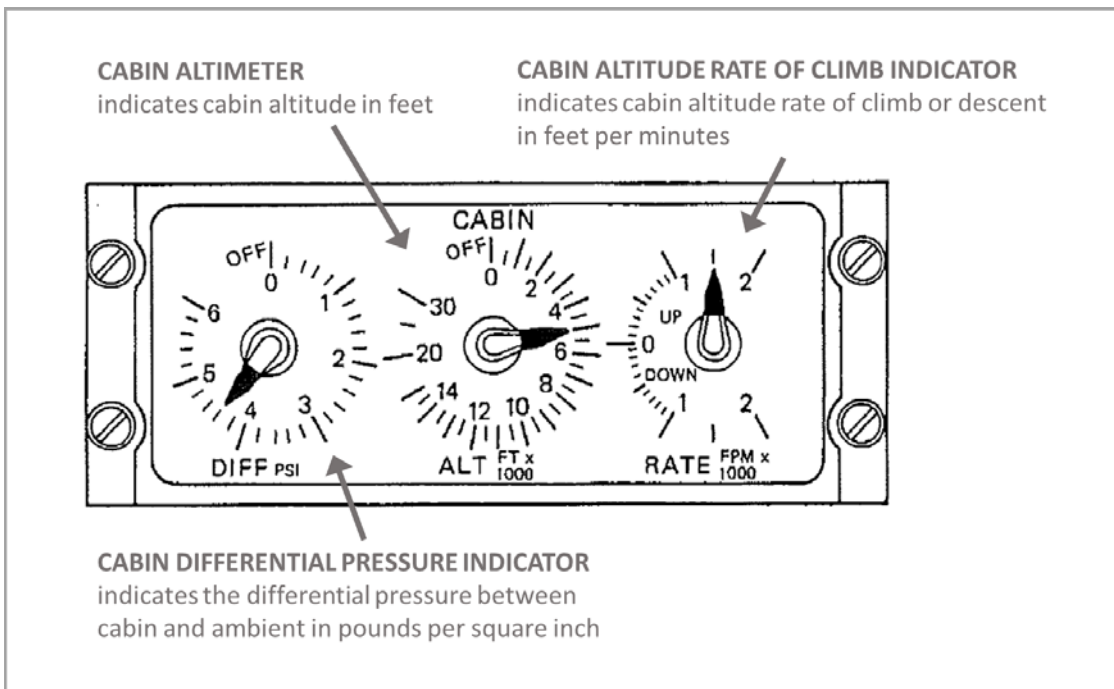
Figure 1: Cabin pressure indicator panel showing the cabin differential pressure, cabin altimeter and cabin altitude rate of climb indicators

At about 10,000 ft, the flight crew conducted the transition checklist items that included checking the cabin pressurisation system and noted that everything was operating normally. The captain observed that the cabin altitude¹ was about 4,000 ft, the rate of climb was between 250 ft and 500 ft, and the maximum differential pressure between the outside air pressure and the cabin air pressure was about 2.5 to 3 psi (Figure 1).

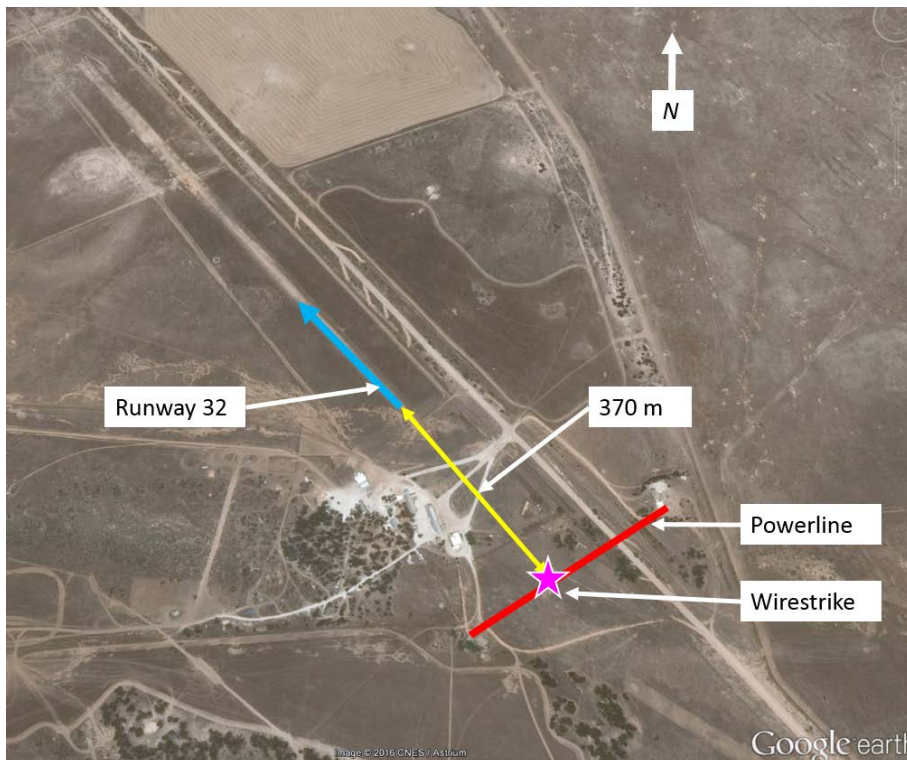
Figure 2: Coorabie ALA showing the powerline 370 m from the threshold

At about 0900, when the aircraft was on final approach to runway 32, the pilot reported that the aircraft decelerated suddenly (from about 120 to 110 kt). At the same time, there was a slight shudder of the right engine and a change in the sound of the propeller pitch. The pilot immediately increased the power to both engines and levelled the aircraft. The pilot checked the engine instruments and the annunciator panel, and there were no abnormal indications.

The pilot and passengers were not injured. The aircraft sustained minor damage.

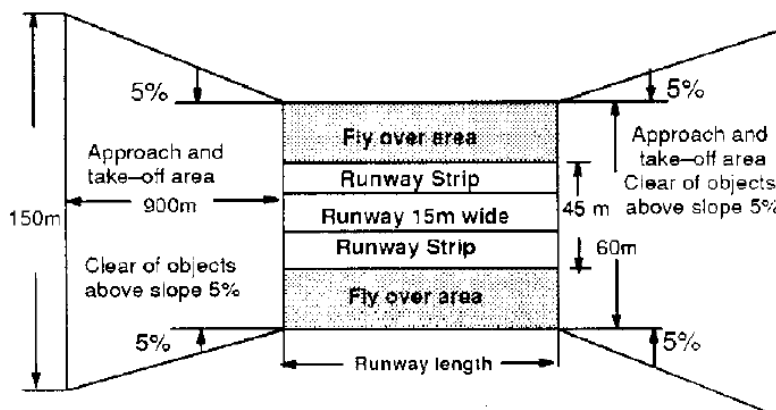
Figure 3: Recommended landing area characteristics

The Civil Aviation Advisory Publication (CAAP) 92-1(1) [Guidelines for aeroplane landing areas](#), provided guidance on how pilots may determine the suitability of an aeroplane landing area (ALA) such as the recommended obstacle clearance standards and suggested landing area markings. The CAAP defined an obstacle free area to mean ‘there should be no wires or any other form of obstacles above the approach and take-off areas, runway, runway strips, fly-over areas or water channels’. The minimum landing area physical characteristics recommended in the CAAP for aircraft (other than single-engine and centre-line thrust aeroplanes not exceeding 2,000 kg maximum take-off weight) for day operations is depicted in Figure 3. This shows the approach and take-off area should be clear of wires within 900 m of the runway ends above a 5 per cent (3°) slope.

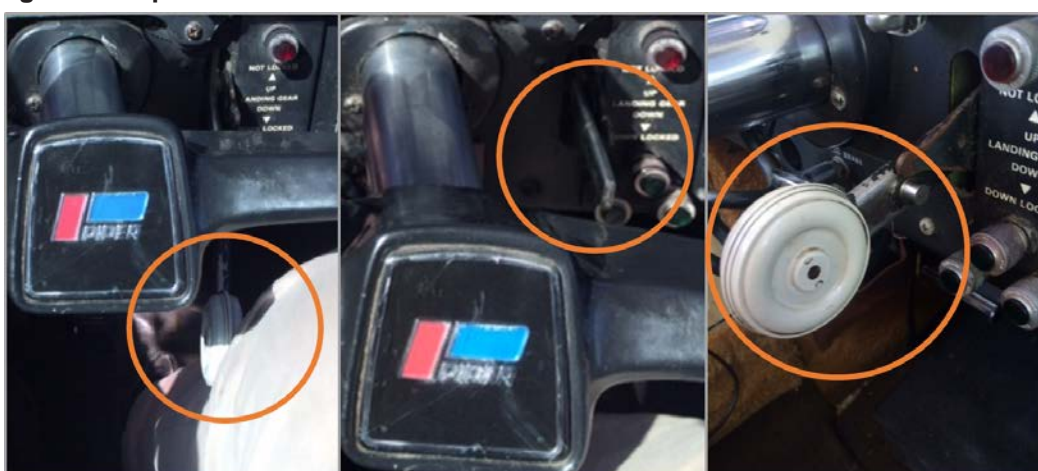
ETW landing gear selector handle removed.

PA31 landing gear selector handle installed.

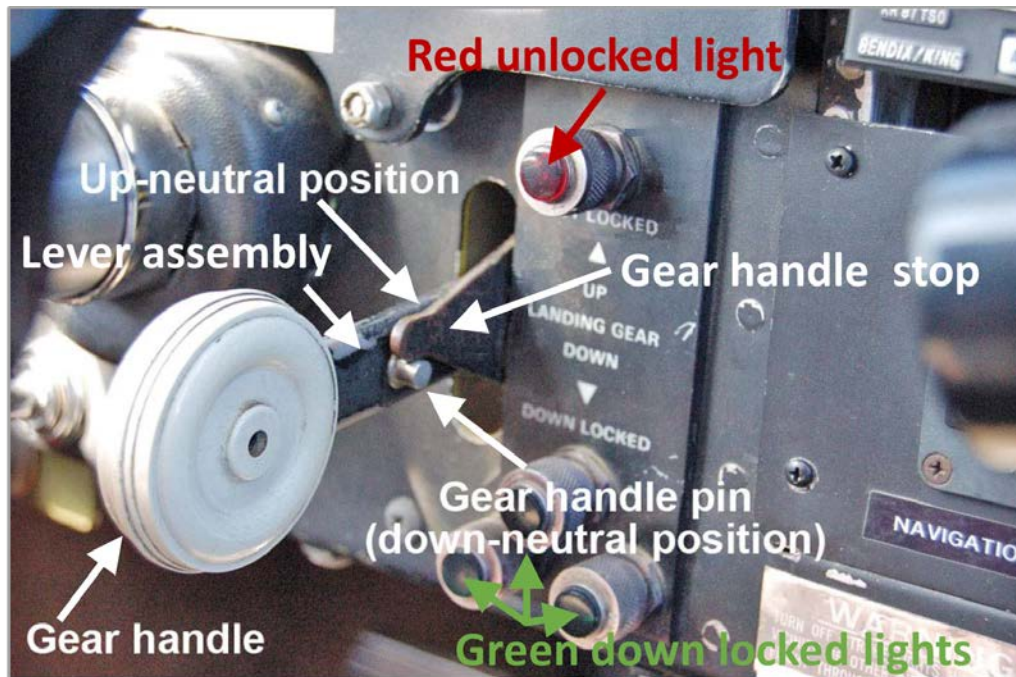
Figure 4: Landing gear selector handle showing the gear handle, lever assembly, gear handle pin and the up and down neutral positions. In addition, the red unlocked light and the green down locked lights.

Located on the instrument panel, above and to the right of the landing gear handle are one red and three green indicator lights (Figure 4). The red light will illuminate when the gear is not locked and the gear handle is either in the up or down position. When each of the individual gear is down and locked the respective green light will illuminate. There is no indication light when the gear is up and locked. When power from either engine is reduced below 10 to 12 inches of manifold pressure, a horn in the cockpit should sound if the gear is not down and locked.
