Aviation Short Investigations Bulletin

Issue 56

ATSB Transport Safety Report
Aviation Short Investigations
AB-2016-176
Final – 17 January 2017

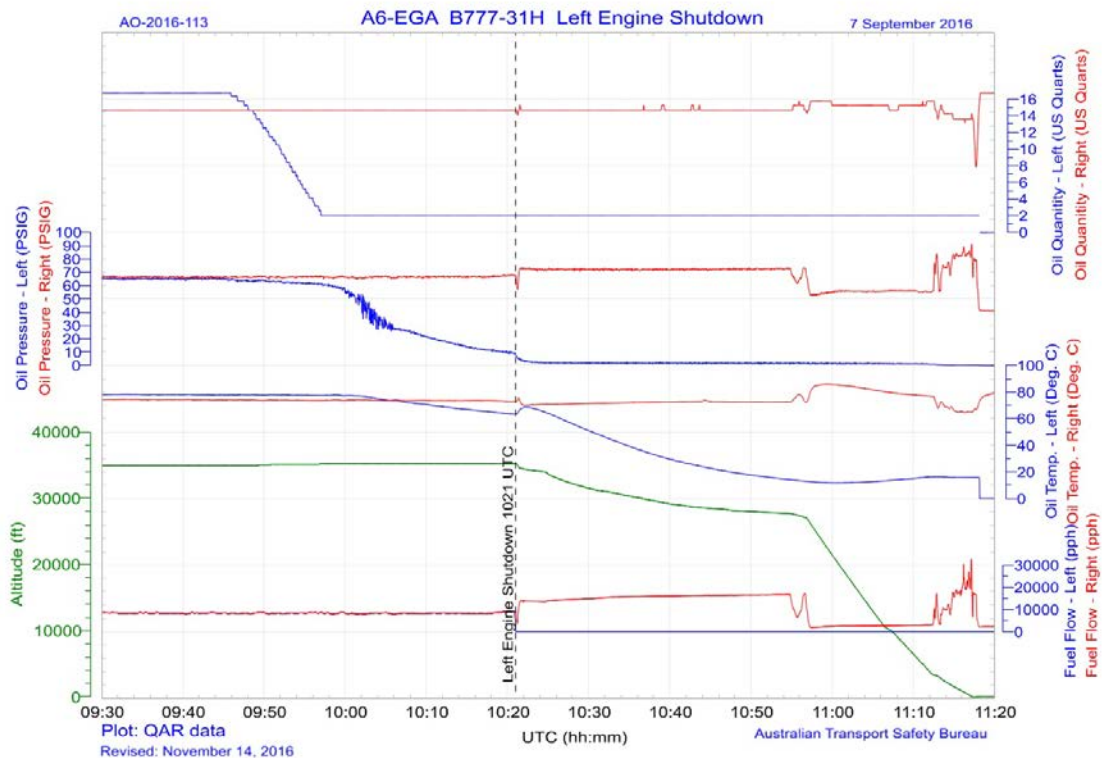
Figure 1: Flight data plot including oil pressure and engine shutdown

The flight crew received a left engine low oil engine-indicating and crew-alerting system (EICAS) message and conducted the associated non-normal checklist. At about 1951, the flight crew shut the left engine down (Figure 1).

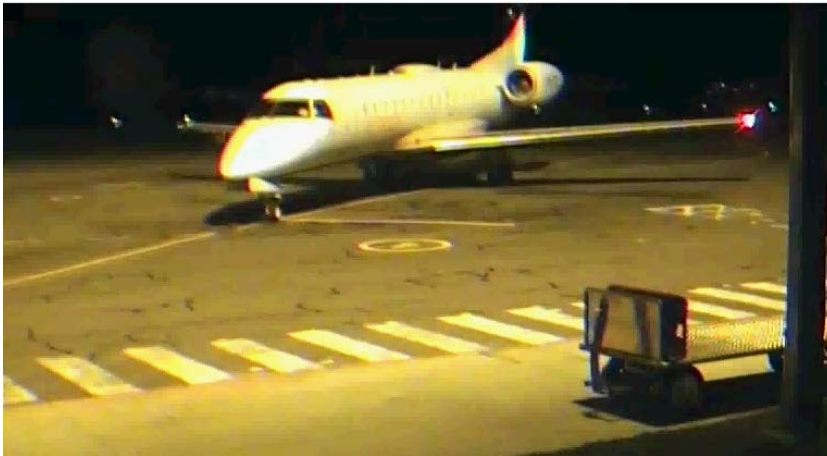
Figure 5: JTG parked at bay 1

Prior to both incidents, the aircraft parked at bay 1 for the embarkation of passengers (Figure 5). This bay is substantially lit by apron floodlights. These lights are not part of the PAL system and remain illuminated when the PAL system extinguishes the runway and taxiway lights.

All three flight crew commented that the apron lighting degraded night-vision and the short taxi from bay 1 to runway 30R did not allow time for eyes to adjust to the dark surrounds of the runway.

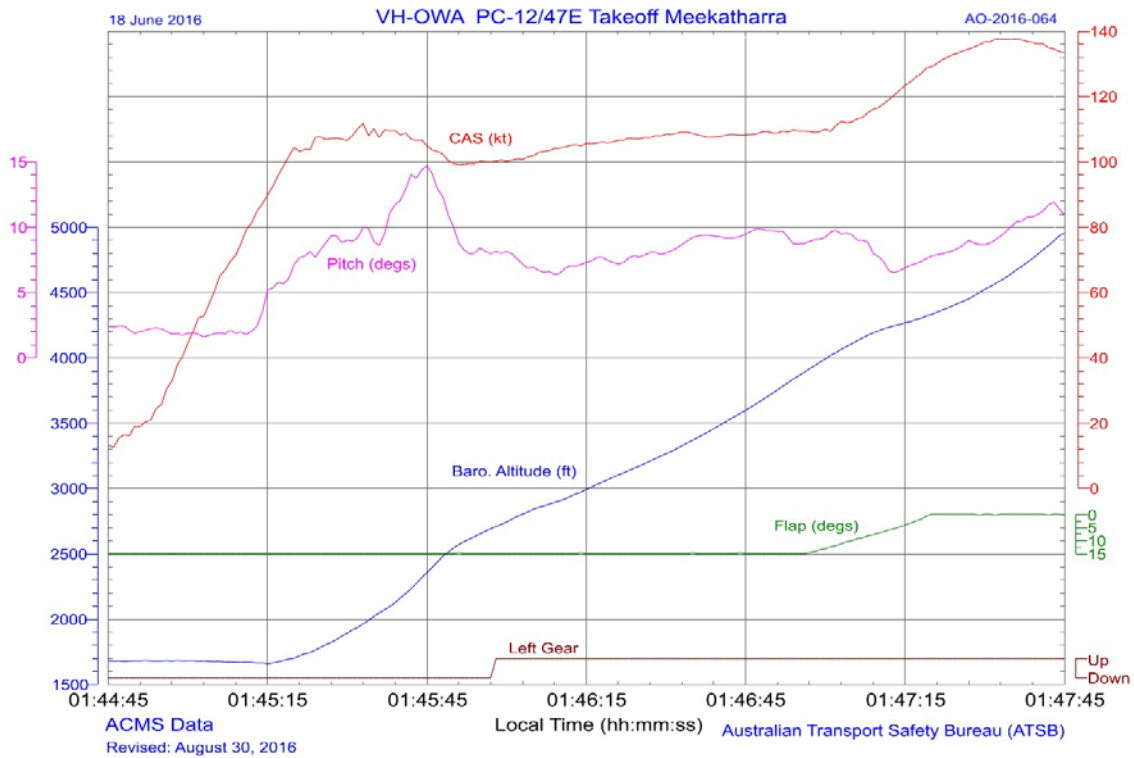
Figure 1: Plot of selected data from the incident flight

The flight data was downloaded from the aircraft condition monitoring system and analysed by the ATSB. Figure 1 depicts the calibrated airspeed and pitch angle from the start of the take-off roll. The change in pitch (pink line) from the pilot pulling back on the control column in reaction to the synthetic vision started at about 0145:30 in Figure 1.

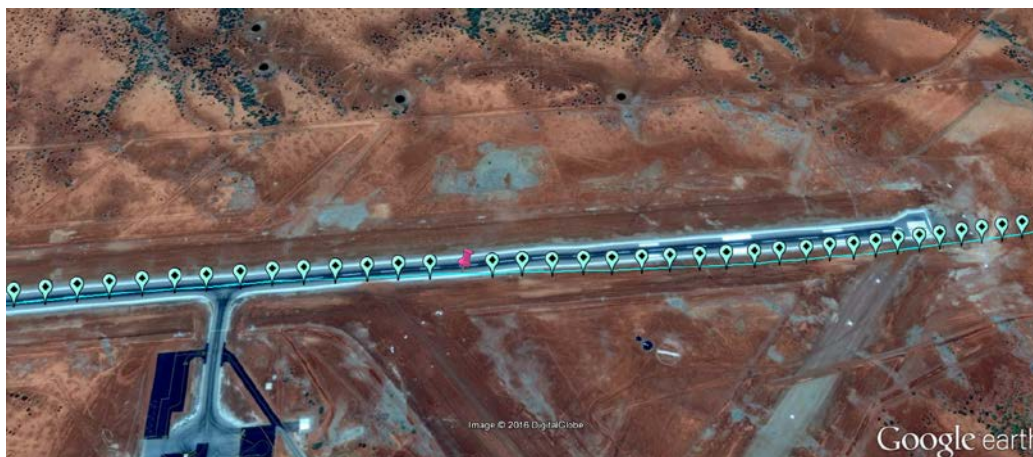
Figure 2: Deviation of OWA (travelling from left to right) from runway centreline showing the estimated point of the radalt failure (in pink)

Figure 2 shows the aircraft recorded GPS track, with the pink marker indicating the first significant increase in pitch attitude, and therefore the approximate point of radalt failure. The aircraft was then at about 250 ft above the runway.

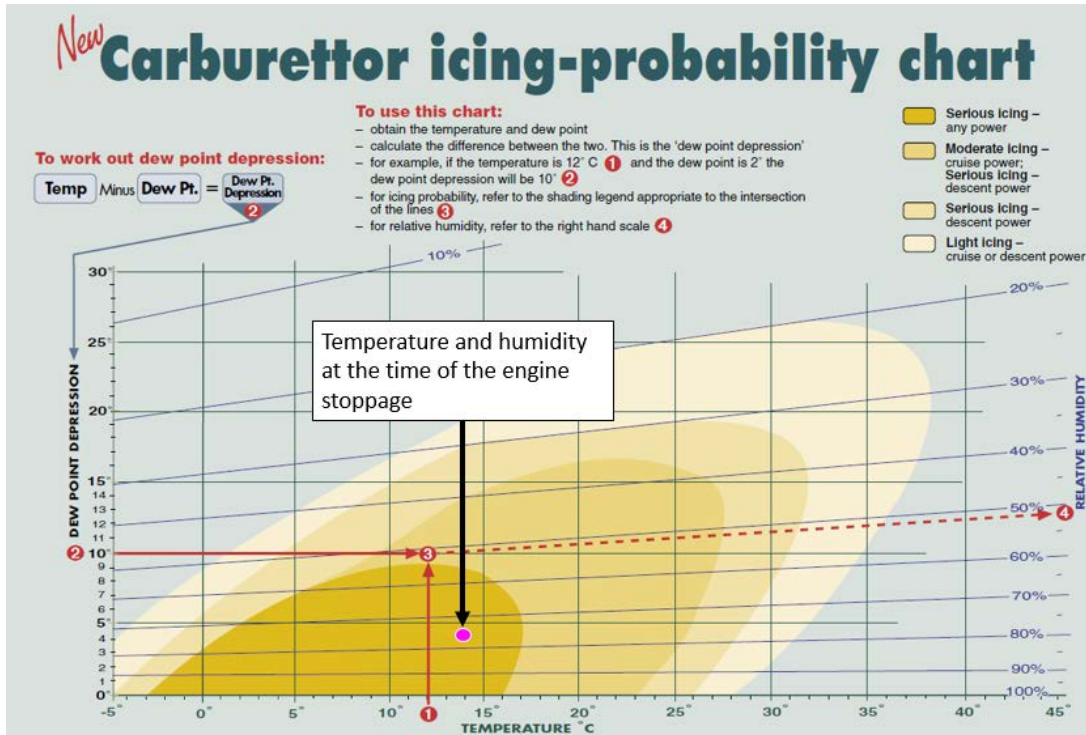
Figure 2: Carburettor icing probability chart

The temperature at the time of the accident was 14 °C, the relative humidity 76 per cent, and the dew point depression 4 °C. According to the carburettor icing probability chart (Figure 2), there was a serious risk of carburettor icing at any power setting.

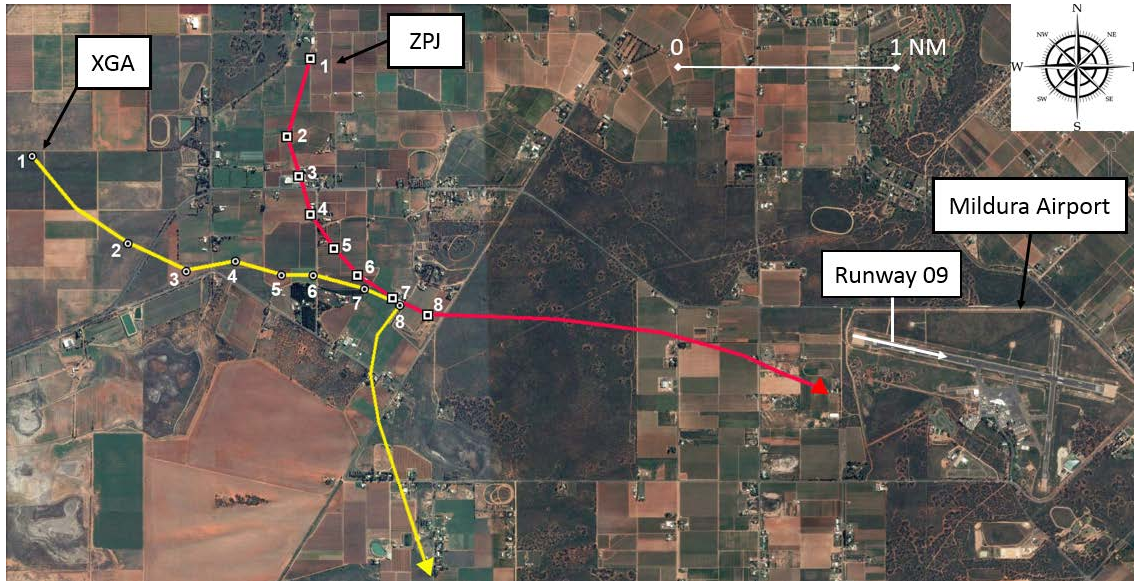
Figure 1: Traffic conflict between ERJ 190 (VH-ZPJ) and GA-8 (VH-XGA)

The PF on board ZPJ decided to discontinue their approach to land on runway 09, as they were too late for their turn onto final and therefore not in a stabilised condition.⁴ However, the PM indicated to the PF that they could not execute a go-around manoeuvre because there was another aircraft joining the circuit on crosswind (the light twin-engine aircraft). The PF decided that continuing the approach to land was not an option and therefore executed the go-around to the south of runway 09, maintained separation from the other traffic on crosswind and then landed from the subsequent circuit. During the go-around manoeuvre, the aircraft's TCAS detected XGA pass about 200 ft above and 0.125 NM behind ZPJ (position 7 & 8 in Figure 1).

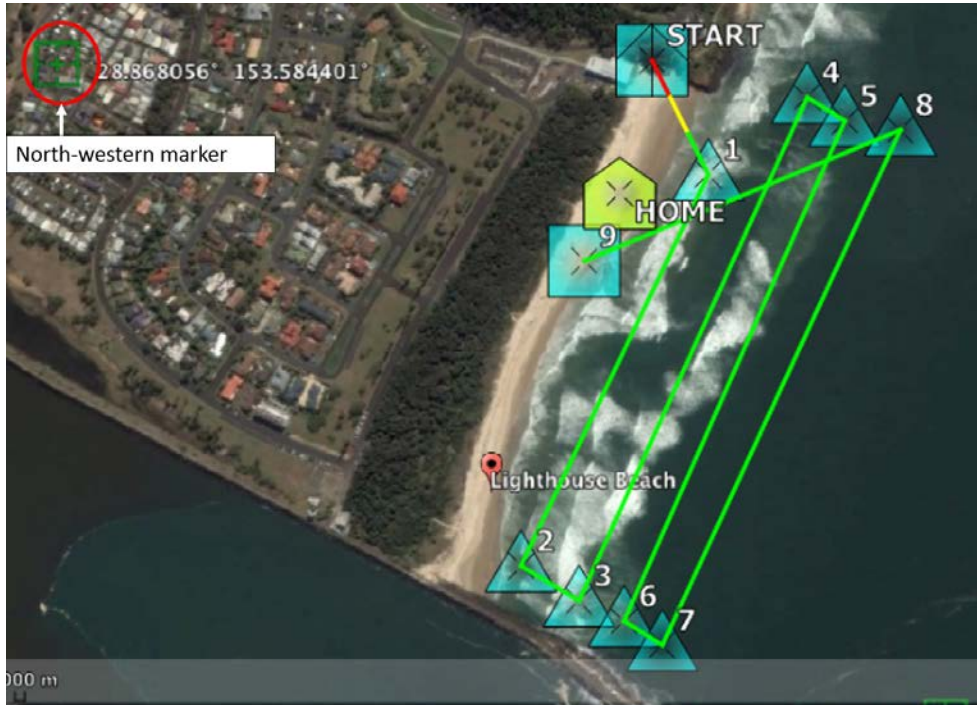
Figure 4: Image uploaded onto GCS with planned mission overlaid

The pilot then transferred an image of the google earth map for the area onto the GCS using a USB stick, and uploaded it to create the ‘Lighthouse Beach’ mission. To georeference³ the image, the pilot then overlaid the markers in the image with a point icon on the controller, and entered the latitude and longitude of two positions into the dialogue box on the GCS. The north-western GCS marker is visible in the top left corner of Figure 4, but the latitude and longitude values visible are image text only.

Once the image had been georeferenced, the pilot then used the graphical interface to place the start and home icons and any intervening waypoints for the planned mission (Figure 4).

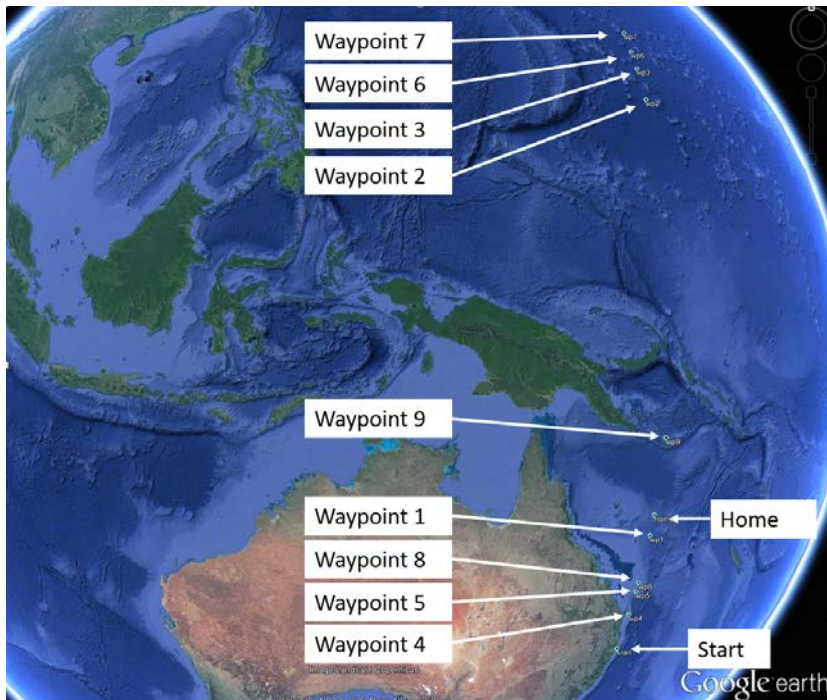
Figure 5: Actual location of home position and waypoints from the GCS

The remote pilot reported that both they and an observer checked each waypoint before the flight, verifying latitude, longitude, altitude and height. However, the GCS data shows that during the planning phase, while the north-western marker was correctly assigned, the south-eastern marker was incorrectly assigned to a georeference point with a latitude in the northern hemisphere. This resulted in all of the waypoints and home location being incorrect, as they were created by dragging icons on the georeferenced image. Waypoints 2, 3, 6 and 7 had latitudes in the northern hemisphere, and the home position was assigned to 17.222395° S and 153.591582° E. That location was in the Coral Sea Islands about 1,200 km north of the start position (Figure 5).
