Lightning strike involving Airbus A330, VH-XFJ

Perth Airport, Western Australia | 26 November 2014

ATSB Transport Safety Report
Aviation Occurrence Investigation
AO-2014-185
Final – 8 March 2017

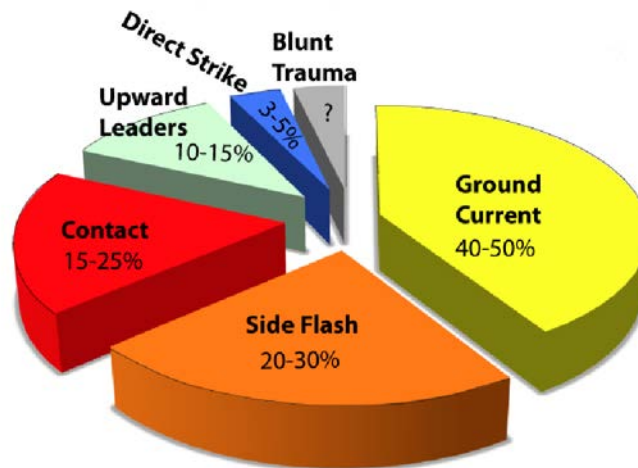
Figure 6: Pie chart of Canadian lightning strike types and annual injury percentages

Canadian research statistics have shown that the most common lightning injuries are the result of indirect strikes, with ground flash/current accounting for 40 to 50 per cent of injuries, and side flash accounting for 20 to 30 per cent of injuries. Only 3–5 per cent of injuries were attributed to direct strikes (Figure 6).
