Near collision involving Hawker Beechcraft Corporation B300C, VH-NAO, and an airport work safety officer

Sydney Airport, New South Wales, 16 August 2016

ATSB Transport Safety Report
Aviation Occurrence Investigation
AO-2016-103
Final – 24 March 2017

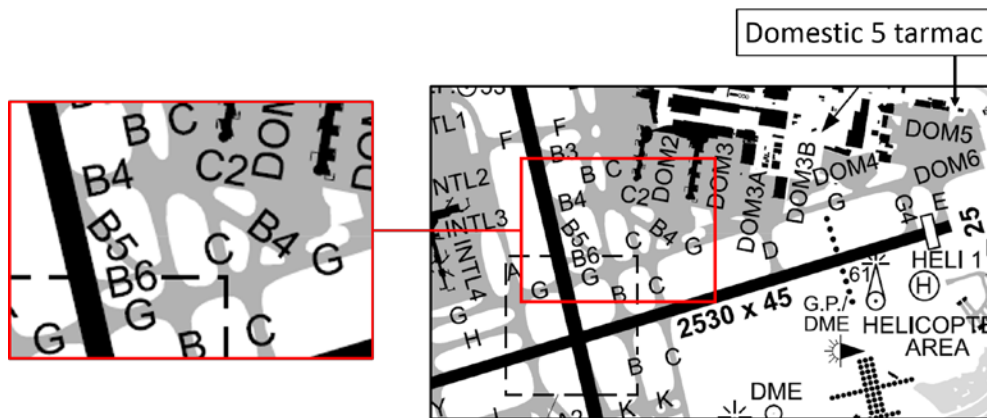
Figure 1: Excerpt from aerodrome chart showing the location of the relevant taxiways

At about the time that NAO taxied, activities commenced in association with planned aerodrome works near the intersection of taxiways golf, charlie and domestic 2 (see Figure 1). Two work safety officers moved to the area in separate vehicles to establish the worksite. Establishment of the worksite included placement of red lights across affected taxiways and covering (taping over) existing green taxiway centre-line and lead-in lighting. Placement of red lights and covering of existing lights was intended to delineate the closed areas of affected taxiways.
