# Aviation Short Investigations Bulletin

Issue 58

**ATSB Transport Safety Report**  
Aviation Short Investigations  
AB-2017-027  
Final – 24 March 2017

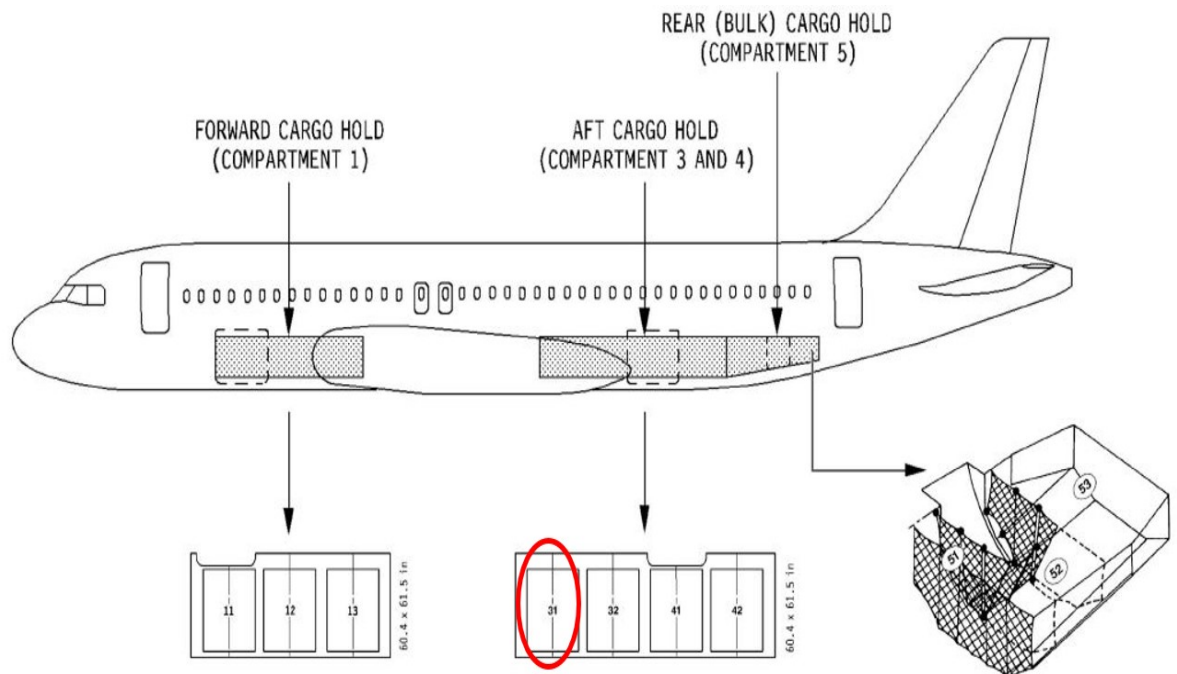
**Figure 1: Aircraft hold positions (with position 31 highlighted)**

Once the aircraft arrived, the leading hand estimated the unloading would require three dollies<sup>2</sup> and retrieved the dollies to unload the aircraft. Loader operator 1 unloaded containers from positions 41, 42, and 32 (Figure 1). Both loader operator 1 and the leading hand assumed only three containers needed to be unloaded.

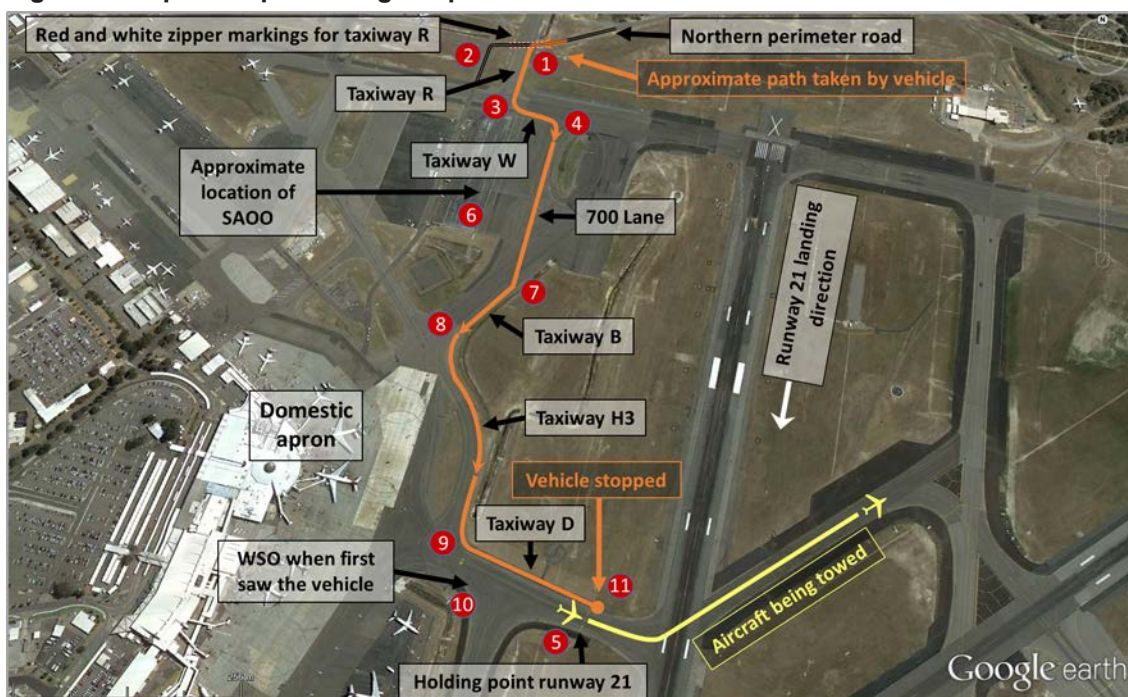
Figure 1: Airport map showing the path of the vehicle

As they drove towards the domestic apron, an area unfamiliar to the driver, the driver observed the aircraft that they were to meet, stationary in a position different to what was expected. They thought the aircraft was on the domestic apron, and instead of continuing along the northern perimeter road to the domestic apron, the driver turned left (Figure 1 item 1) and crossed the red and white zipper markings<sup>1</sup> that denote the road is crossing taxiway R (Figure 2). About another 50 m past taxiway R, was a left turn (item 2) for vehicles to access the domestic apron.

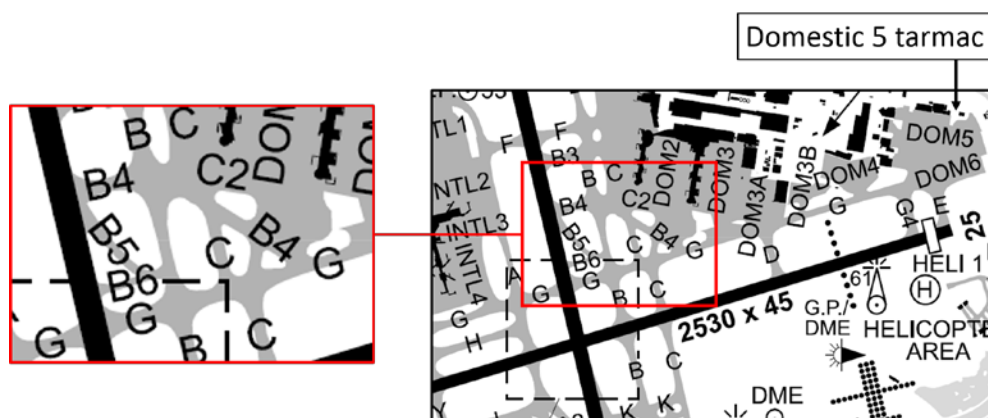
**Figure 1: Excerpt from aerodrome chart showing the location of the relevant taxiways**

At about the time that NAO taxied, activities commenced in association with planned aerodrome works near the intersection of taxiways golf, charlie and domestic 2 (see Figure 1). Two work safety officers moved to the area in separate vehicles to establish the worksite. Establishment of the worksite included placement of red lights across affected taxiways and covering (taping over) existing green taxiway centre-line and lead-in lighting. Placement of red lights and covering of existing lights was intended to delineate the closed areas of affected taxiways.

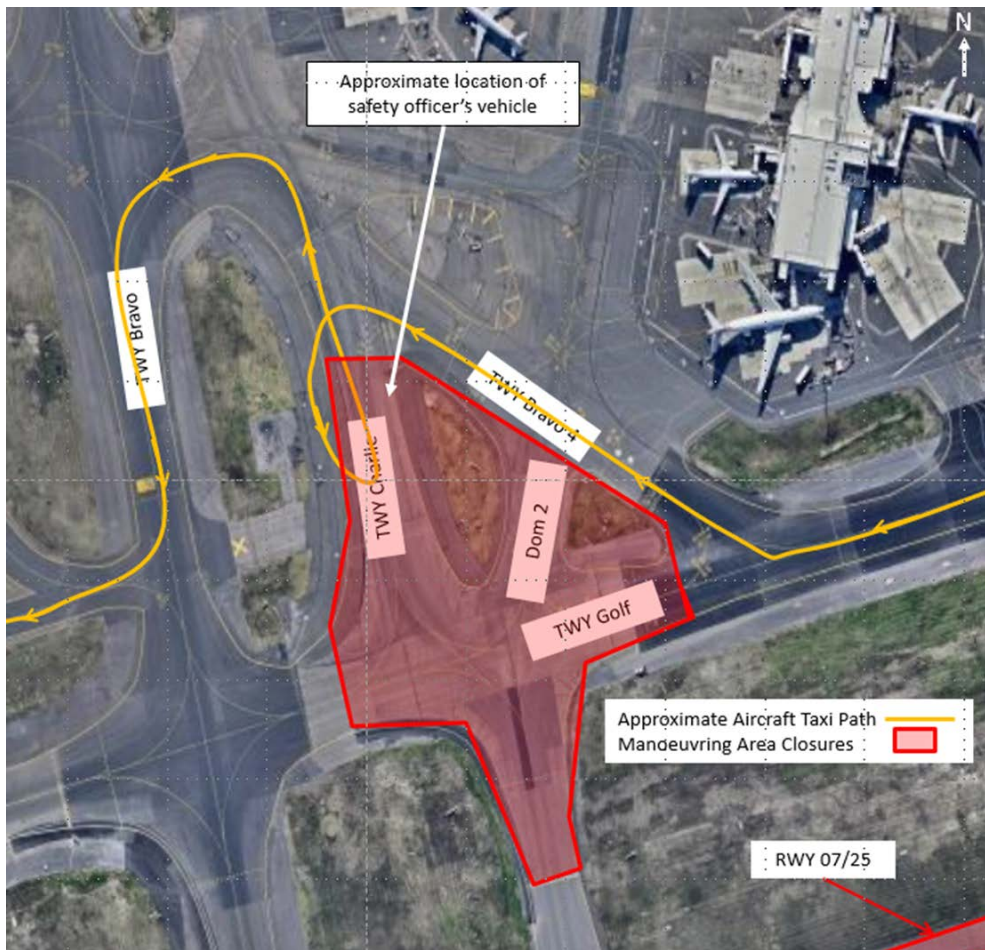
Figure 2: Approximate aircraft taxi path and location of safety officer's vehicle

The pilot made a 180 degree turn on charlie and headed north, back towards bravo 4. The safety officer saw that NAO was returning and moved the vehicle off the centre line. The pilot passed the vehicle and taxied onto bravo 4, before making a left turn onto bravo, as initially intended. The approximate taxi path of the aircraft and the position of the safety vehicle at the time the aircraft entered charlie are shown in Figure 2.
