Aviation Short Investigations Bulletin

Issue 59

ATSB Transport Safety Report
Aviation Short Investigations
AB-2017-036
Final – 27 April 2017

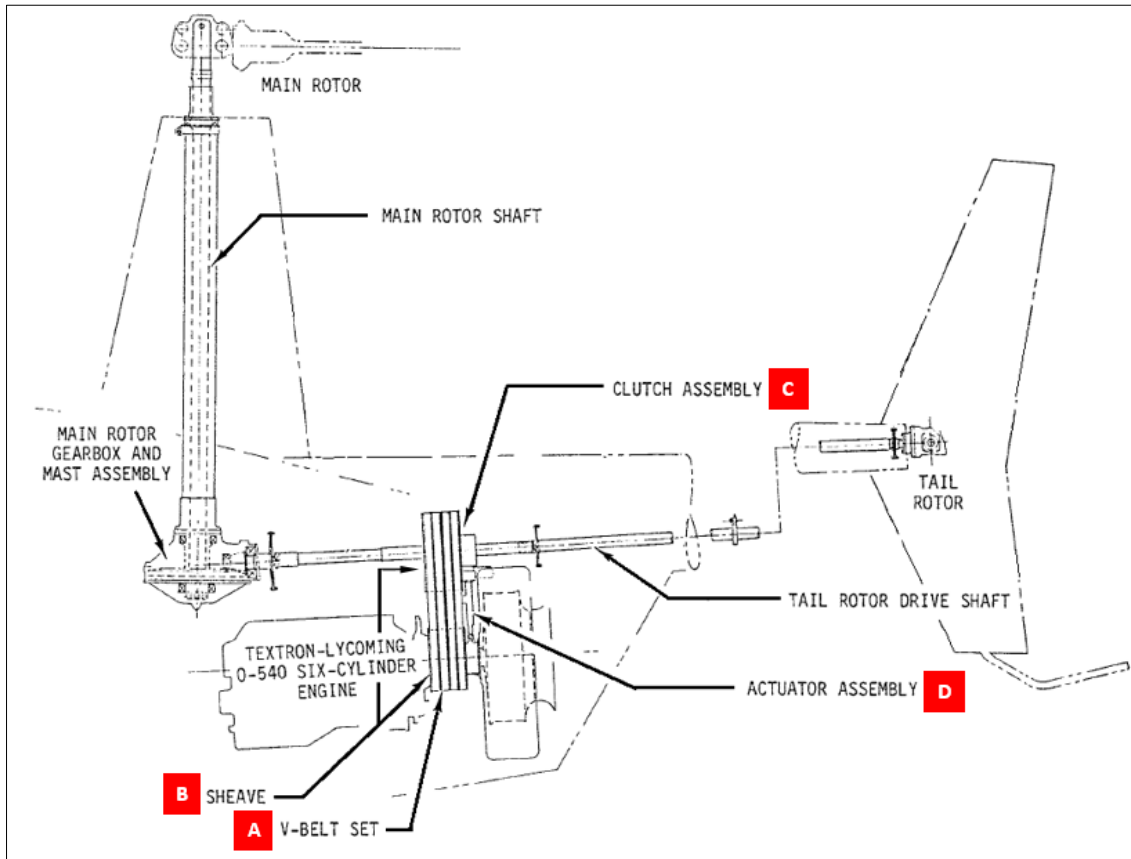
Figure 3: R44 rotor drive system

The rotors are driven by a V-belt sheave drive system, bolted directly to the crankshaft of the engine (Figure 3). Four, double V-belts (A) transmit power from a lower sheave to an upper sheave (B), which has a clutch in its hub (C). The clutch transmits power forward to the main rotor and aft to the tail rotor. A clutch actuator (D), positioned between the lower and upper sheave, extends to tension the V-belts and prevent slippage.

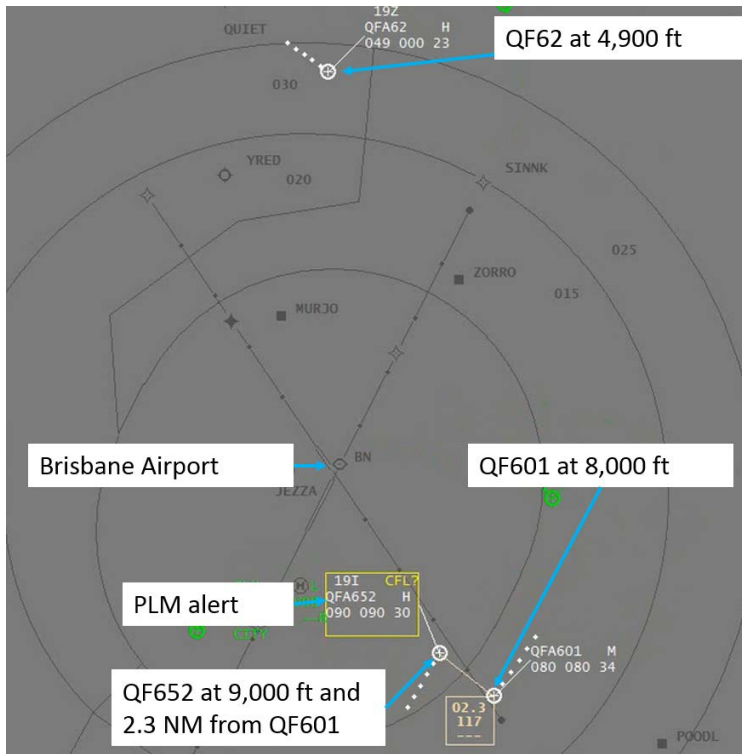
Figure 1: Traffic disposition and PLM alert

As the two aircraft passed each other, radar data showed QF652 at an altitude of 9,000 ft and QF601 at 8,000 ft, with 2.3 NM lateral separation (Figure 1). Figure 2 shows QF652 at 8,700 ft and lateral separation with QF601 of 2.6 NM (Figure 2). The incorrect descent clearance resulted in a loss of separation with QF601, where the separation required was 3 NM or 1,000 ft and the minimum separation recorded was 2.5 NM and 700 ft.
