# Aviation Short Investigations Bulletin

Issue 60

AB-2017-050

Final – 24 May 2017

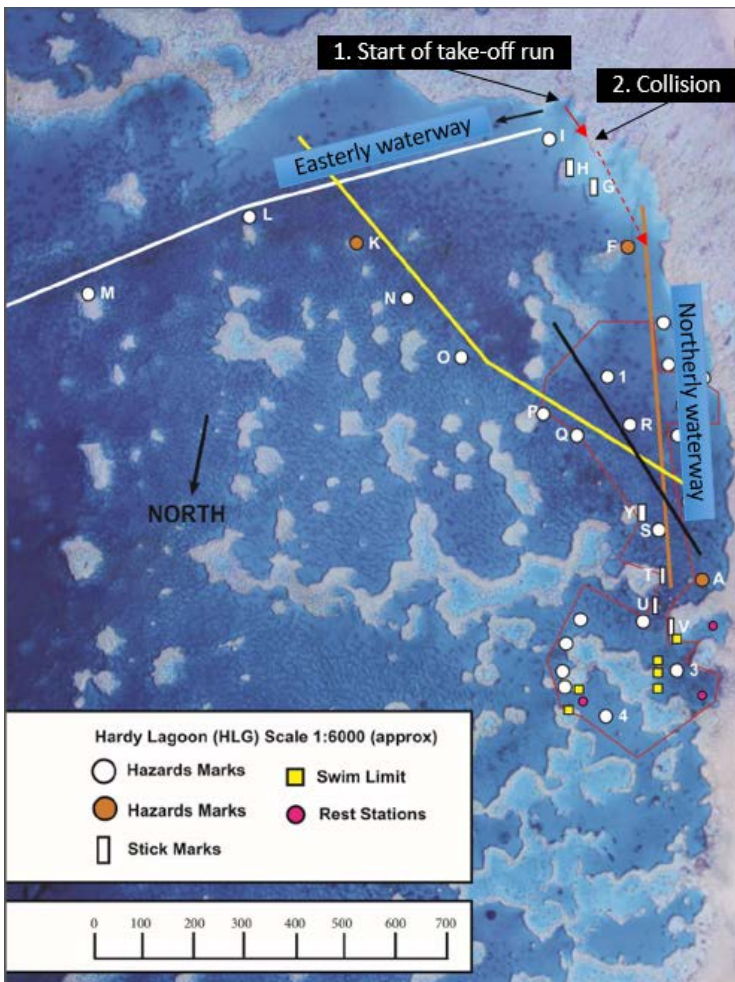
Figure 1: Hardy Lagoon (north pointing downwards)

The wind effect on the aircraft indicated to the pilot that the northerly waterway was the most into wind waterway. In order to maximise the take-off distance available the pilot applied power to start the take-off run from a position to the south-east of the northerly waterway, while aiming to join the waterway at buoy F (Figure 1). Shortly after applying full power, and before the aircraft entered the northerly waterway, both floats struck submerged reef, which brought the aircraft to a stop.

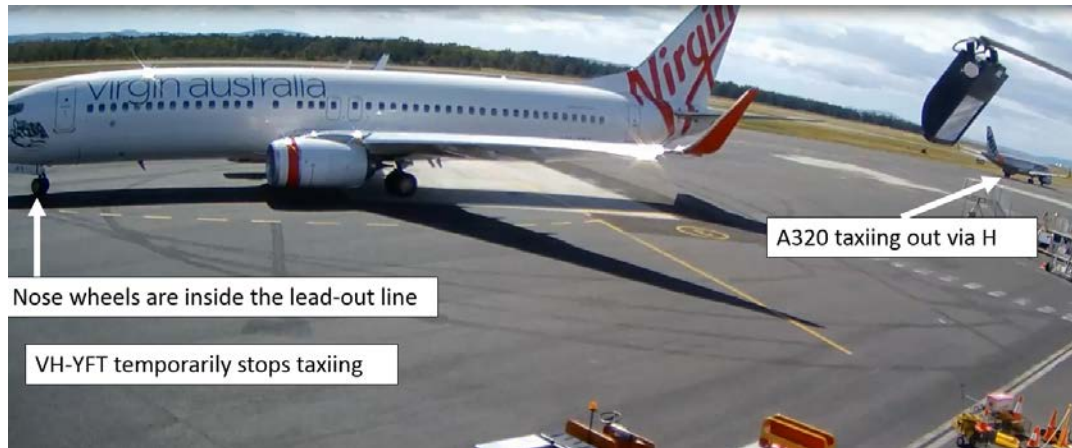
**Figure 4: YFT stopped taxiing during the turn out of bay 3**

The captain elected to stop the aircraft and clarify their taxi clearance. YFT stopped part way through the turn, about 90° from its parked position (Figure 4). At that time, the nose wheels were inside the lead-out line, and the aircraft was pointing towards the left wingtip of VUP.

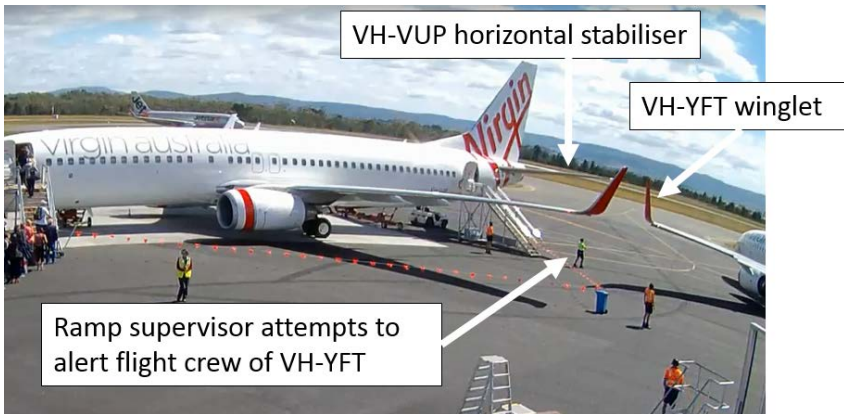
**Figure 6: Collision imminent**

As the aircraft recommenced taxiing, the dispatcher initially observed the wingtips of the two aircraft clear each other. However, as YFT then tracked towards the tail of the parked aircraft as it started to turn, the ramp supervisor assessed that a collision between the left wingtip of YFT and left horizontal stabiliser of VUP was imminent. The ramp supervisor commented that they then lowered their arms towards a crossed position to show that clearance between the two aircraft was reducing,<sup>6</sup> and attempted (unsuccessfully) to make eye contact with the flight crew (Figure 6).

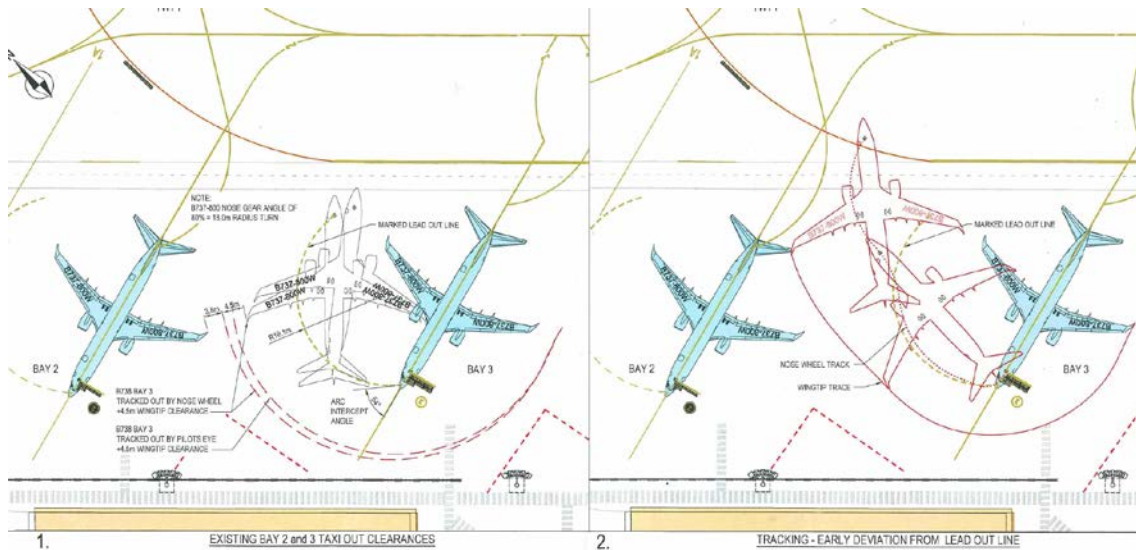
**Figure 10: Airport survey markings showing B737 aircraft taxi track with nose wheel on lead-out line (left) and approximate incident taxi path (right)**

The Hobart Airport operator reported that the bays were surveyed regularly to ensure they met the required standards. The airport operator constructed a schematic diagram of the aircraft's taxi path from the CCTV footage and the aircraft dimensions on the surveyed apron markings (Figure 10).

The captain commented that the (power-out) bays in Hobart are not aligned at right angles to taxiway H. This tends to give a false sense of being clear of adjacent aircraft once the cockpit is well past the aircraft and heading towards taxiway H, as the wingtips are so far behind the flight deck and outside the normal viewing arc of the pilots.
