Australian Government
Australian Transport Safety Bureau

Aviation Short Investigations Bulletin

Issue 61

ATSB Transport Safety Report
Aviation Short Investigations
AB-2017-068
Final – 27 July 2017

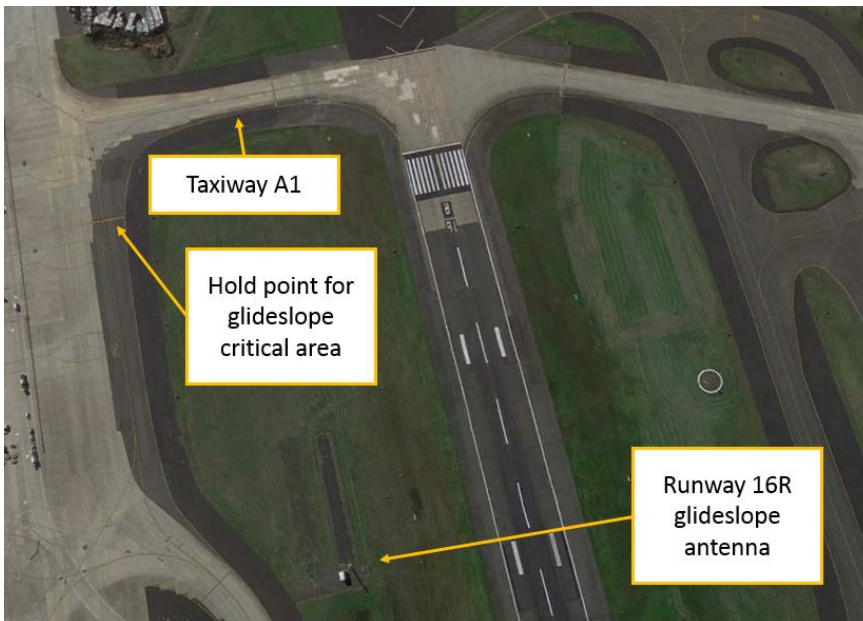
Figure 2: Runway 16R glideslope antenna and critical area hold point

Disturbances to ILS localiser and glideslope courses are caused by fixed structures, such as buildings (static distortion), and moving vehicles or aircraft (dynamic distortion). The total ILS course distortion is determined by the root square summation of static and dynamic distortion and this is used to define critical areas⁷ near each localiser and glideslope antenna (Figure 2).

At the time N416MC intercepted the runway 16R localiser, a Boeing 787 was holding on taxiway A1, within the runway 16R glideslope critical area (Figure 3). However, the weather conditions did not require air traffic control to activate the ILS critical area, and N416MC was instructed to go-around before reaching the outer marker.⁸

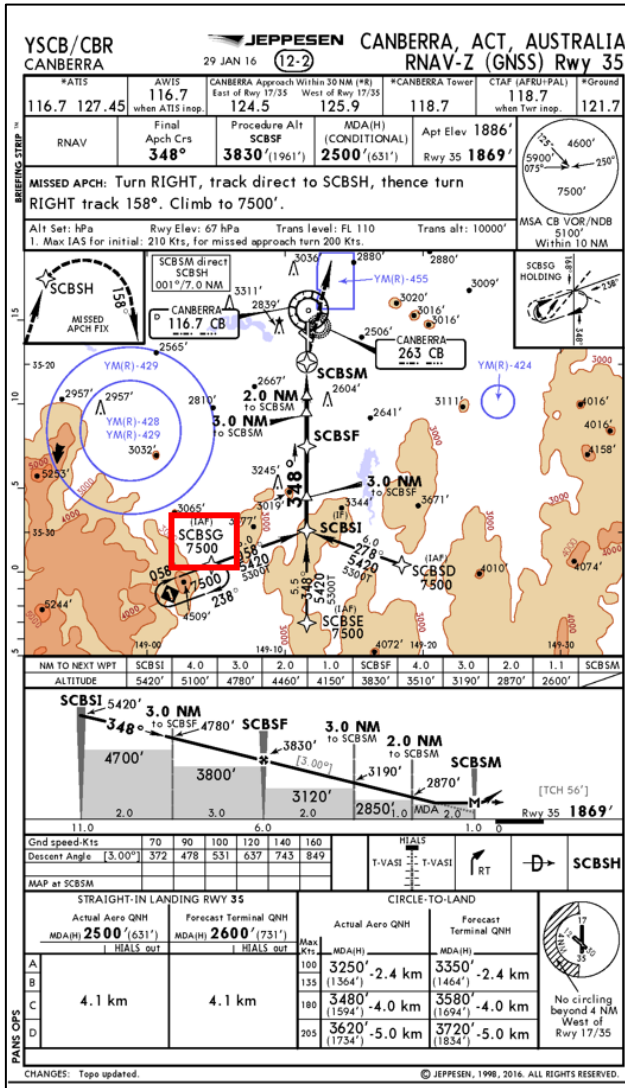
Figure 2: RNAV-Z Approach

After the controller advised the flight crew to expect the RNAV-Z approach, the captain manually re-entered SCBSG into the FMC without detecting that the 7,500 ft MSA constraint was now missing. The captain then manually connected SCBSG to SCBSI for the continuation of the approach.

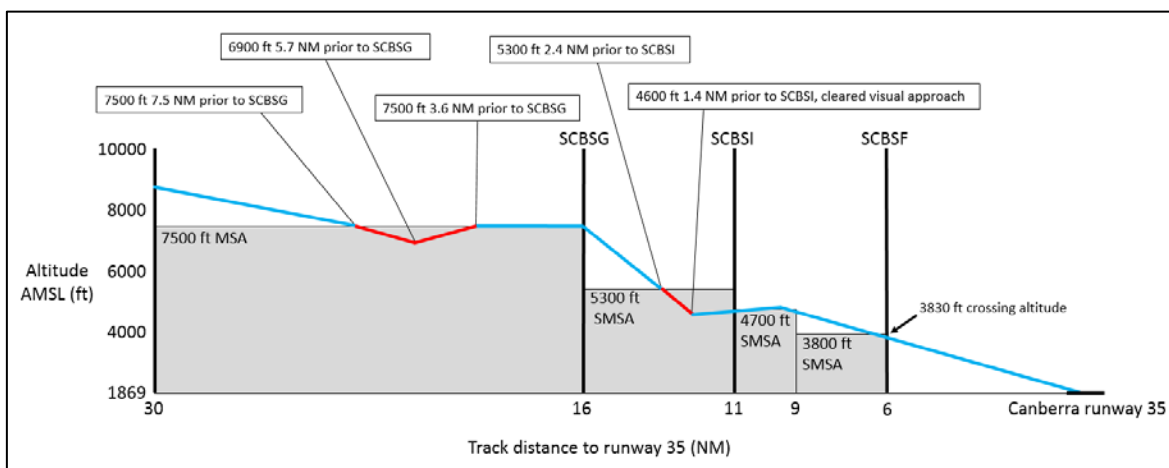
Figure 3: Arrival and approach profile

At 0909.16 in visual conditions, the aircraft tracked towards SCBSG. About 7.5 NM (13.9 km) prior to SCBSG, the aircraft descended below 7,500 ft (Figure 3). At 0909.37, as the aircraft descended to about 7,000 ft, the controller contacted the flight crew and advised that they were required to maintain 7,500 ft until SCBSG. The flight crew immediately disconnected the autopilot and

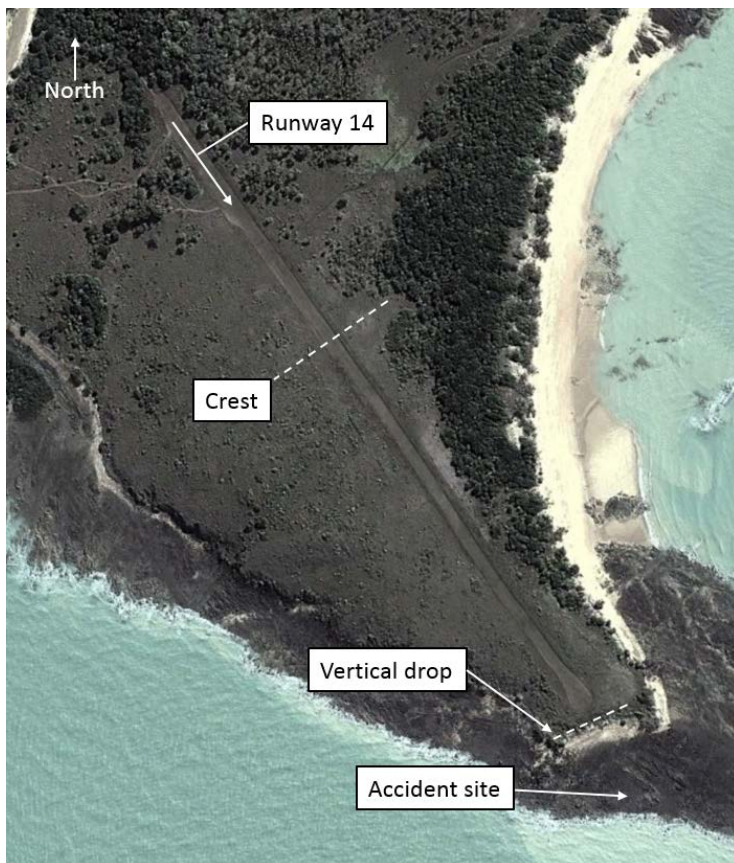
Figure 5: Avoid Island ALA

While preparing for the departure, the pilot observed a 5–10 kt wind from the south-east and elected to use runway 14 for take-off. Runway 14 was a grass runway, 800 m long and included a slight rise in the middle. At the end of the runway was a vertical drop of about 2 meters down to a rocky beach.

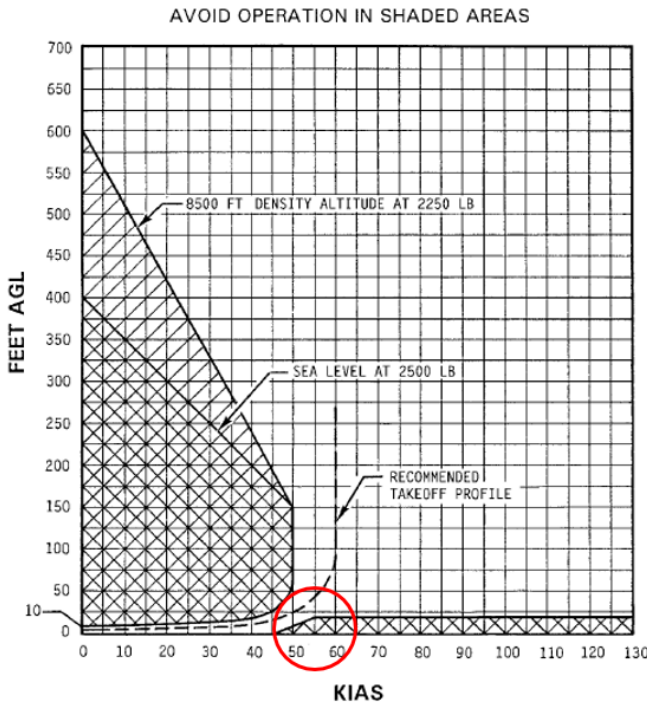
Figure 2: Robinson R44 II height-velocity curve

The pilot commented that their intention, in accordance with the height-velocity curve (Figure 2) published in the aircraft’s pilot operating handbook, was to descend and remain in ground effect³ until the helicopter had sufficient forward speed to achieve translational lift.⁴
