Aviation Short Investigations Bulletin

Issue 62

ATSB Transport Safety Report
Aviation Short Investigations
AB-2017-082
Final – 5 September 2017

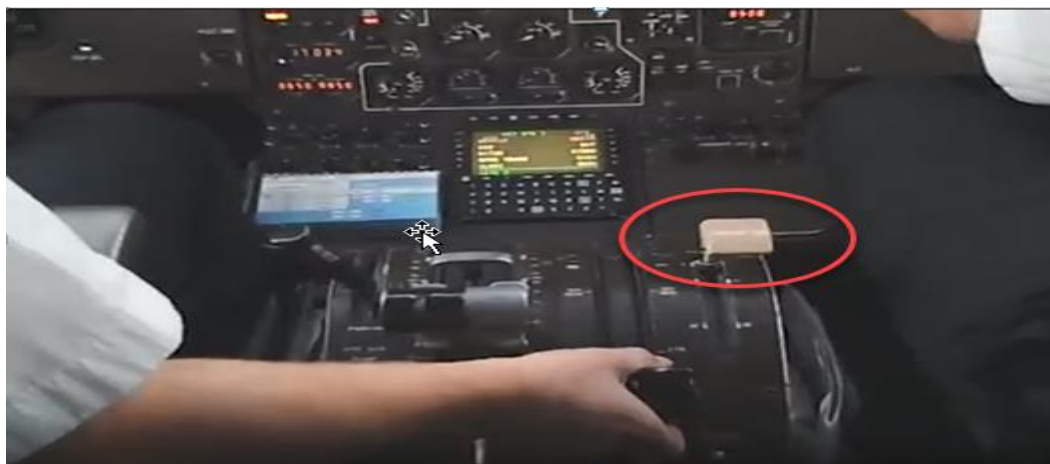
Figure 1: Location of flap lever on ATR72

While the aircraft was turning onto the final approach leg, the captain directed the first officer to select flap 30, set the airspeed indicator bug to the approach speed (V_{APP}),² and start the before landing checklist. The first officer completed a radio call with ATC, moved the flap selection lever (Figure 1), set the approach speed (104 kt) and responded 'V approach set', and then started the checklist.

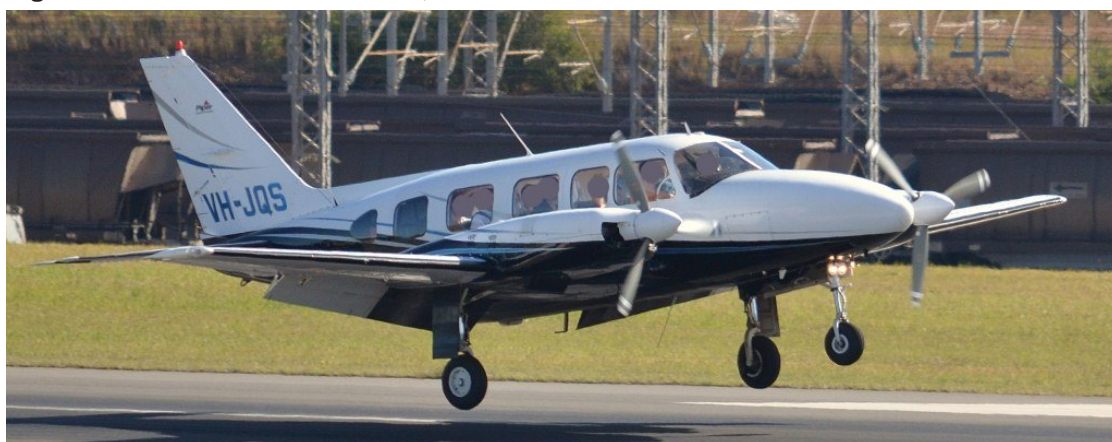
Figure 1: The occurrence aircraft, VH-JQS

On the morning of 29 March 2017, a Piper PA-31-350 aircraft (Figure 1), registered VH-JQS, was on a private visual flight rules flight from Moorabbin, Victoria (Vic.) to Barwon Heads/Geelong aeroplane landing area (Barwon Heads ALA),¹ Vic. The pilot was the only person on board.

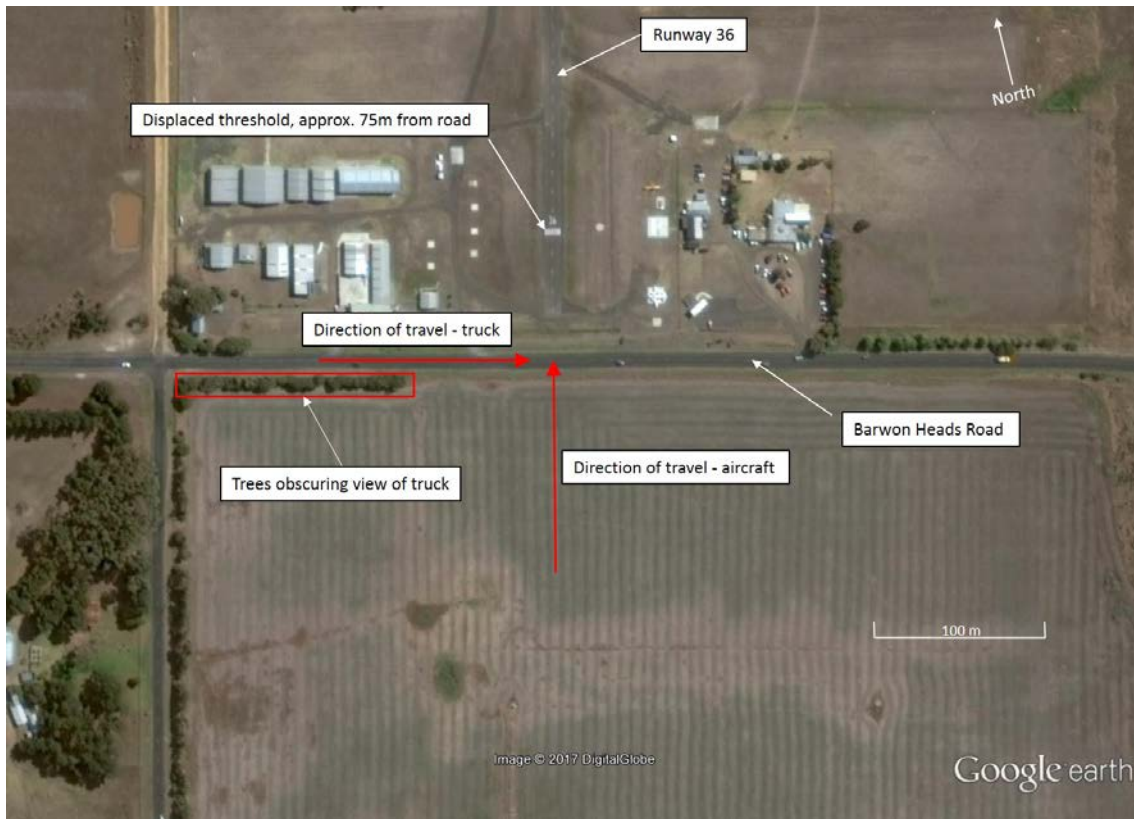
Figure 2: Barwon Heads/Geelong aeroplane landing area (ALA).

At a distance of about 0.5 NM (0.9 km) from runway 36, the pilot detected the aircraft becoming slightly low on the desired approach profile. The pilot retracted the flaps by 10° in an attempt to reduce the rate of descent. As the aircraft approached runway 36, the pilot noticed the aircraft was still lower than intended and decided to increase power. The pilot looked down momentarily at the throttle quadrant as they put their hand on the throttle control. As they looked back up, they observed a truck approaching from the left along Barwon Heads Road (Figure 2).

The pilot applied full power to conduct a go-around.² As full power was applied, the aircraft passed over Barwon Heads Road and the left main landing gear impacted the truck. The pilot observed the truck continue on Barwon Heads Road without stopping and the pilot continued with the go-around. The pilot elected to leave the landing gear extended in case it had sustained damage.

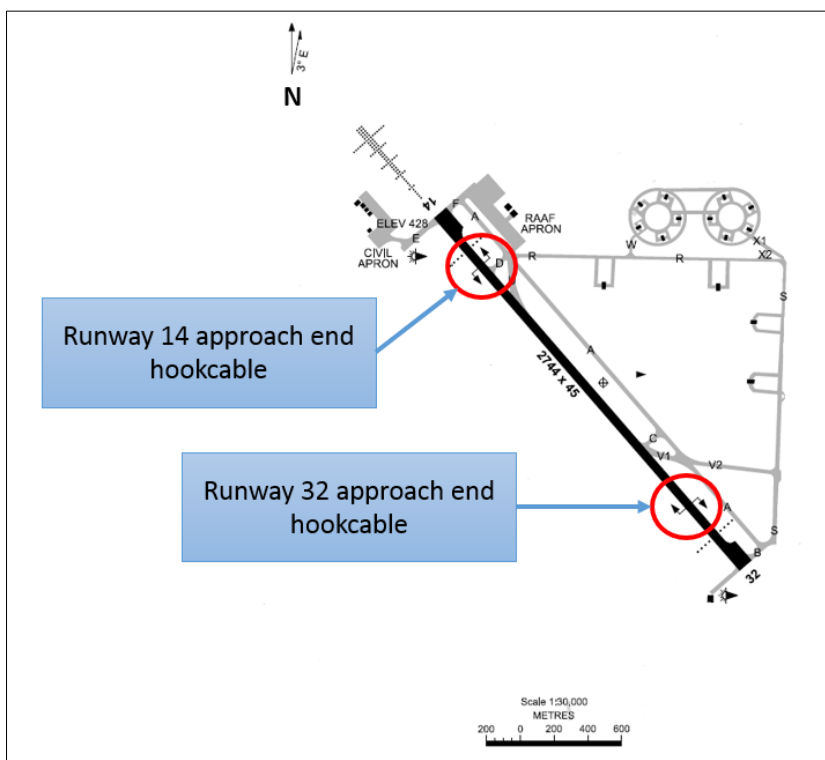
Figure 1: Tindal airport runway hookcables

Tindal Airport has bi-directional hookcables, used to stop military jets in an emergency, positioned at both ends of the runway (Figure 1). The air traffic control tower had opened for a scheduled military jet departure and was therefore active when COQ made its approach to land. During the tower opening checklist procedure, the tower controller annotated the 'cables' check was completed. About 21 minutes after the tower opened, COQ requested a clearance to land from the base leg position for runway 14. The tower controller scanned the control console, noted that both hookcable pushbutton lights were green, and cleared COQ to land on runway 14.

When COQ was on short final approach to land on runway 14, the pilot noticed the approach end hookcable was raised.¹ They² adjusted their aim point beyond the hookcable and landed without incident. The pilot of COQ reported the position of the hookcable to the tower controller, who then rectified the situation.

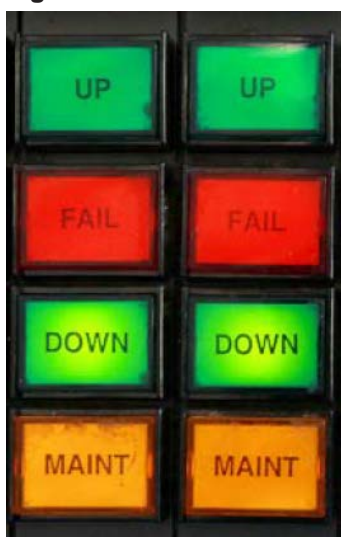
Figure 2: Tower control console hookcable pushbuttons

The AAS may be controlled by air traffic control from the air traffic control tower using the cable control console pushbutton selection/indicator lights (Figure 2). There are four pushbutton selection/indicator lights for each hookcable. Two separate green UP and green DOWN pushbuttons are used to select, and then indicate, the desired position for each hookcable.

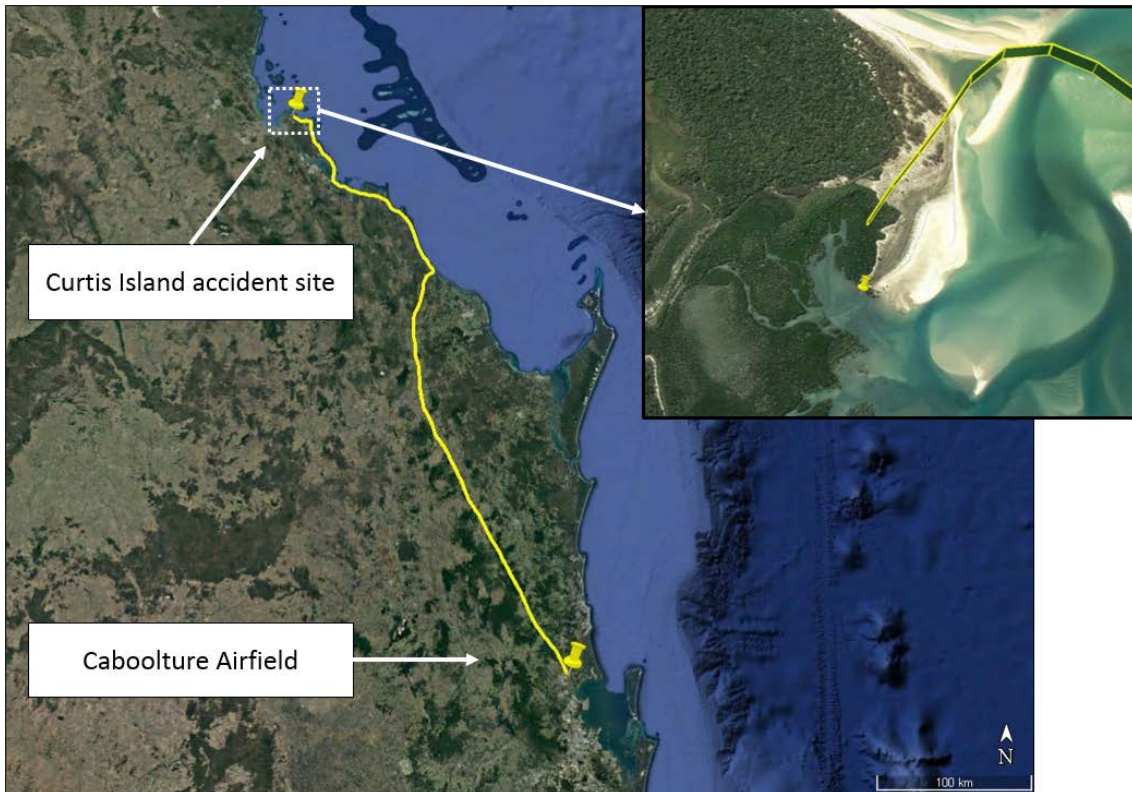
Figure 1: VH-DPU track and accident site (drop pin)

Prior to departure, the helicopter had been refuelled to full at Caboolture Airfield. The helicopter was flown for about 2.5 hours north, initially inland, then coastal to the north of Curtis Island where the pilot planned to land for a fishing trip (Figure 1). At 1142 Eastern Standard Time (EST), the pilot sent a text message from their¹ mobile phone to a friend monitoring their search and rescue time, which indicated they had arrived at their planned fishing spot.² At 1144, the helicopter was recorded on an OzRunways application, running on a mobile device, at the north-east coast of Curtis Island heading 209°.

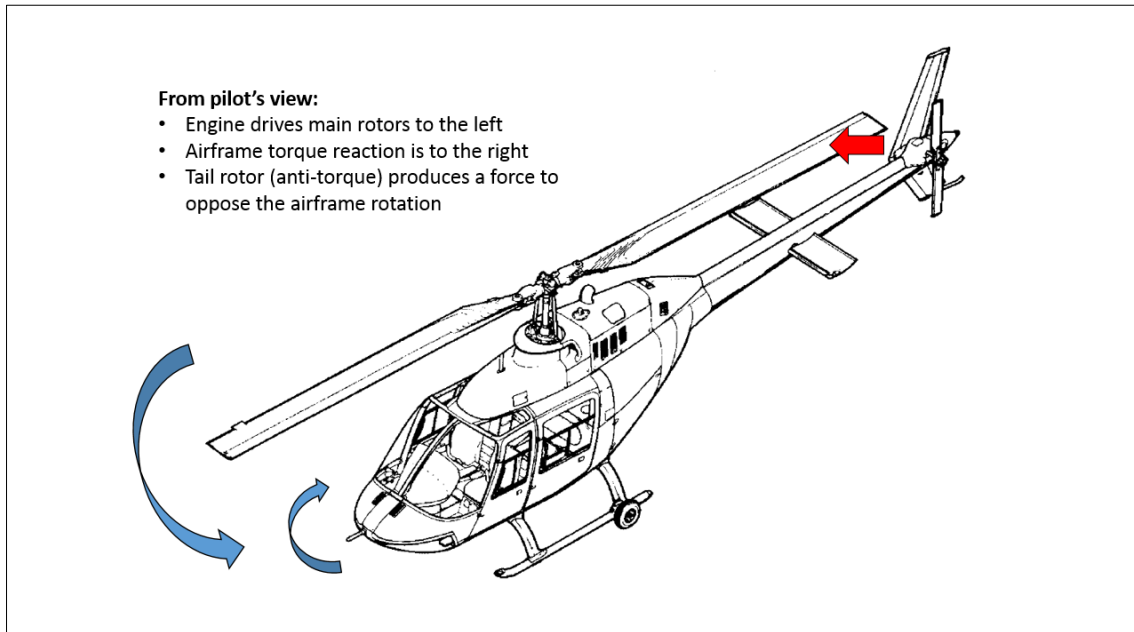
Figure 4: General effect of engine torque

The AB206A helicopter engine drives the main rotors to the left, when viewed from the pilot’s seat. This subjects the airframe to a turning moment to the right (Figure 4). The tail rotor provides the anti-torque force to prevent the engine power from turning the airframe to the right. It is mechanically connected to the main rotor system through the main rotor gearbox and operates at a speed, which is much higher, but proportional to the main rotors. A reduction in rotor speed will reduce the anti-torque force provided by the tail rotor and can lead to loss of tail rotor effectiveness and consequently loss of directional control.

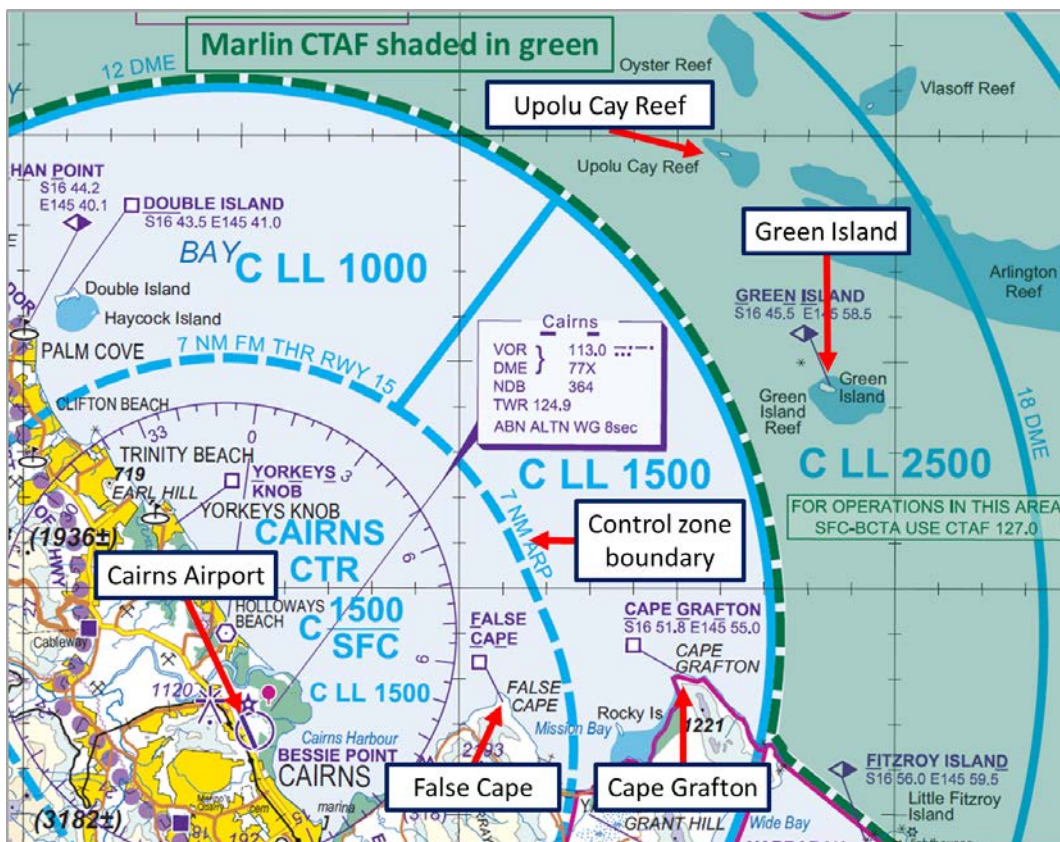
Figure 1: Extract of Cairns visual terminal chart showing the Marlin CTAF shaded in green, Green Island and Cape Grafton

On 5 February 2017, at about 1639 Eastern Standard Time (EST), a Bell 407 helicopter, registered VH-VHU (VHU), departed from Cairns Airport, Queensland, on a local scenic charter flight (visual flight rules), tracking towards Green Island (Figure 1). On board were the pilot and six passengers.

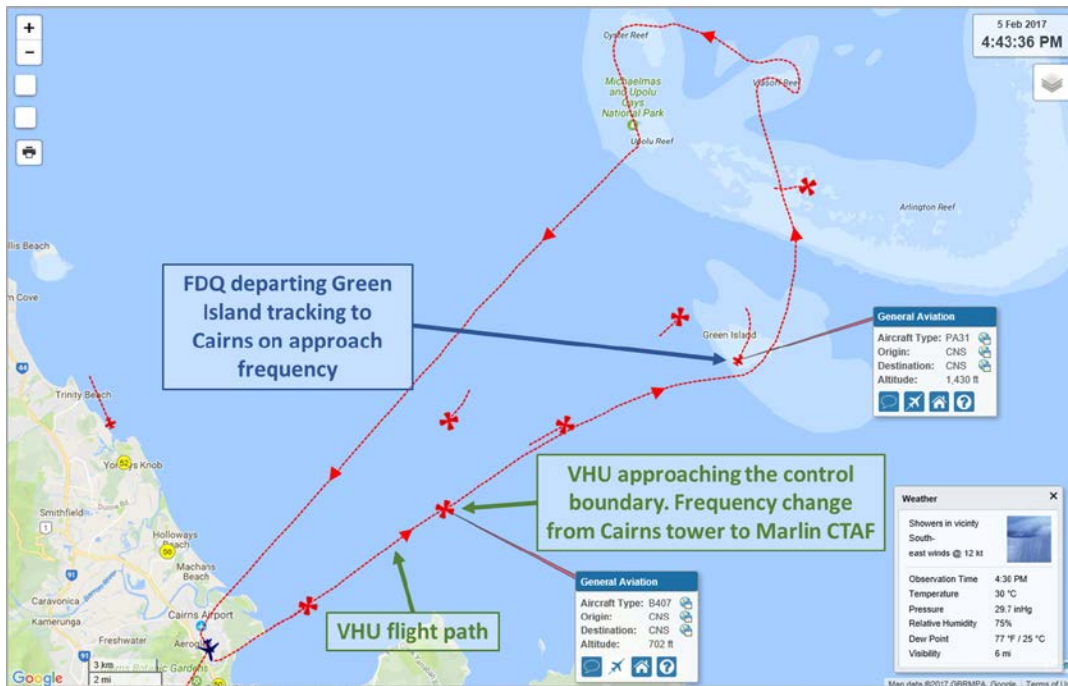
Figure 2: Location of VHU when changed to the Marlin CTAF and approximate location of FDQ when commenced tracking direct to Cairns

About 30 seconds later, the approach controller cleared the pilot of FDQ (then orbiting at Green Island) to track to Cairns via a left base circuit leg for runway 15 at 1,500 ft (Figure 2).

As VHU approached 900 ft on climb, the pilot indicated that their attention was inside the cockpit to ensure they did not climb above 1,000 ft and to set up the helicopter in the cruise. When the pilot subsequently scanned outside, they sighted an aircraft rapidly approaching³ in the opposite direction (FDQ). The pilot of VHU conducted a rapid descent to increase the separation with FDQ and estimated that the vertical separation between the two aircraft was between 100 to 150 ft.⁴ Radar data indicated that the minimum separation between the two aircraft was 400 ft vertically and 500 m horizontally.

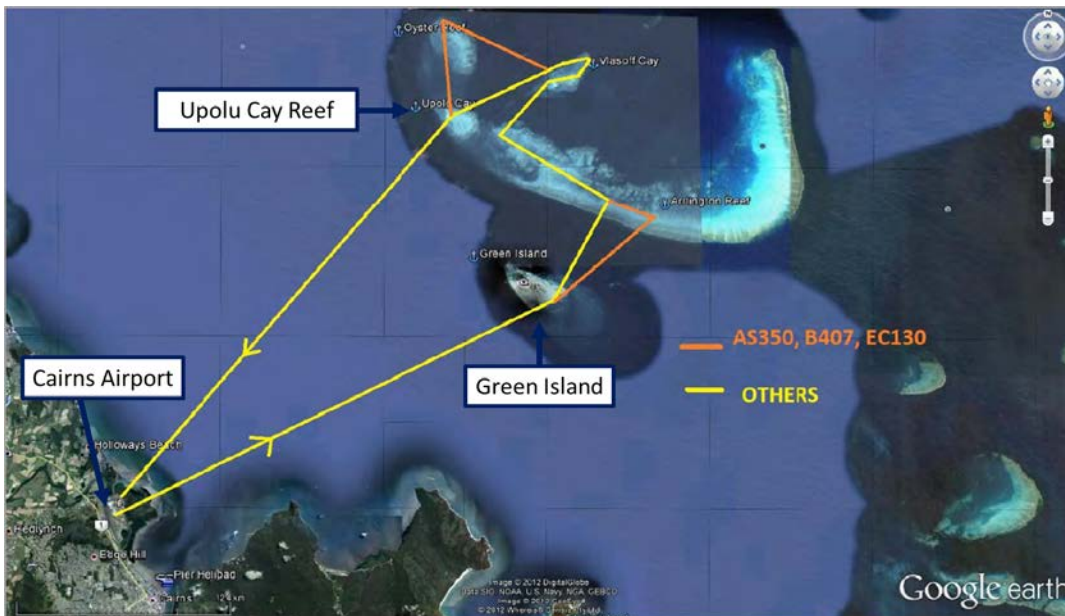
Figure 3: Suggested route for scenic flights

In the interim, on 10 January 2017, the operator of VHU sent an email to the chief pilots of other scenic flight operators with a suggested route for scenic flights (Figure 3). They reported that all helicopter operators agreed to fly in a counter clockwise direction and that this had decreased the incidence of near collisions between helicopters.
