Fuel planning event, weather-related event and ditching involving Israel Aircraft Industries Westwind 1124A, VH-NGA

6.4 km WSW of Norfolk Island Airport | 18 November 2009

ATSB Transport Safety Report
Aviation Occurrence Investigation
AO-2009-072 (reopened)
Final – 23 November 2017

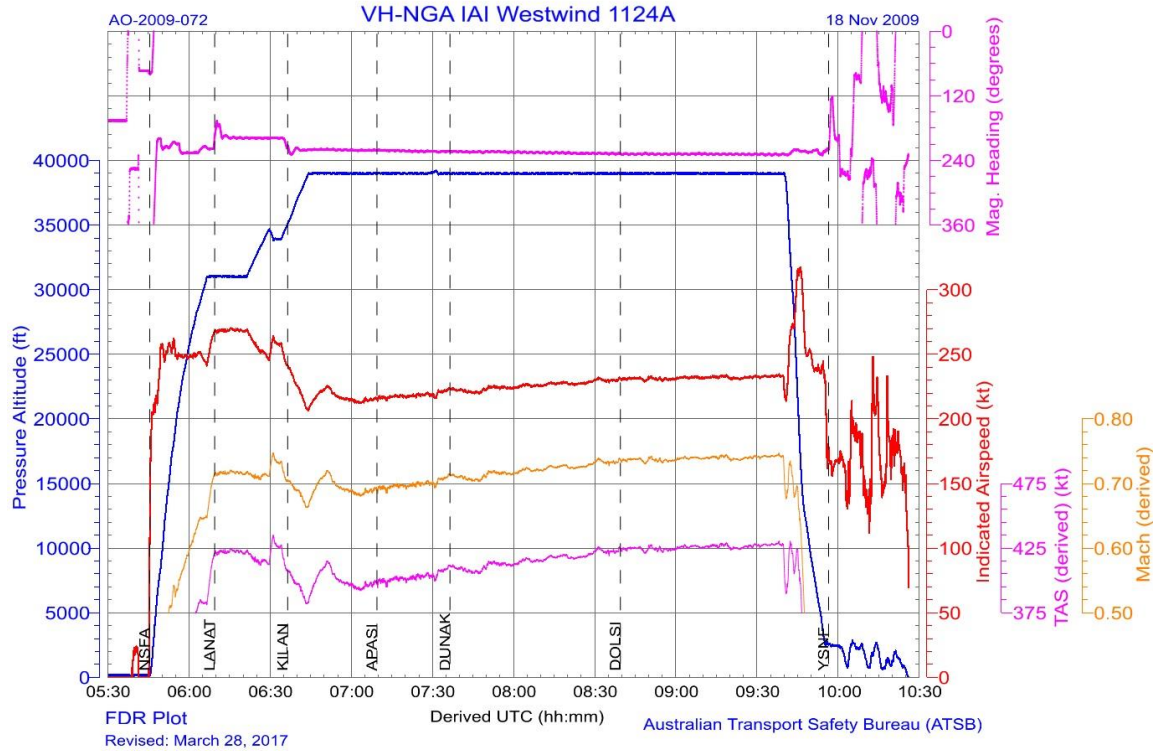
Figure 4: Downloaded and derived data from the FDR for the accident flight

The captain reported that, soon after reaching FL 390 and setting the thrust, he started doing detailed fuel and performance calculations. At that stage he was confident he had more than sufficient fuel for the flight.

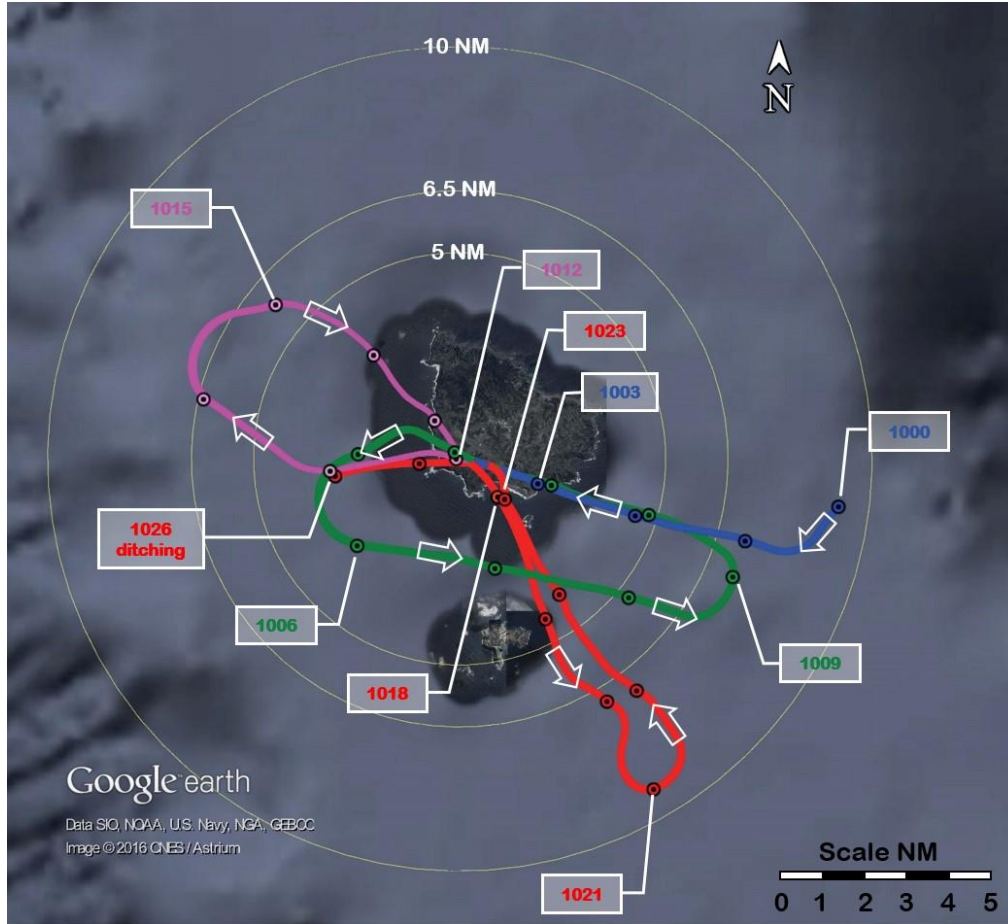
Figure 5: Aircraft's lateral position from 1000 until the ditching showing the first approach (blue), second approach (green), third approach (purple) and fourth approach and ditching (red)

Figure 5 shows the aircraft's track during the four approaches and the ditching. Table 9 summarises the communications between the flight crew and the Unicom operator during this period.

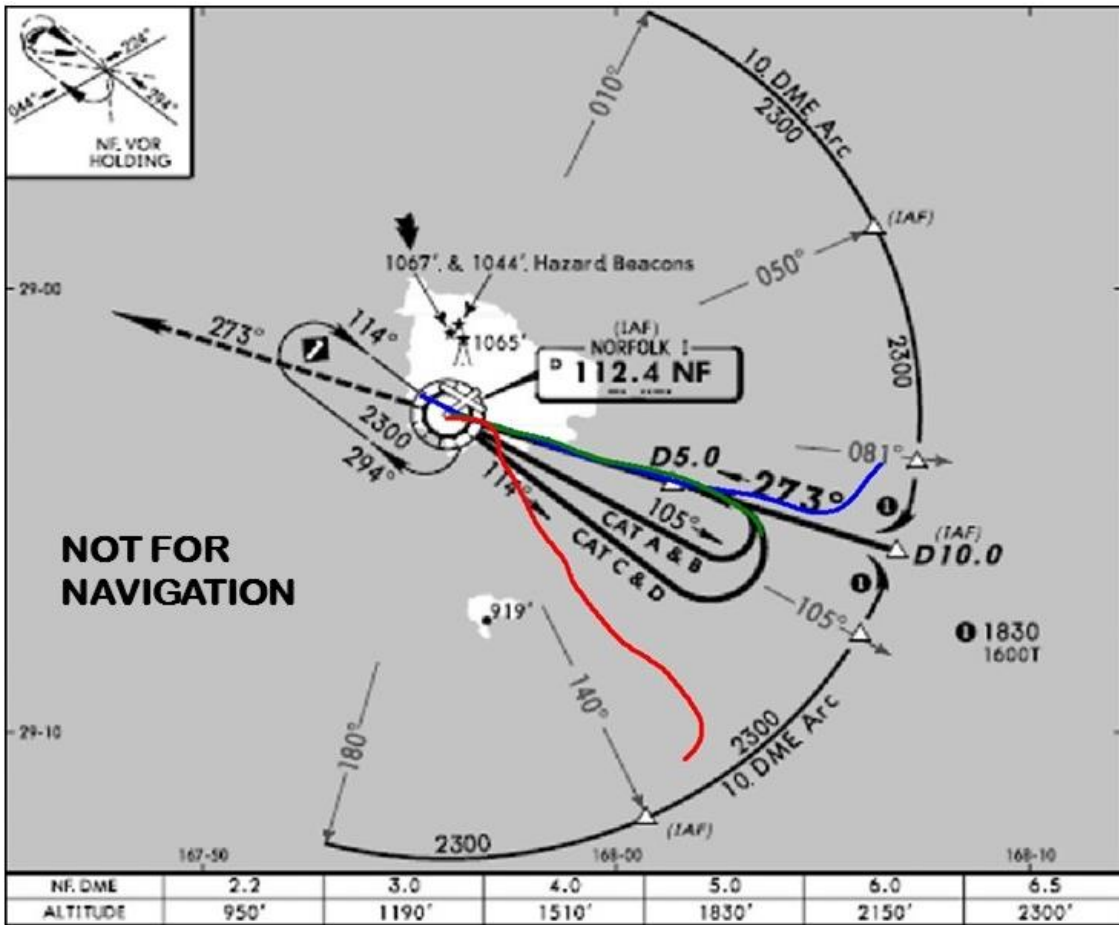
Figure 6: Final approach tracks flown to runway 29 (approaches 1 (blue), 2 (green) and 4 (red)), overlaid on chart extract of procedure used by the crew on the night of the accident

At 6.5 NM, the crew selected the landing gear down and initiated descent for the final approach. The descent profile flown was above the recommended descent profile published on the approach chart. Events during the final approach to runway 29 included:

Figure 6 shows the approximate ground track of the aircraft during the approach to runway 29 relative to the instrument approach chart (in red), and Figure 7 shows the vertical profile relative to the recommended profile (in red). As indicated in Figure 6, at 1021:19 the aircraft was about 9.2 NM and turning on to an inbound track to the VOR that was about 30° left of the published inbound track (altitude 2,040 ft and commencing a descent).

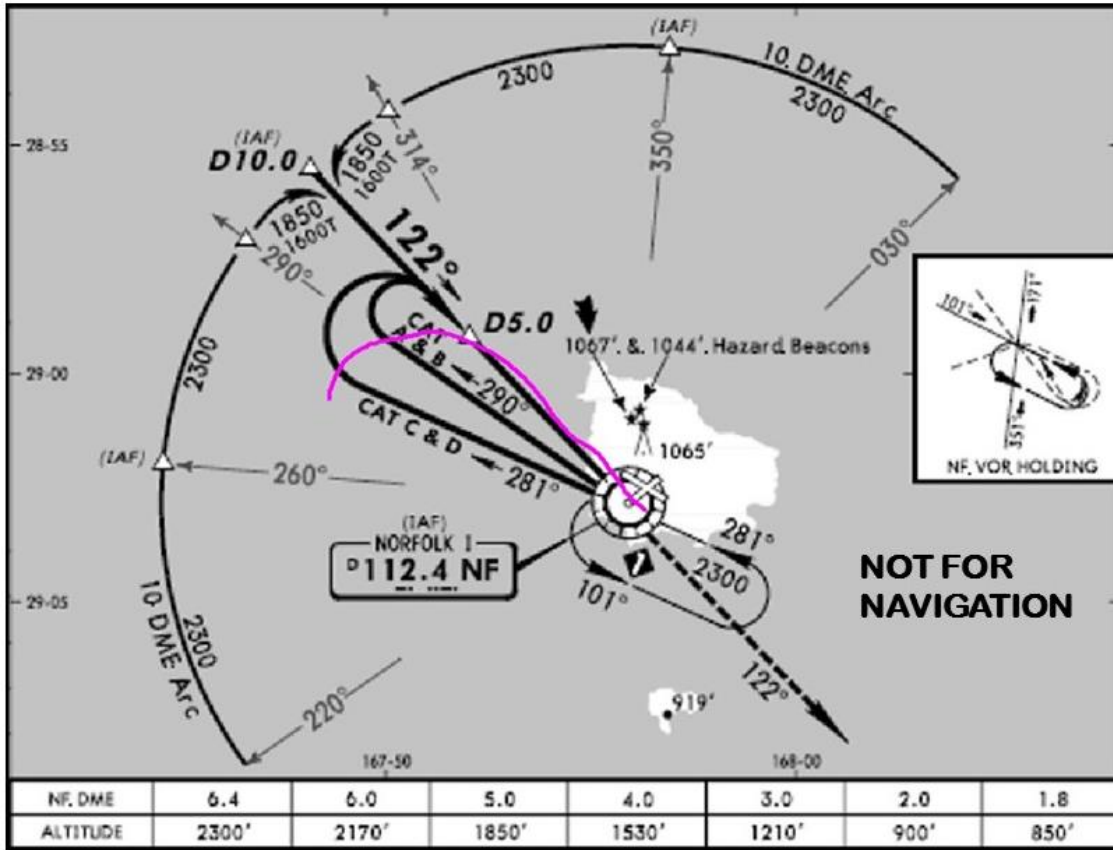
Figure 8: Final approach track flown to runway 11 (approach 3), overlaid on chart extract of procedure used by the crew on the night of the accident

At 1014:00, and about 6.2 NM, the captain initiated a right turn. The aircraft turned inside the published initial approach fix. The right turn continued and, at about 1015:13, the aircraft was about 5.2 NM, descending through 1,800 ft and approaching the final approach track. The first

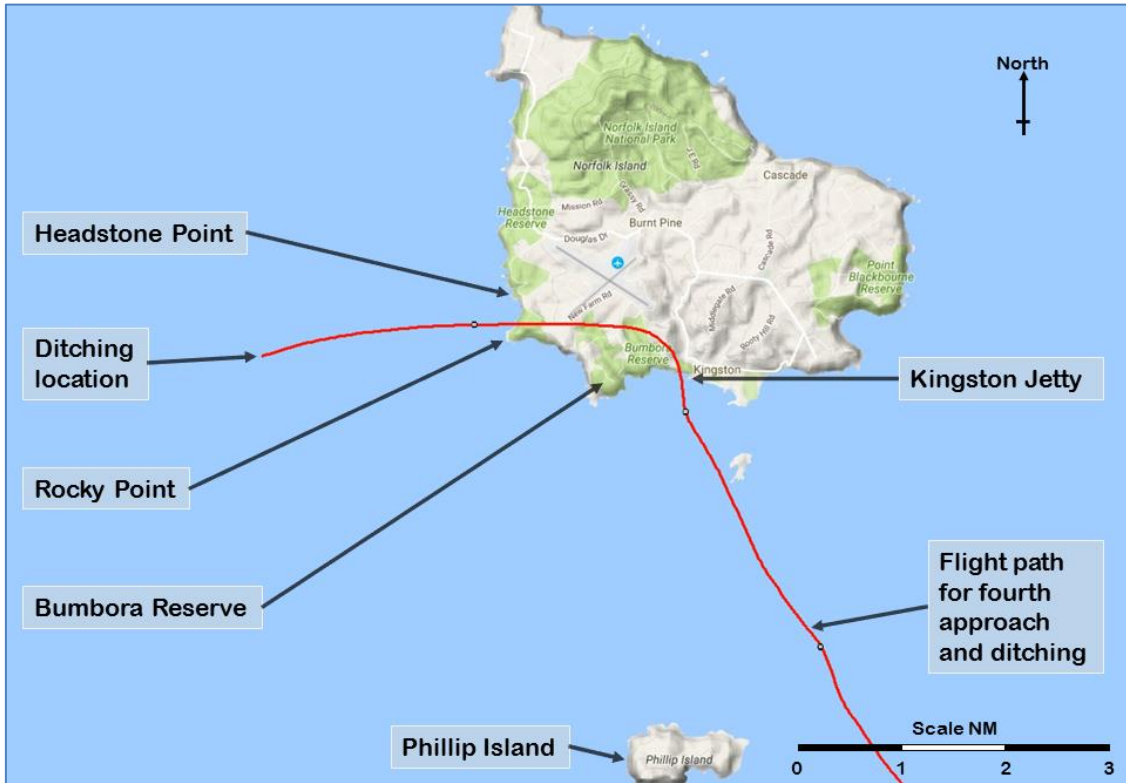
Figure 10: Map showing Norfolk Island and flight path of aircraft in period prior to ditching

Figure 10 shows the flight path of the aircraft during the final stage of the fourth approach and the ditching. The captain recalled there was low terrain to the south and west of the airport. He said turning left (to the west) was the quickest way to reach the water and he knew there were no islands in that area.

The ditching occurred 6.4 km west-south-west of the airport, or 4.6 km west of the nearest land (which was Rocky Point, Figure 10). The ATSB fuel analysis indicated there was probably about 440 lb of fuel remaining at the time of the ditching.

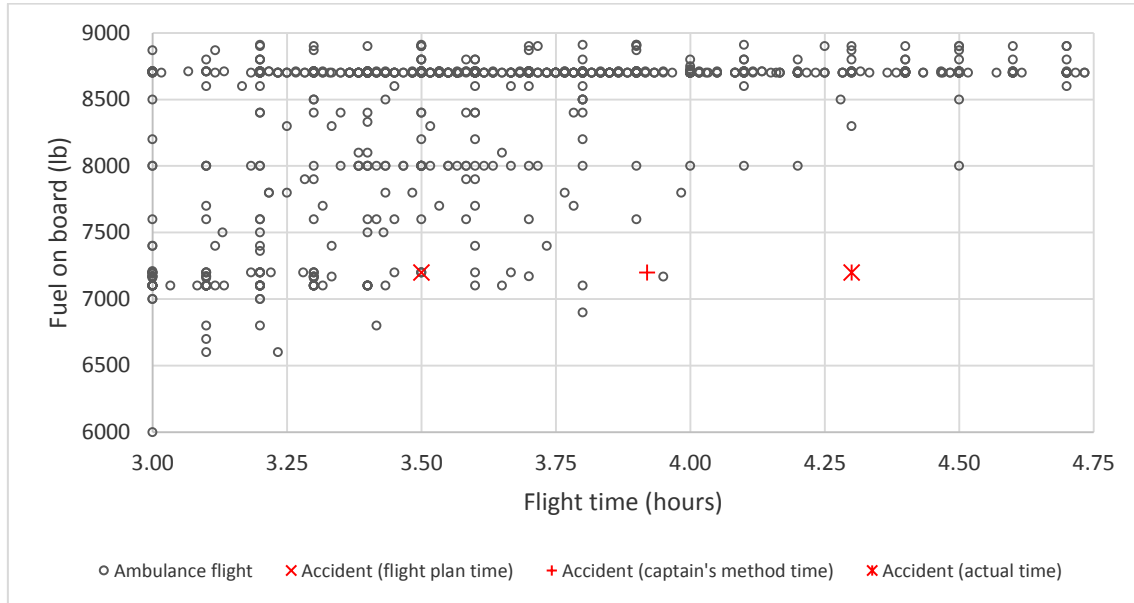
Figure 35: Fuel on board and flight time for the operator's long-distance air ambulance flights to all destinations (2002–2009)

Figure 35 shows the fuel on board and flight time of the 828 air ambulance flights with a flight time of 3.00–4.75 hours, and compares these to the accident flight (in terms of the submitted flight plan time, the flight plan time based on using the captain's normal flight planning method and the actual flight time to the first missed approach).

As indicated in the figure, most of the 580 air ambulance flights with a flight time of 3.25–4.24 hours departed with full fuel. More specifically:

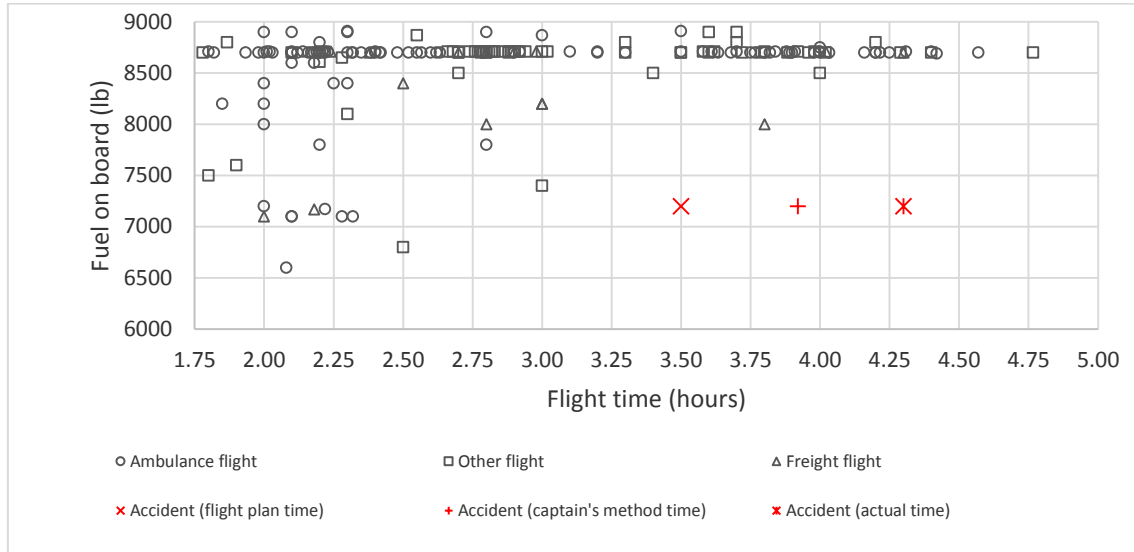
Figure 36: Fuel on board and flight time of the operator's Westwind flights to remote aerodromes (2002–2009)

Figure 36 shows the fuel on board and the flight time for the 184 flights that landed at a remote aerodrome, and compares these to the accident flight (in terms of the submitted flight plan time, the flight planned time based on using the captain's normal method and the actual flight time to the first missed approach).

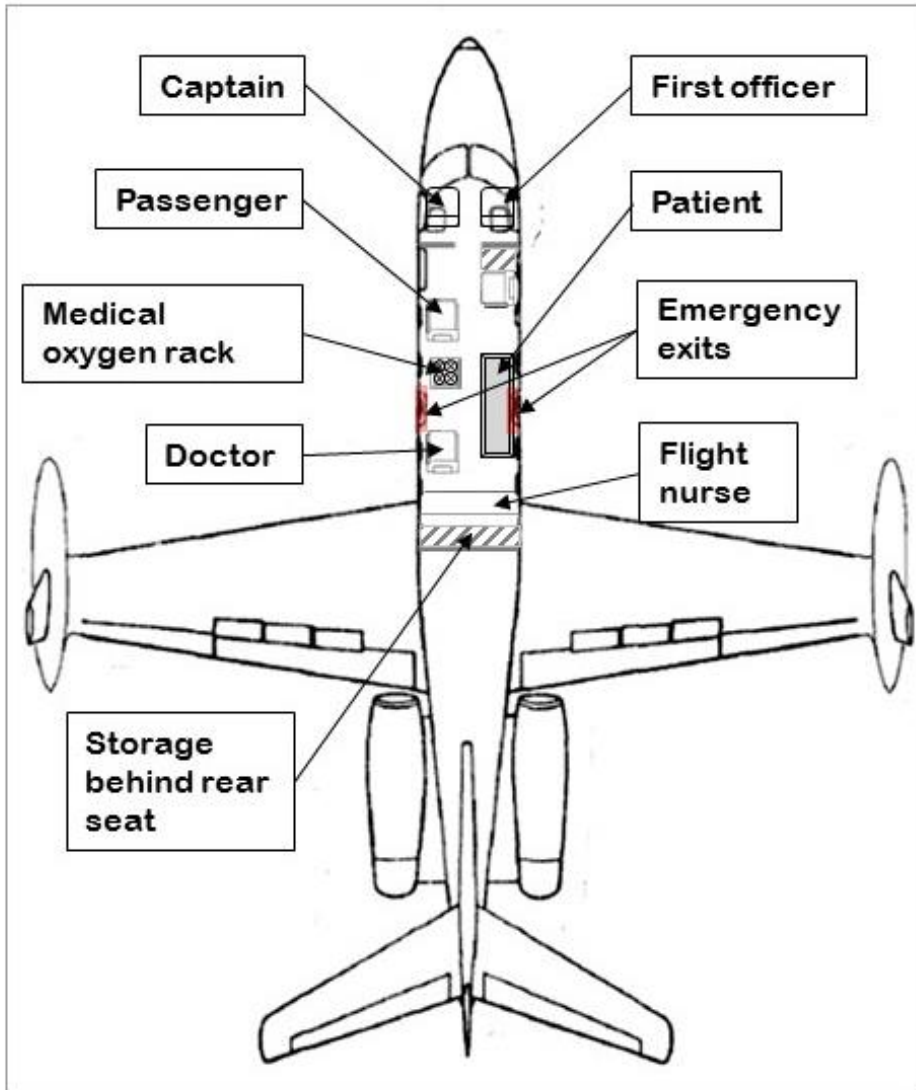
Although remote islands had a similar amount of unforecast weather below the landing minima as the capital city airports, it should be noted the potential consequences are more serious, given the locations of the airports.

Figure 39 shows the seating position of each of the occupants of VH-NGA during the ditching. The main entry door was located on the left side, just rear of the cockpit. The two emergency exits were located just forward of the wings, one on each side.

The stretcher was located on the right side of the cabin. Although the stretcher was located in front of the right emergency exit, its height was about halfway between the cabin floor and the bottom of the exit.²²⁶ The stretcher was approved to be used by a patient during take-off and landing. The patient was secured to the stretcher via an over-the-shoulder four-point harness and straps around the waist and thighs.

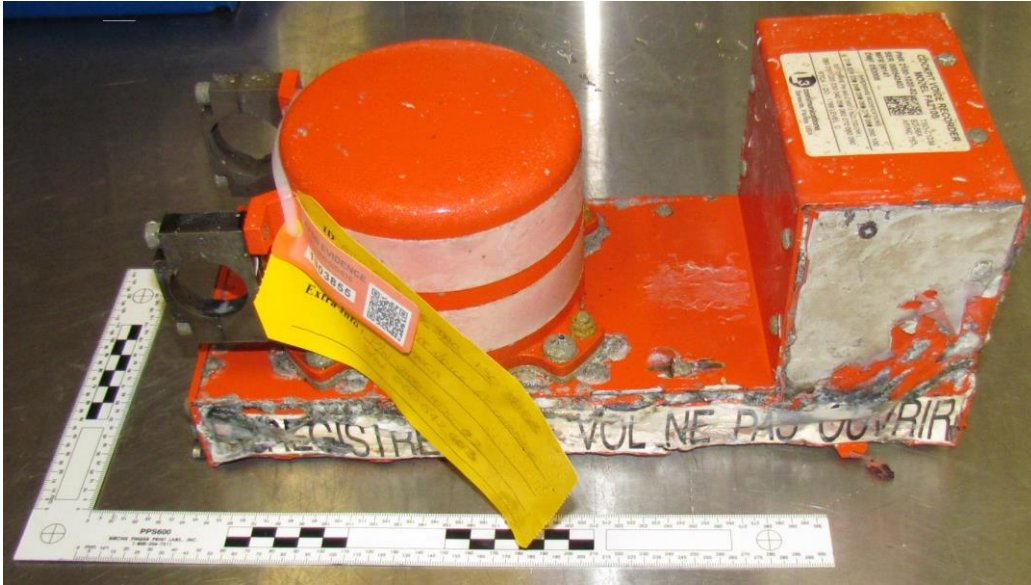
Figure A2: Recovered CVR at the ATSB laboratories in Canberra, 16 November 2015

An example of a FA2100 CVR is shown in Figure A1. The CVR unit recovered from VH-NGA is shown in Figure A2 and the crash-survivable memory unit, as removed from the CVR chassis, is shown in Figure A3.

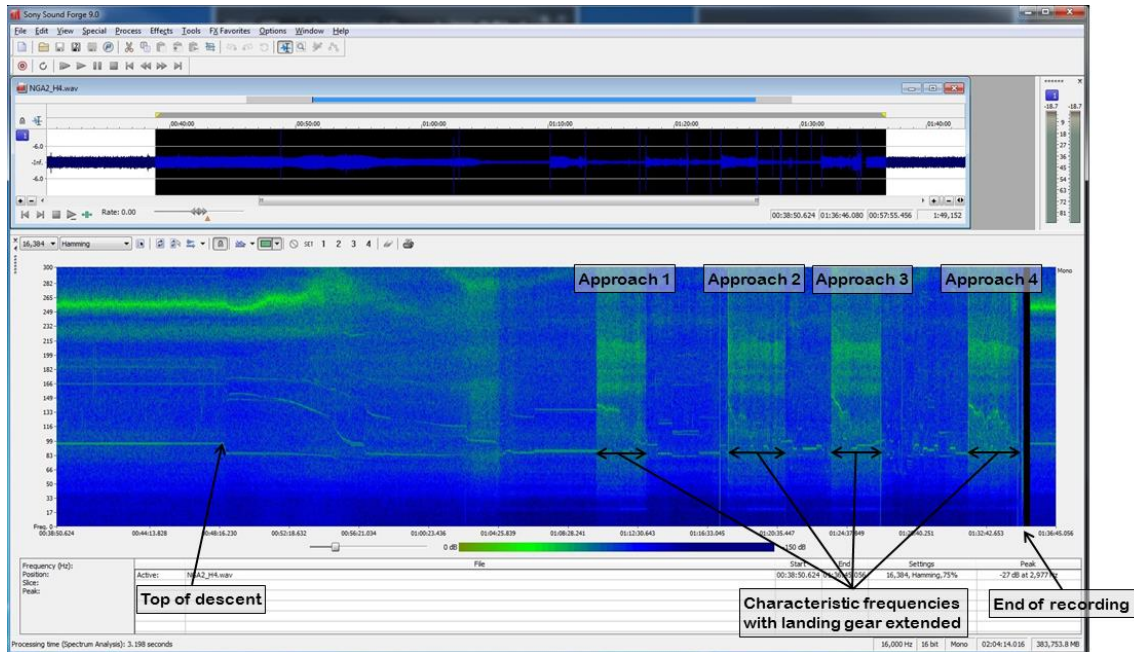
Figure A5: Audio frequency spectra plot of signals recorded by the cockpit area microphone

The CAM recording channel contained information relevant to the aircraft configuration. Figure A5 shows an audio frequency spectra plot of aircraft operation from top of descent to the end of the recording.

Characteristic frequency patterns were identified on the CAM channel, associated with aircraft operation with the landing gear extended. These frequencies included the airflow noise associated with the extended landing gear and fairings.

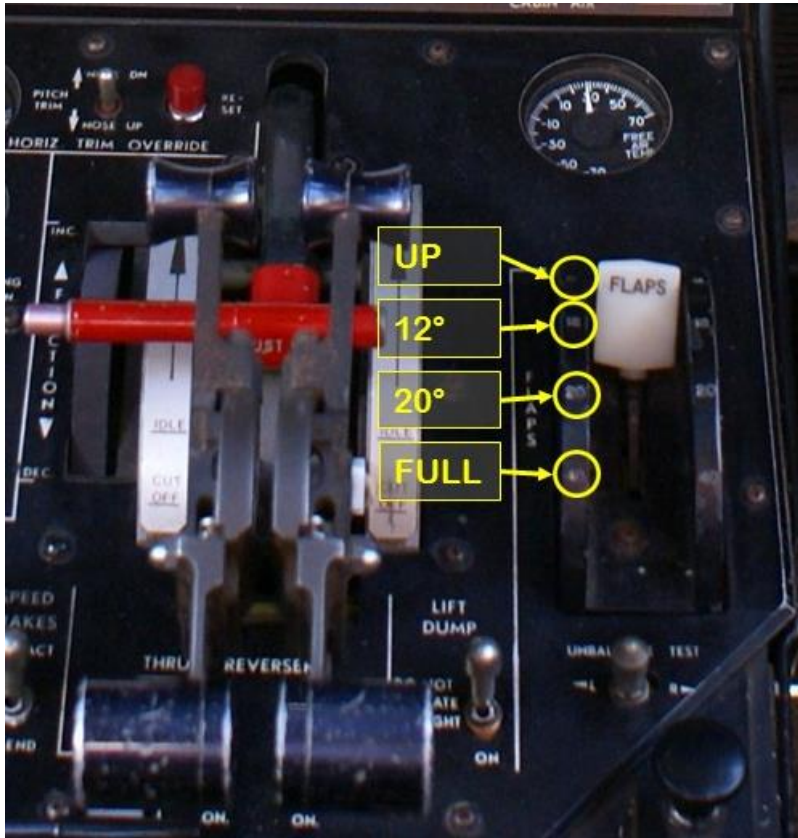
Figure A6: Photograph of flap selector mounted on centre pedestal and showing flap positions

The trailing edge flaps fitted to the Westwind 1124A had four positions - UP (0°), 12°, 20° and FULL (40°). The flaps were activated by a flap selector on the centre pedestal (see Figure A6) and each flap selection position was associated with a physical detent, such that any movement of the flap lever resulted in an audible click on the CAM recording channel.

A review of the CAM channel identified there were distinctive click sounds that corresponded to almost all known flap setting changes. The only two exceptions occurred during the start of the second and third missed approaches, when potential sounds were masked by the activation of the landing gear warning warn. Table A1 provides further details. As indicated in Table A1, there was no indication the flight crew selected full flap during the fourth approach.

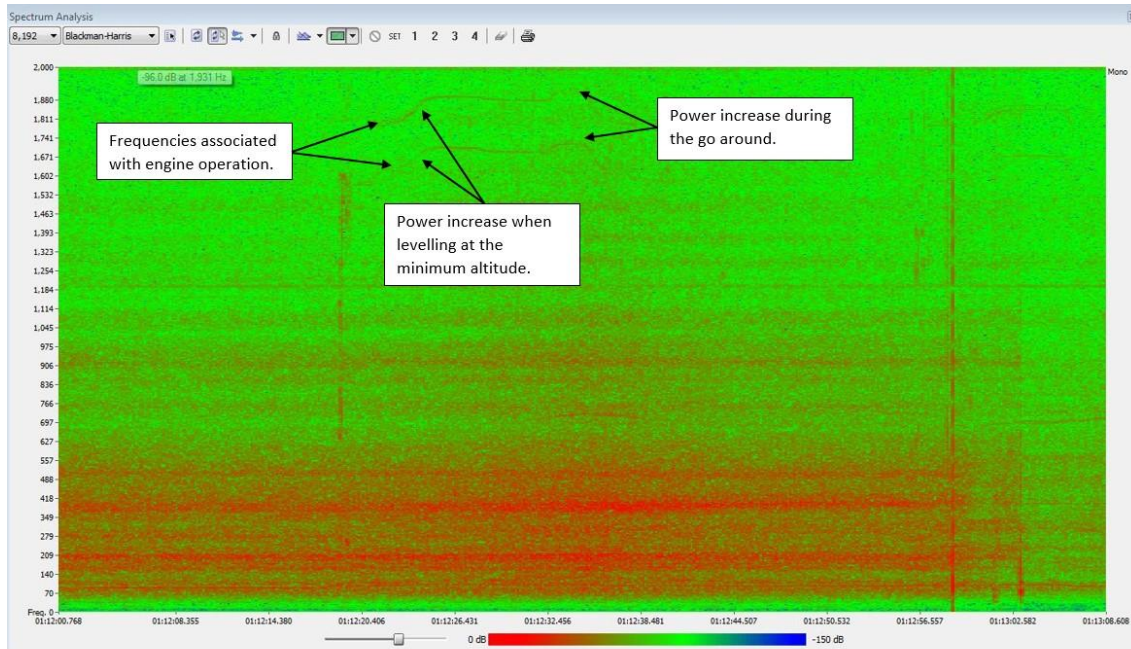
Figure A7: Frequency spectra plot during the first approach

Analysis of the CVR recording did not identify any tones or frequency spectra that could be positively identified with engine operation. During the approaches there were frequencies detected that were possibly associated with engine speed, with those frequencies only detectable during high-power engine operation (Figure A7). There were also a series of background tones that were observed to decrease in frequency about 8 seconds prior to the first impact (Figure A8). When compared to other approaches and the aircraft at the top of descent, these tones could possibly be associated with a power reduction prior to impact.

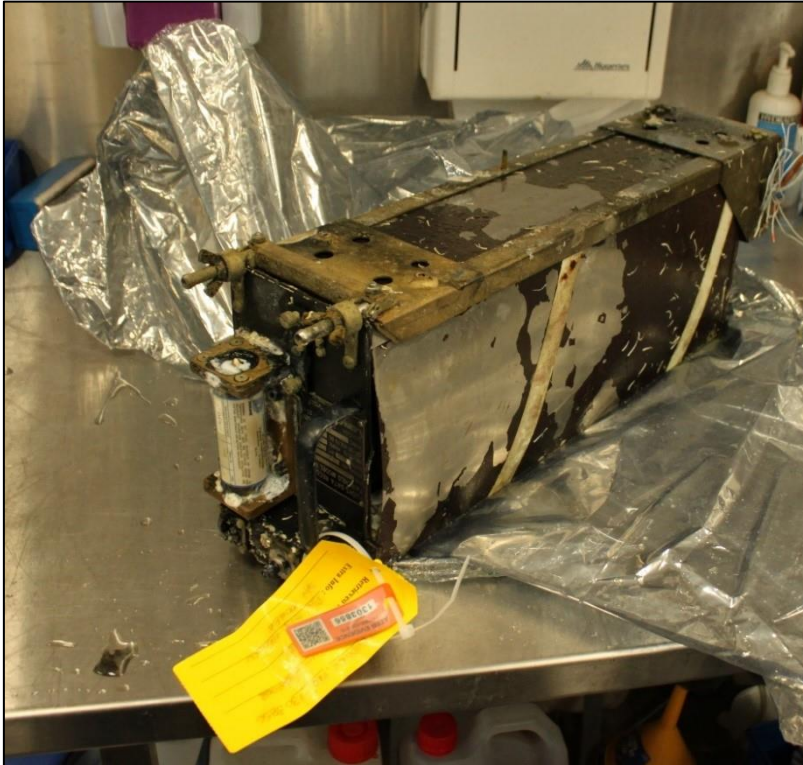
Figure B3: FDR at the ATSB laboratories in Canberra (16 November 2015)

An example of an F1000 FDR is shown in Figure B1 and B2. Figure B3 shows the FDR recovered from VH-NGA.

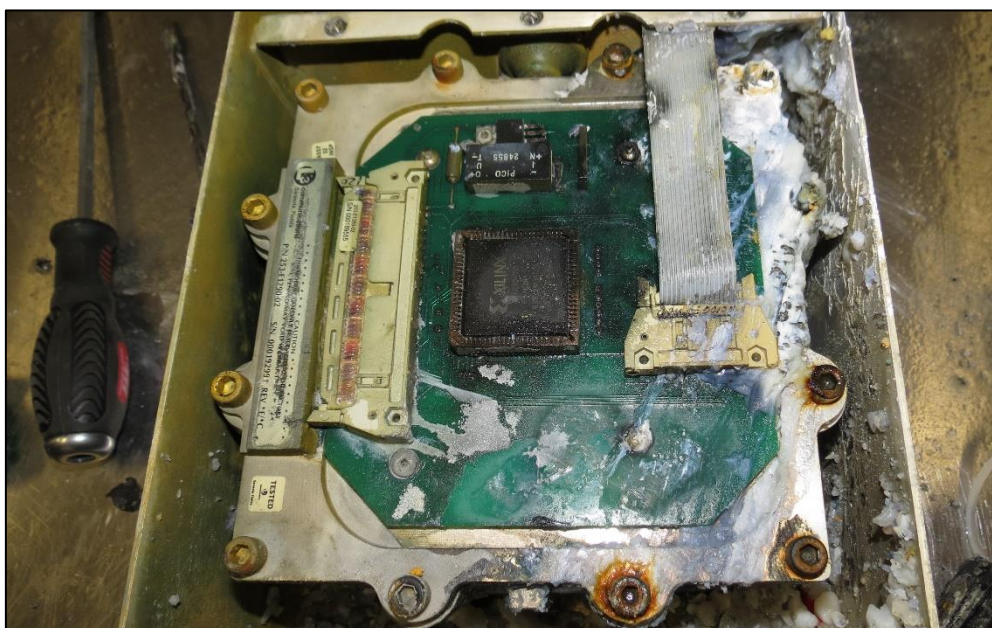
Figure B4: FDR memory module (16 November 2015)

- This file was transferred to the ATSB flight recorder specialist's laptop computer and analysed using Insight Analysis version 4.5.0.503. Analysis showed the download was successful and that data from the accident flight had been recovered. The FDR data covered 116 hours of aircraft operation.

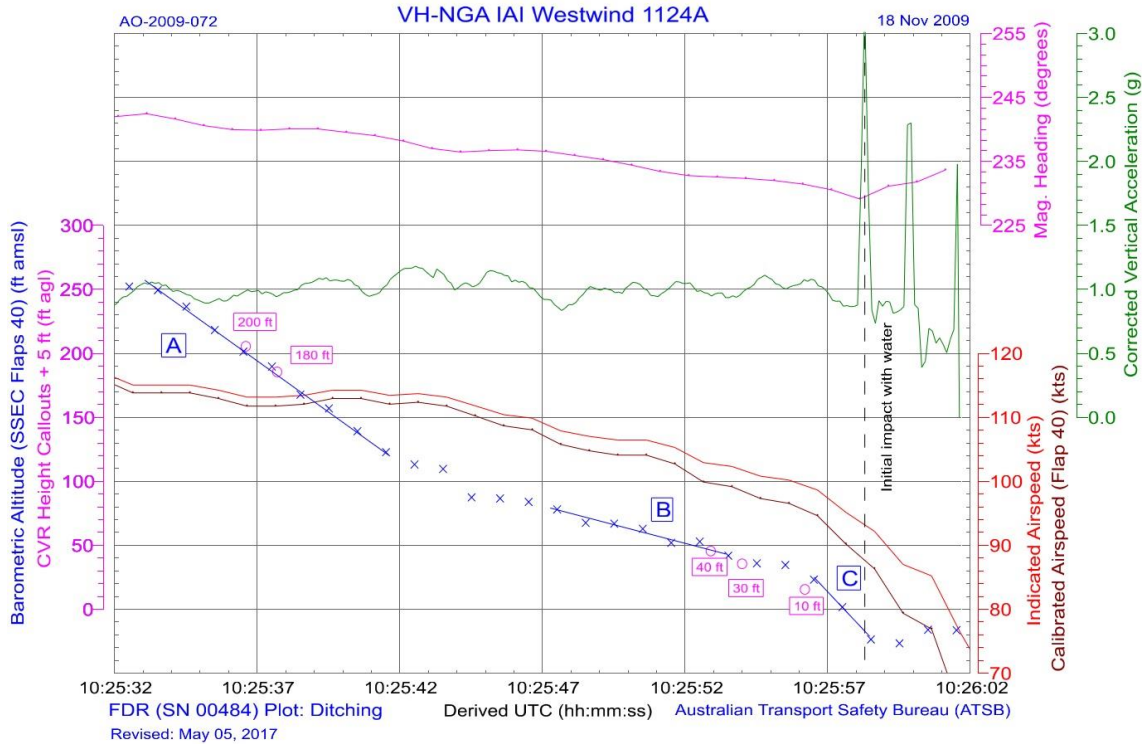
Figure B6: Data from the FDR showing the last recorded 30 seconds

- Period A – the aircraft was in a stable descent with a descent rate of 950 ft/minute and an IAS of about 114 kt.
- Period B – the descent rate decreased to about 360 ft/minute and the IAS began to steadily decrease at a rate of about 1 kt per second. This was consistent with a change in the aircraft state at about 1025:42. This could be due to one or a combination of a change in engine thrust, flap setting, gear position and/or pitch attitude.
- Period C – during the final 2 seconds of flight the descent rate increased and the IAS reduced at an increased rate of about 3 kt per second.

The inherent limitations of barometric pressure sensing, particularly over short time periods and also close to the ground/water, meant that pressure altitude alone could not be reliably used to estimate the descent rate at impact.

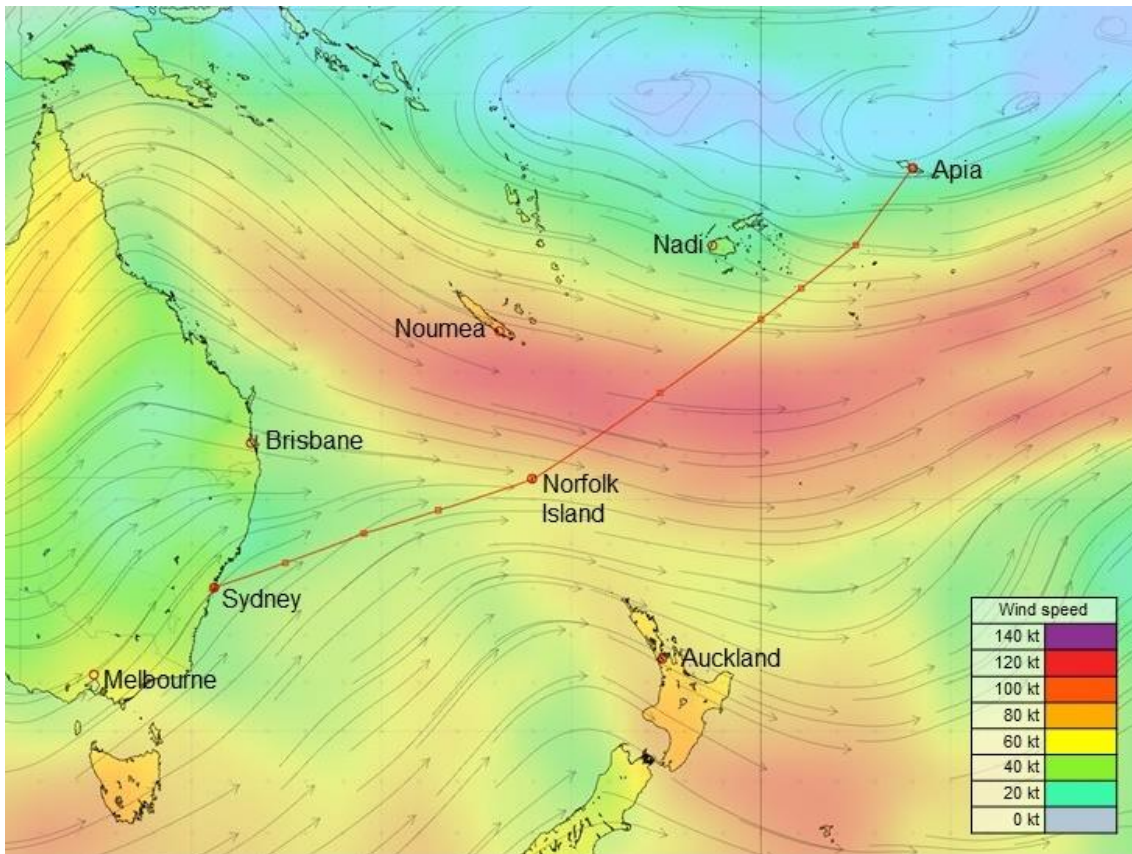
Figure D1: GFS 200 hPa analysis 1800 UTC, 17 November 2009

This chart shows the wind direction and strength at FL 385 along the route at 1800 UTC, the day prior to the accident. This corresponds with the time the aircraft was approximately 2/3 of the distance between Norfolk Island and Apia.

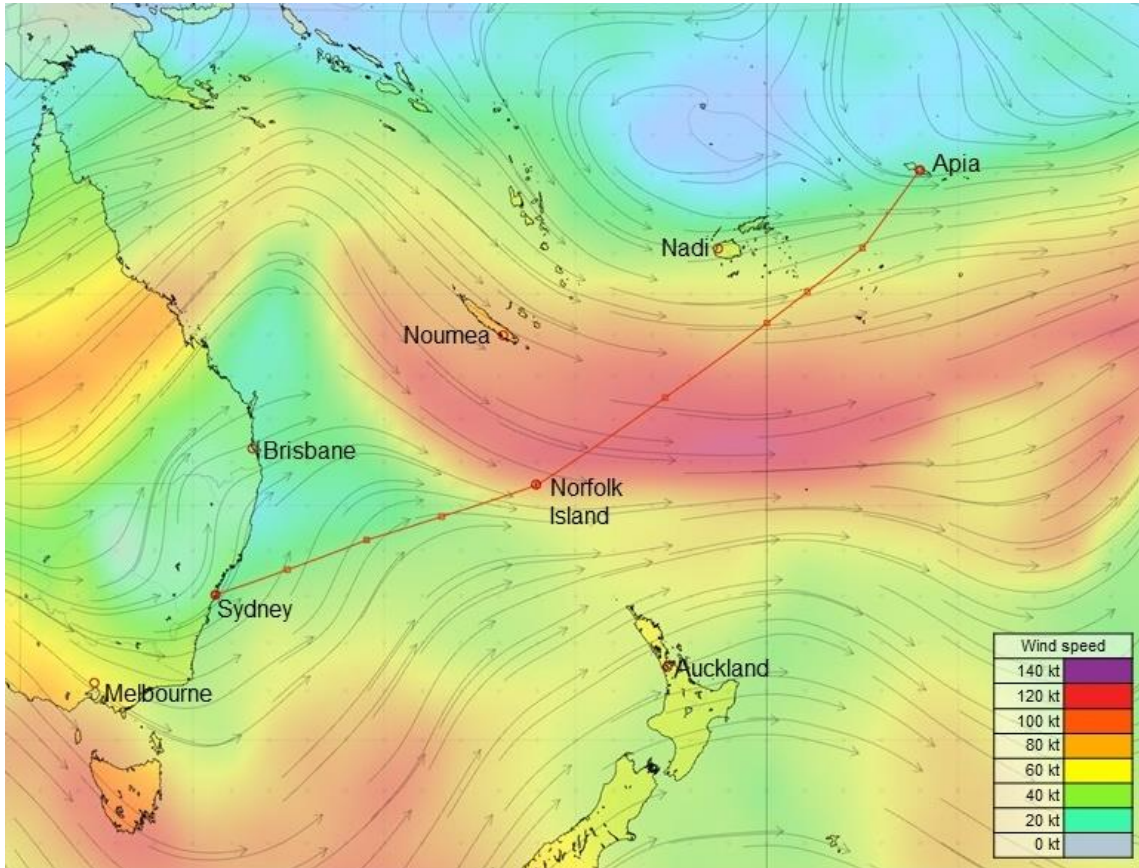
Figure D2: GFS 200 hPa analysis 1200 UTC, 18 November 2009

This chart depicts the westerly jetstream at FL 385 north of Norfolk Island and is the closest GFS analysis to the final hour of the flight and the time of ditching.

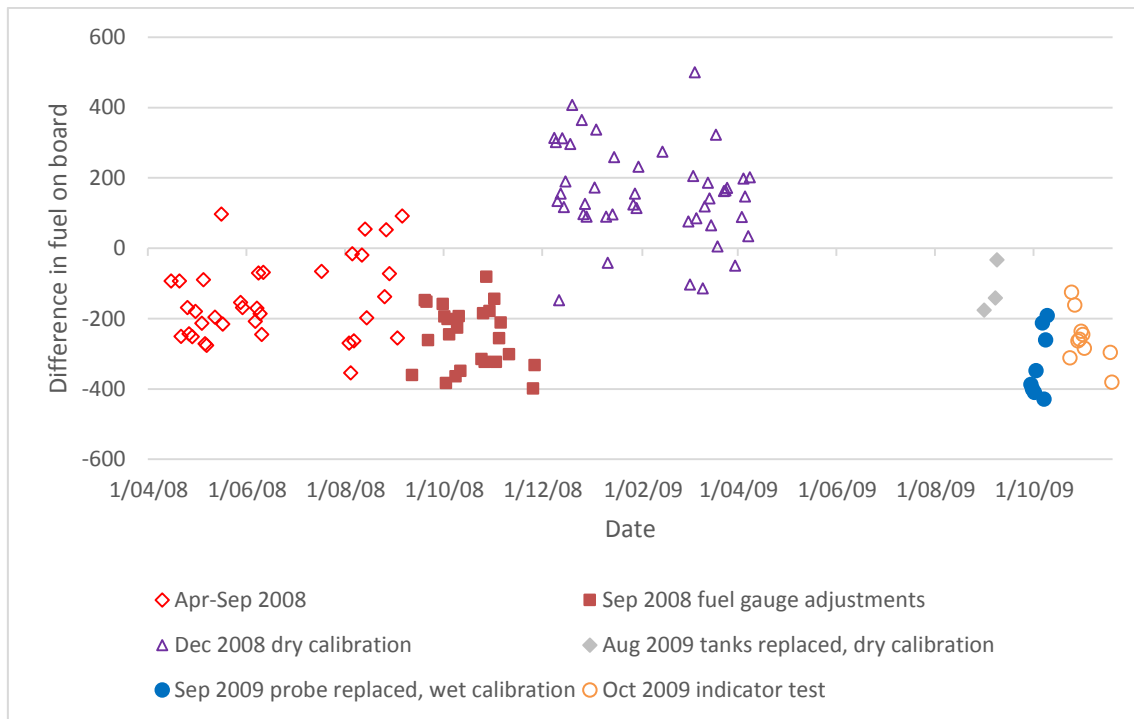
Figure F1: Difference between recorded and estimated fuel on board VH-NGA

Figure F1 shows the difference between the recorded and estimated fuel on board prior to refuelling for the period from 1 April 2008 to 18 November 2009, after a small number of outliers were removed. The data is presented in six periods, depending on the date of maintenance activities (see Table 17). Table F1 provides summary statistics for the six periods.

Note: A negative value indicates the recorded fuel on board was less than the estimated fuel on board. In other words, the gauges were underreading. Although written flight records were not available for the 17–18 November 2009, data was included for the Sydney to Norfolk Island flight on 17 November and the flight from Apia to Norfolk Island on 18 November 2009.

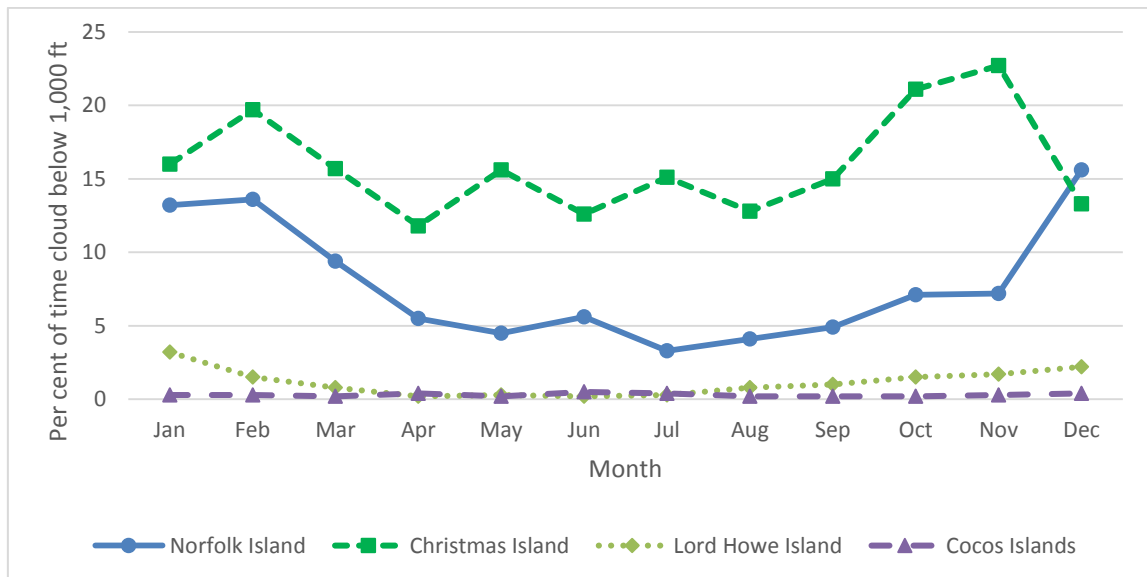
Figure H1: Average percentage of time broken / overcast cloud base is below 1,000 ft

As can be seen in both figures, Norfolk Island and Christmas Island have a significantly higher number of days where low cloud is below these specified heights, particularly during the summer months.

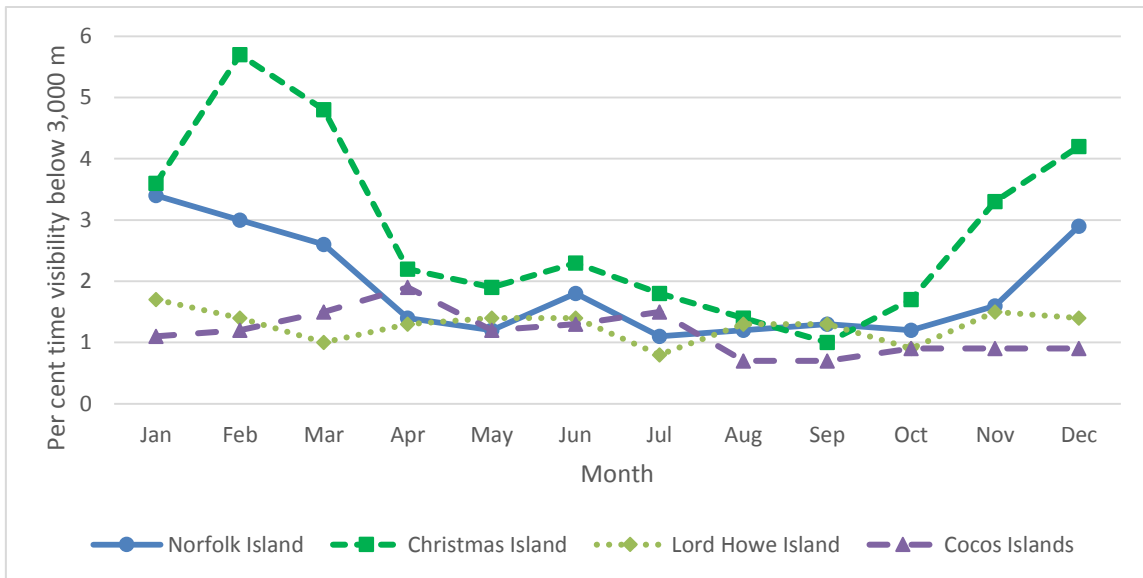
Figure H3: Average percentage of time visibility is below 3,000 m

Figure H3 shows the average percentage of the time each month that the recorded visibility was below 3,000 m. This distance broadly is just less than the landing minima for instrument approaches. The data shows a similar pattern of results as those for low cloud.

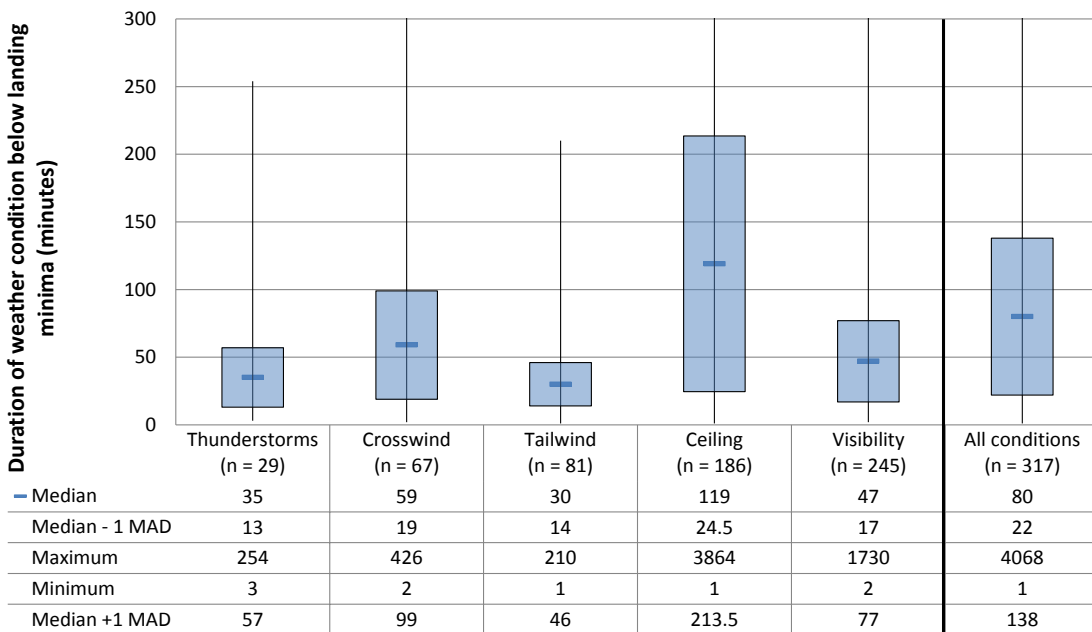
Figure J2: Duration of observations below landing minima (hours per year) by landing minima parameters (number of episodes per year shown in brackets) for Westwind 1124/1124A without RNAV, Norfolk Island Airport 2009–2014

Figure J2 shows the median duration that landing minima parameters were observed below the accident aircraft type landing minima at Norfolk Island during 2009–2014. Ceiling below the landing minima had considerably longer reported durations and larger variability than the other parameters, with a median duration of almost 2 hours per episode. Variability is represented by the blue box around the median based on ± 1 median absolute deviation (MAD).³⁸¹

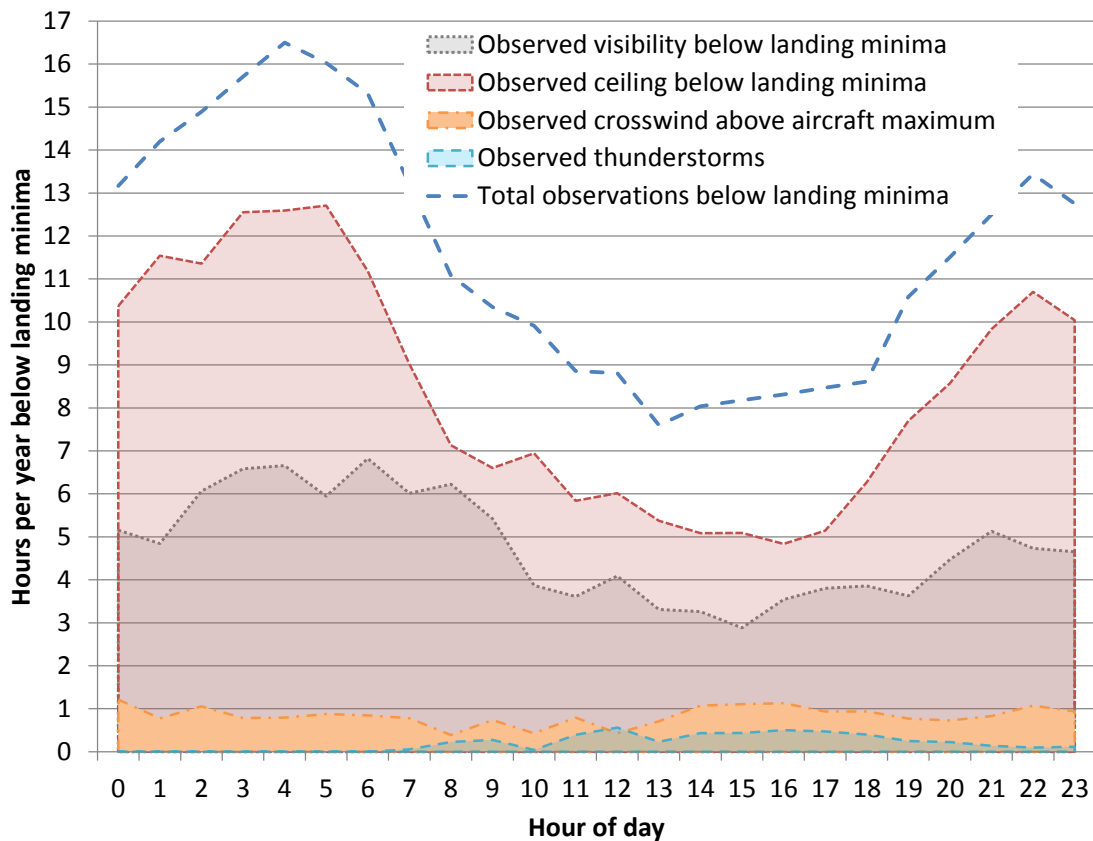
Figure J3: Time of day of individual observed weather phenomena when conditions were below the landing minima at Norfolk Island Airport, 2009–2014 for Westwind 1124/1124A without RNAV (dashed blue line shows total time any observation was below the landing minima)

The time the aircraft arrived at Norfolk Island on 18 November 2009 (about 2130 local time) was also associated with a relatively high level of observations below the landing minima (about 13 hours per year and most often due to low ceiling).

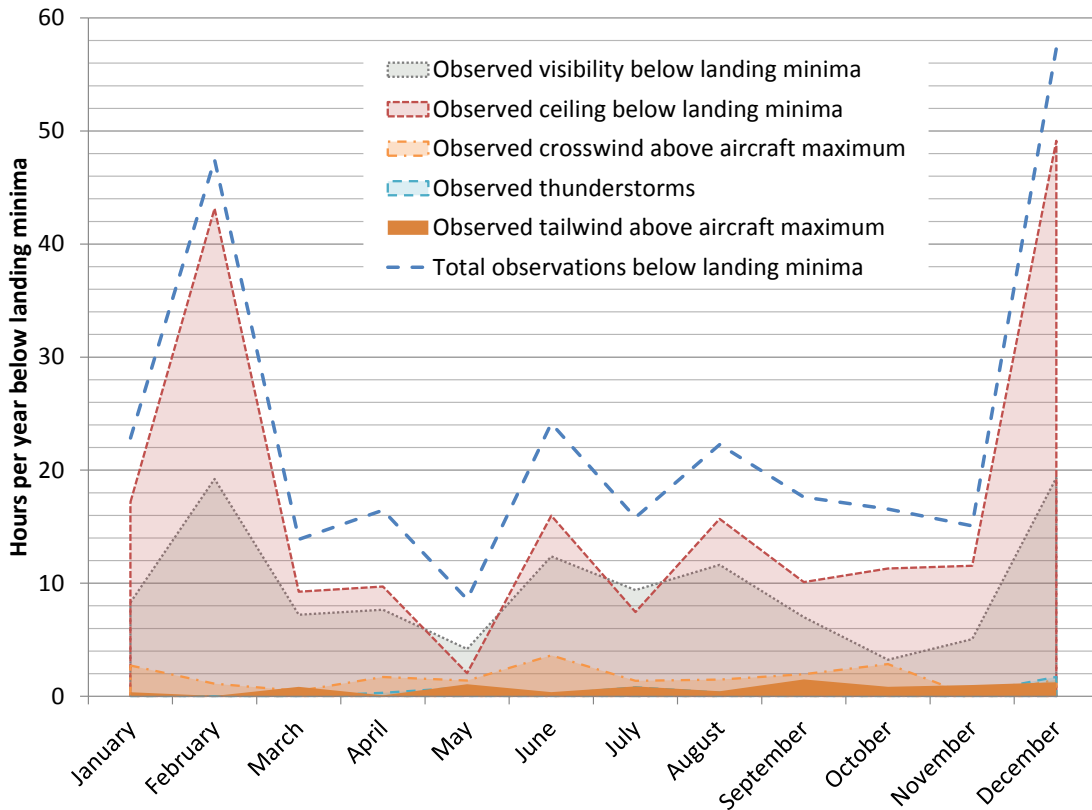
Figure J4: Month of individual observed weather phenomena when conditions were below the landing minima at Norfolk Island Airport, 2009–2014 for Westwind 1124/1124A without RNAV (dashed blue line shows total time any observation was below landing minima)

Figure J4 shows the same data as for Figure J3 by each month for individual landing minima parameters. With the exception of May and July, low ceiling was the most prevalent in all months. Summer (December to February) was the peak season for observations below the landing minima, again driven by low ceiling, which was observed between 75 per cent and 91 per cent of conditions below the landing minima during these months.
