Fuel planning event, weather-related event and ditching involving Israel Aircraft Industries Westwind 1124A, VH-NGA

6.4 km WSW of Norfolk Island Airport | 18 November 2009

ATSB Transport Safety Report
Aviation Occurrence Investigation
AO-2009-072 (reopened)
Final – 23 November 2017

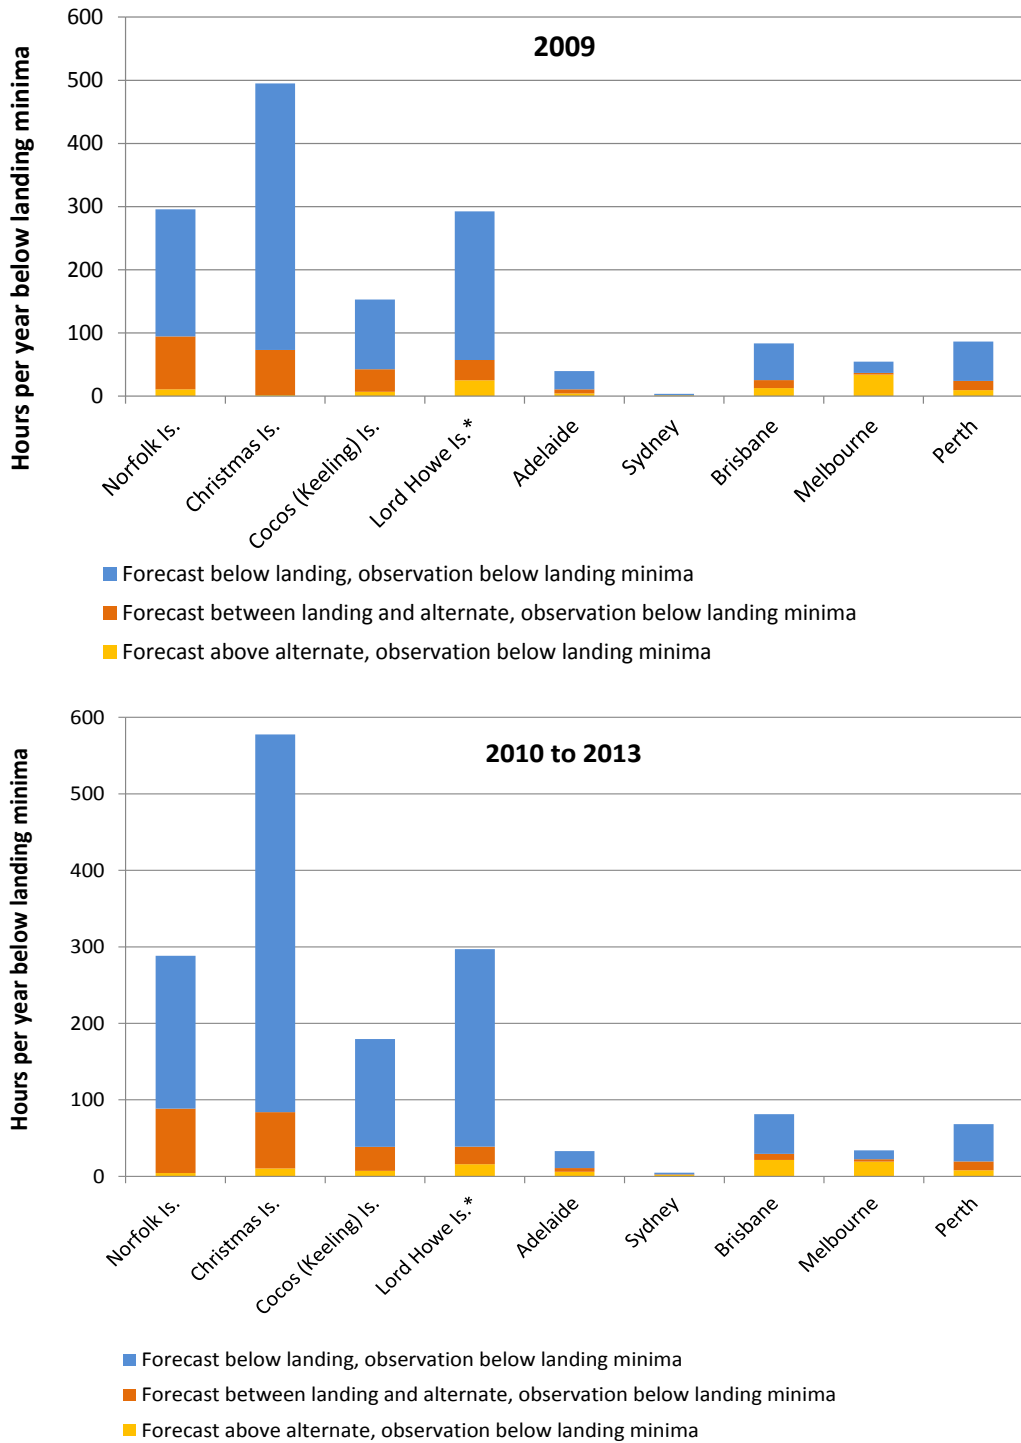
Figure J6: Observations below landing minima (hours per year) by TAF above alternate minima, between alternate and landing minima and below landing minima averaged for simulated TAF retrieval 1–3 hours prior to arrival for Westwind 1124/1124A without RNAV at selected airports, 2009–2013³⁸⁶

Figure J6 shows observations below the landing minima in hours per year for each airport. This is divided for when the TAF predicted conditions above the alternate minima (yellow), between the alternate and landing minima (orange) and below the landing minima (blue). All upper graphs in each figure of this section show the accident year 2009, with the average of all years 2010 to 2013 shown in the lower section. These year ranges were selected due to common data availability across all the airports.

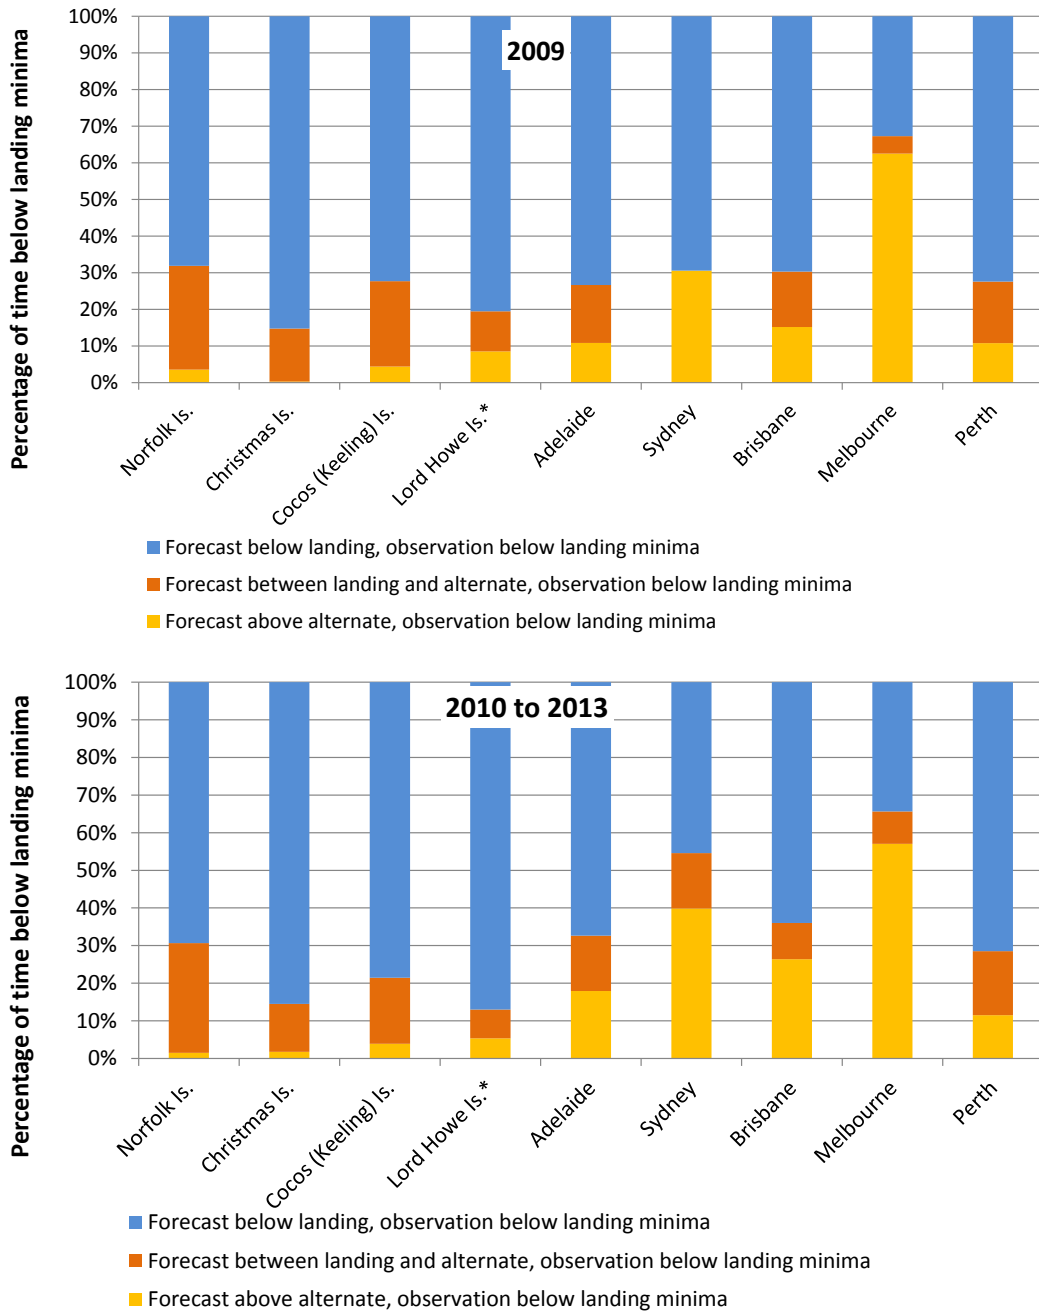
Figure J8: Percentage of time below landing minima by TAF above alternate minima, between alternate and landing minima and below landing minima averaged for simulated TAF retrievals 1–3 hours prior to arrival for Westwind 1124/1124A without RNAV at selected airports, 2009–2013

Figure J6 provided data on the total time below the landing minima that was forecast and not forecast. To provide an indication of the relative accuracy of predictions between the airports, Figure J8 shows the same data as for Figure J6 calculated as a percentage of the total conditions below the landing minima at each airport for the accident aircraft type.

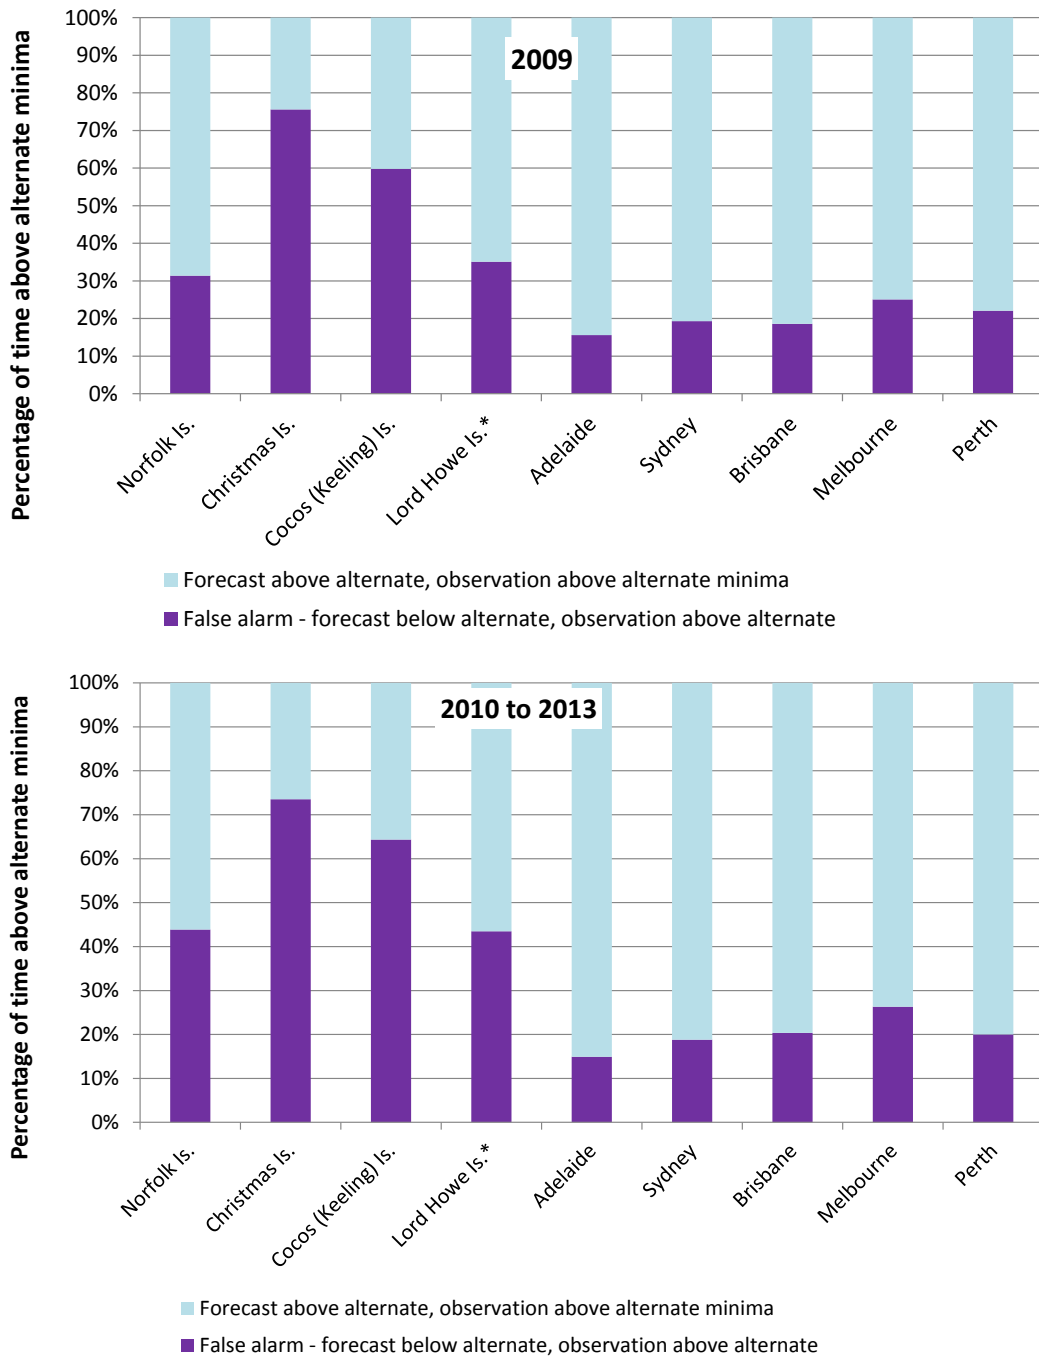
Figure J10: Percentage of time above alternate minima by TAF above alternate minima, between alternate and landing minima and below landing minima for averaged for simulated TAF retrievals 1–3 hours prior to arrival for Westwind 1124/1124A without RNAV at selected airports, 2009–2013

Figure J10 shows the same data as for Figure J9 calculated as a percentage of the total conditions above the alternate minima at each airport for the accident aircraft type.

- The false alarm percentages for the capital city airports averaged about 20 per cent during 2009–2013.

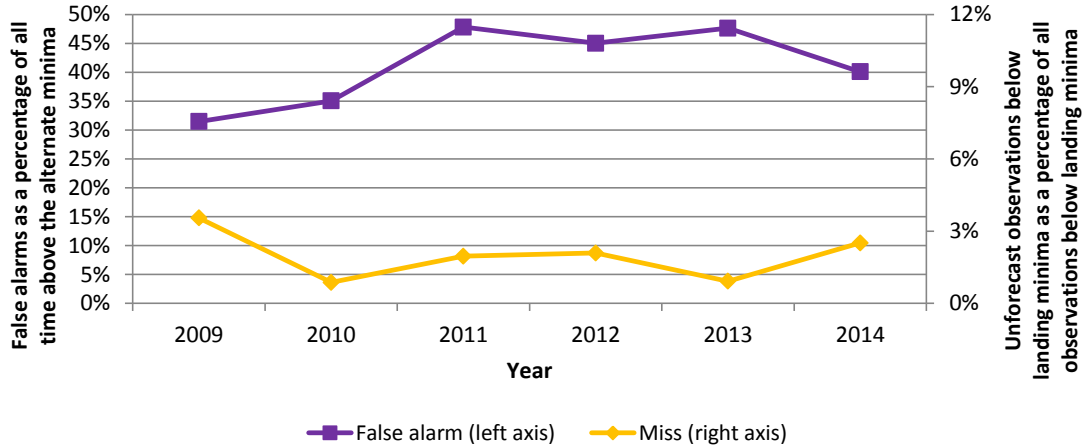
As indicated in the figure, the proportion of time associated with misses decreased after 2009 and the proportion of time associated with false alarms increased after 2009, particularly from 2011–2014. Overall, this data suggests weather forecasting at Norfolk Island was more conservative after 2009. However, the relative extent to which the apparent improvement in the forecasting of weather below the landing minima was due to improved forecasting models and practices and/or a more conservative approach could not be determined.

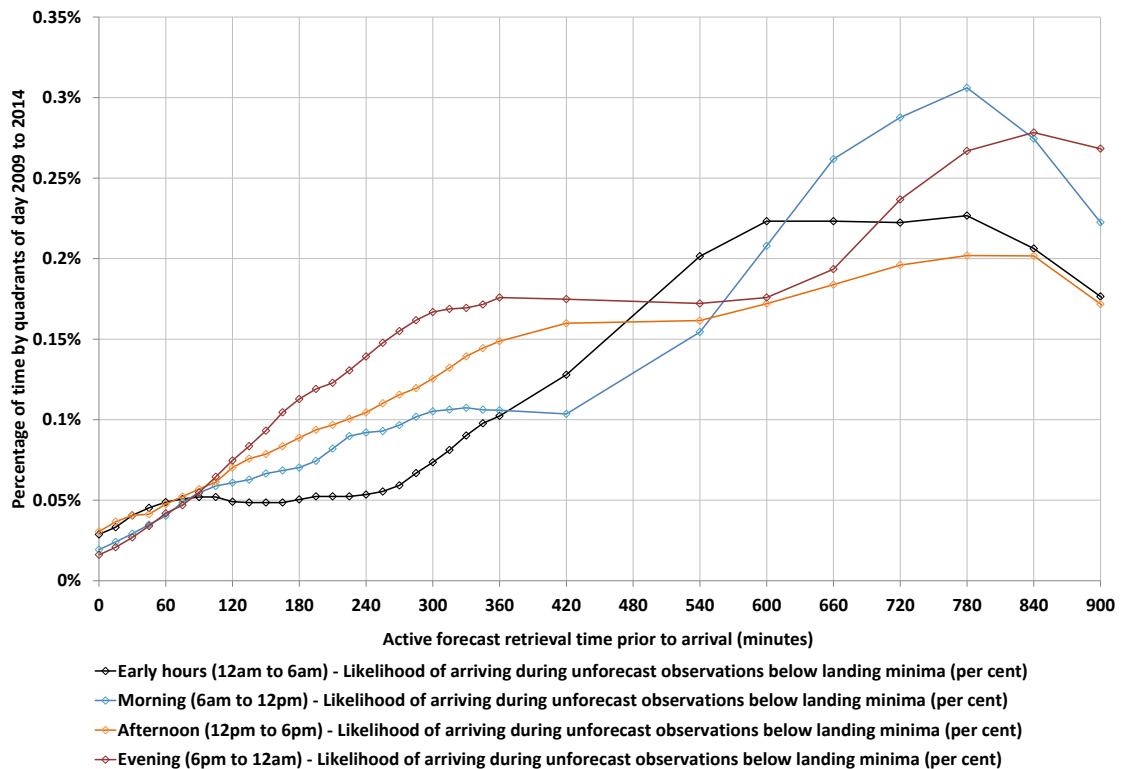
Figure J12: Likelihood of arriving during unforecast observations below the landing minima by quadrant of day for simulated TAF retrieval times 0–900 minutes prior to arrival, Norfolk Island Airport, 2009–2014 for Westwind 1124/1124A without RNAV

From the perspective of operational decision-making, this shows that forecasts retrieved at the latest possible time (before the point of no return) provided a better warning of potential conditions below the landing minima at Norfolk Island Airport during 2009–2014.

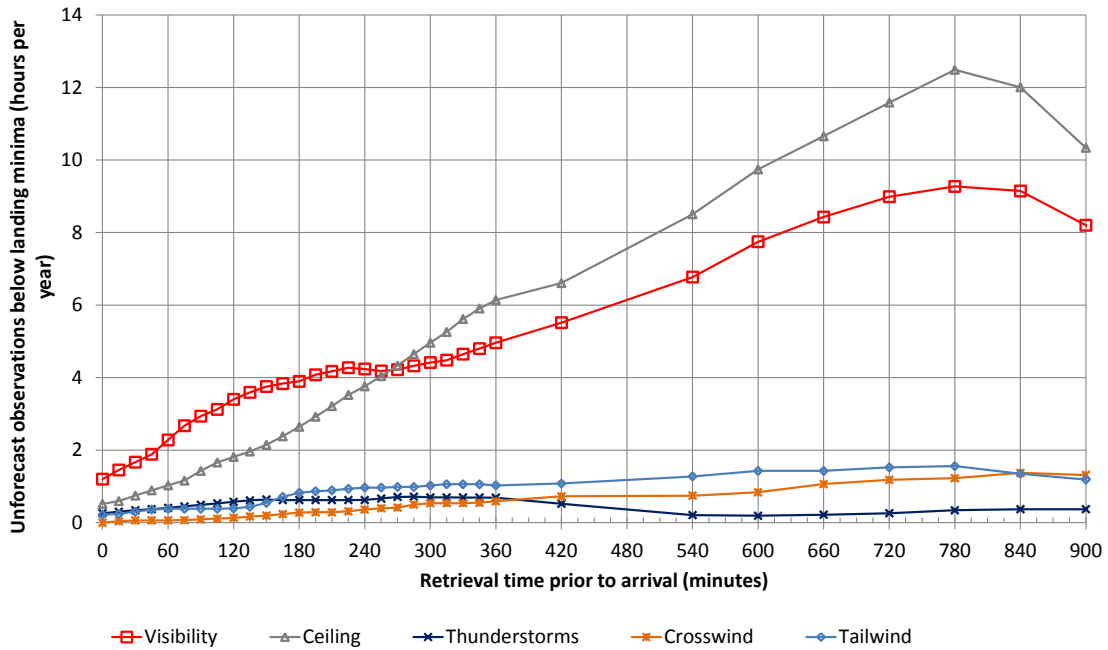
Figure J13: Likelihood of arriving during unforecast observations below the landing minima by landing minima parameter for simulated TAF retrieval times 0–900 minutes prior to arrival, Norfolk Island Airport, 2009–2014 for Westwind 1124/1124A without RNAV

Figure J13 shows the hours each year of unforecast observations below the landing minima for each of the minima criteria for TAF retrievals up to 15 hours prior to arrival. Increasing the TAF retrieval time prior to arrival had the greatest effect for reported visibility and ceiling below the landing minima.

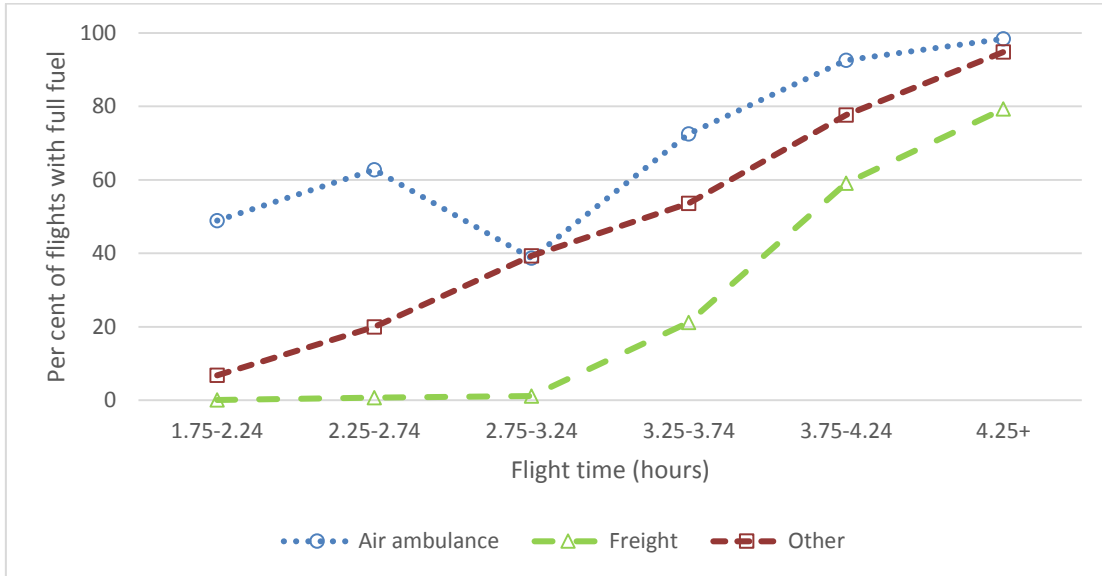
Figure M1: Percentage of the operator’s Westwind flights that departed with full fuel (2002–2009)

Overall, air ambulance flights had a higher percentage of flights that departed with full fuel and a lower percentage of flights that departed with full main tanks or less. This is consistent with weight limitations being a factor for many of the freight flights and some of the other flights. In addition, a significantly higher percentage of air ambulance flights were conducted to remote or semi-remote aerodromes (see appendix N).

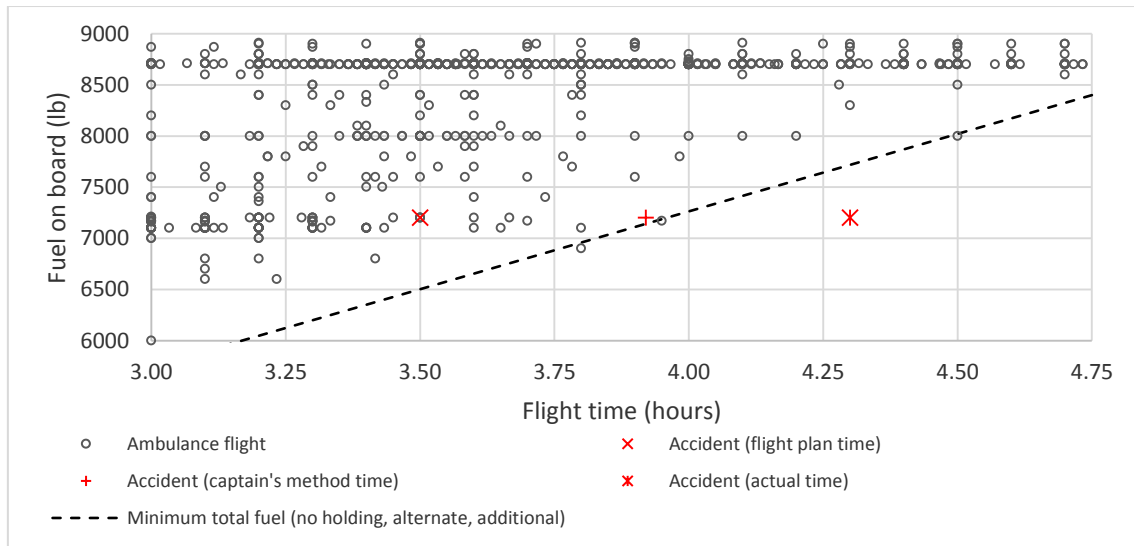
Figure M3: Fuel on board and flight time for the operator’s long-distance air ambulance flights to all destinations compared to minimum total fuel (2002–2009)

Figure M3 shows the fuel on board and flight time of the 828 air ambulance flights with a flight time of 3.00–4.75 hours. It also compares the fuel on board to the minimum total fuel for a normal operation, depicted by the dashed line. The distance above the line provides an indication of the potential amount of discretionary fuel (assuming no requirements for alternate, holding or additional fuel for aircraft system failures).

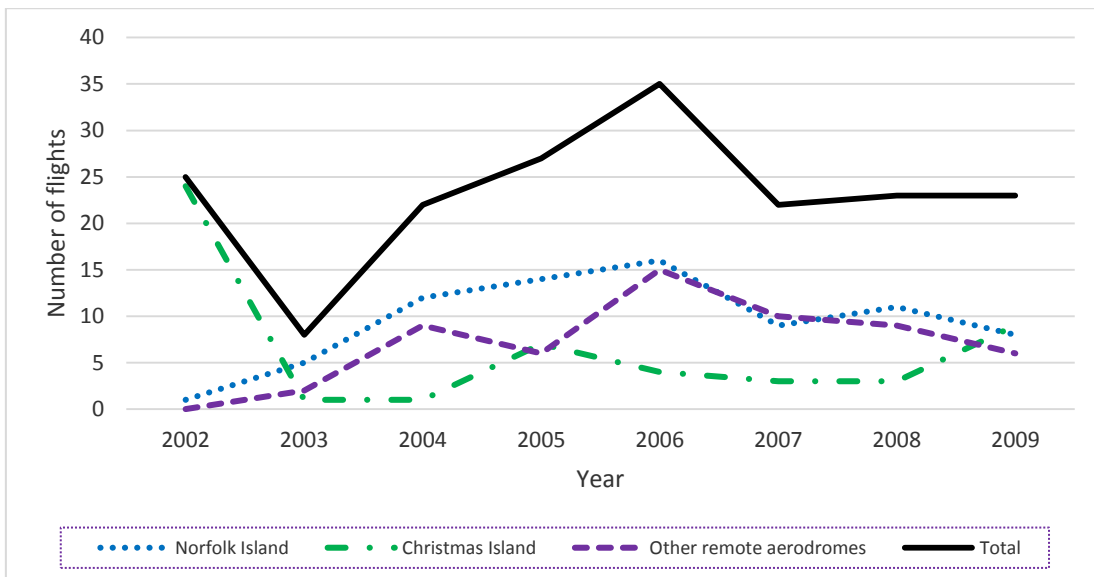
Figure N1: Number of flights to remote aerodromes each year (2002–2009)

Figure N1 shows the number of flights each year (up to 17 November 2009). The number of flights was fairly constant from 2004–2009, averaging about 25 flights per year. The number of flights to Norfolk Island was also fairly constant from 2004–2009, with about 12 flights a year. There was a relatively large number of flights to Christmas Island in 2002. Most (21) of these 24 flights were aerial work flights (with no passengers) for the same client.

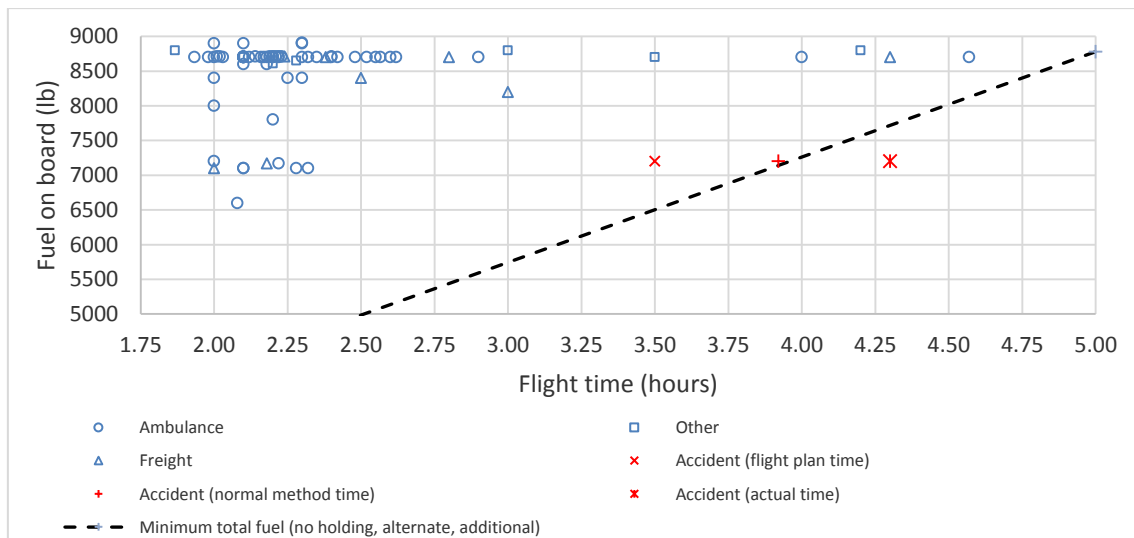
Figure N2: Fuel on board and flight time of the operator’s Westwind flights to Norfolk Island (2002–2009)

- Both flights with a flight time of 4.25 hours or more departed with full fuel.
- All 3 flights with a flight time of 3.25–4.24 hours departed with full fuel.
- Most (3) of the 4 flights with a flight time of 2.75–3.24 hours departed with full fuel. The other flight was a 3.00-hour freight flight from Tonga during the day that departed with 8,200 lb.
- The longest flights that departed with full main tanks were 2 air ambulance flights of 2.30 hours from Sydney.

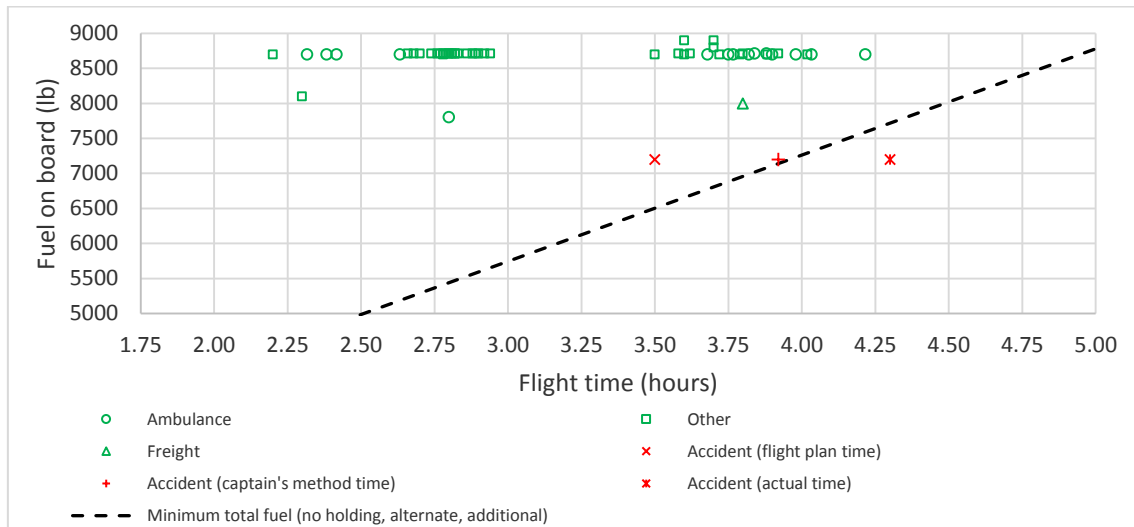
Figure N3: Fuel on board and flight time of the operator’s Westwind flights to Christmas Island (2002–2009)

- Almost all (23) of the 24 flights with a flight time of 3.25–4.24 hours departed with full fuel. The exception was a 3.80-hour freight flight during the day from Darwin that departed with 8,000 lb.
- Almost all (17) of the 18 flights with a flight time of 2.75–3.24 hours departed with full fuel. The exception was a 2.80-hour air ambulance flight at night from Broome that departed with 7,800 lb.

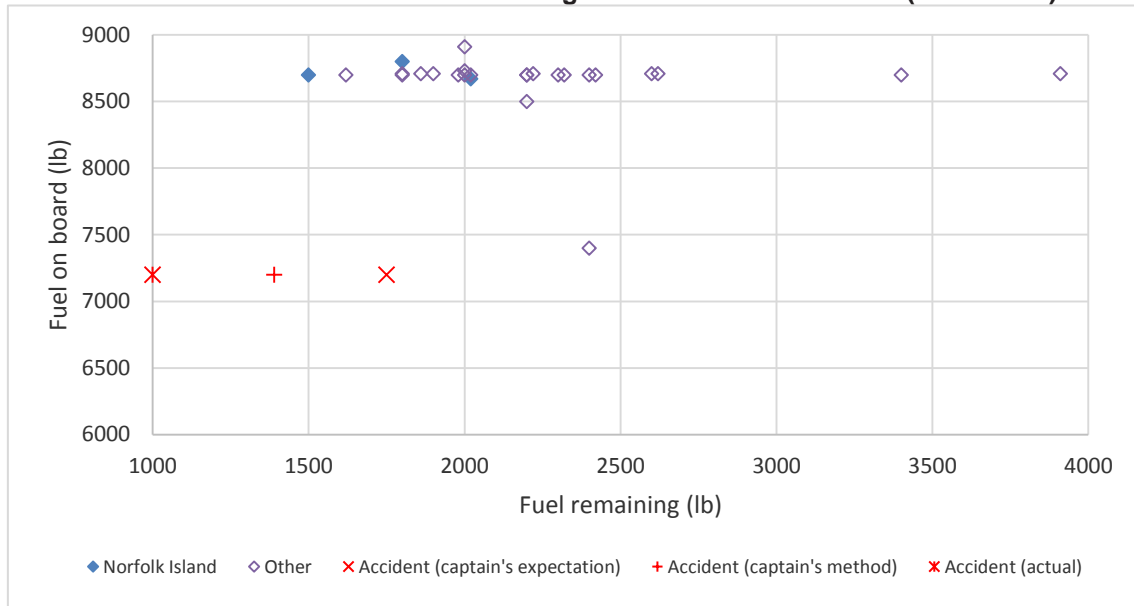
Figure N5: Fuel on board and fuel remaining after engine shutdown for the 26 flights to remote aerodromes where the fuel remaining was insufficient to divert (2002–2009)

The flight that did not depart with full fuel was the charter flight to the Cocos Islands that departed with 7,400 lb and had 2,400 lb of fuel remaining. As noted above, this 3.00-hour flight from Learmonth carried passengers and freight and may have departed with as much fuel as possible. The flight landed at night about 30 minutes prior to civil twilight, and therefore the crew would have encountered daytime conditions if they were required to hold due to an airport lighting problem. The forecast conditions were better than the alternate minima and the actual conditions were significantly better than the alternate minima.

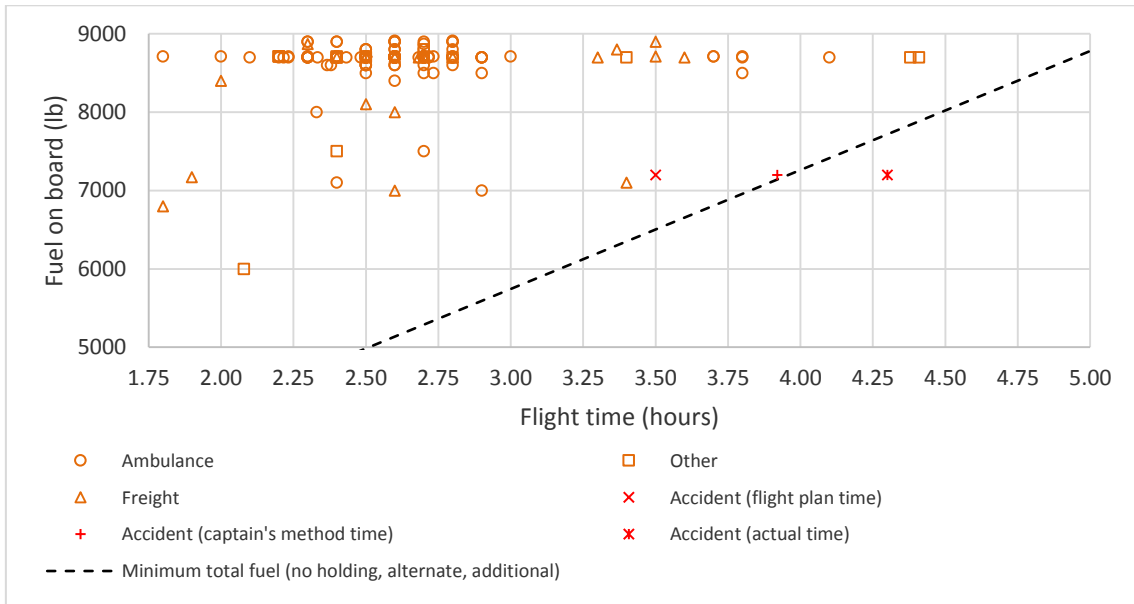
Figure N6: Fuel on board and flight time of the operator’s Westwind flights to semi-remote aerodromes (2002–2009)

- Both flights with a flight time of 4.25 hours or more departed with full fuel.
- Almost all (12) of the 13 flights with a flight time of 3.25–4.24 hours departed with full fuel. The other flight was a 3.40-hour freight flight from Hihifo to Noumea during the day that departed with full main tanks.
- Almost all (18) of the 19 flights with a flight time of 2.75–3.24 hours departed with full fuel. The other flight was a 2.90-hour air ambulance flight during the day from Singapore to Makassar that departed with full main tanks.
