ATSB Investigation No. A0-2017-109

Loss of control + collision in terrain involving
UH-BAA HOBART 7/11/17

**LOSS OF CONTROL DURING HYDRAULIC PRESSURE
FAILURE TRAINING
EUROCOPTER AS350 BA HELICOPTER, C-GPHN
HÉLI-EXCEL INC.
SEPT-ÎLES AIRPORT, QUEBEC
03 FEBRUARY 2013**

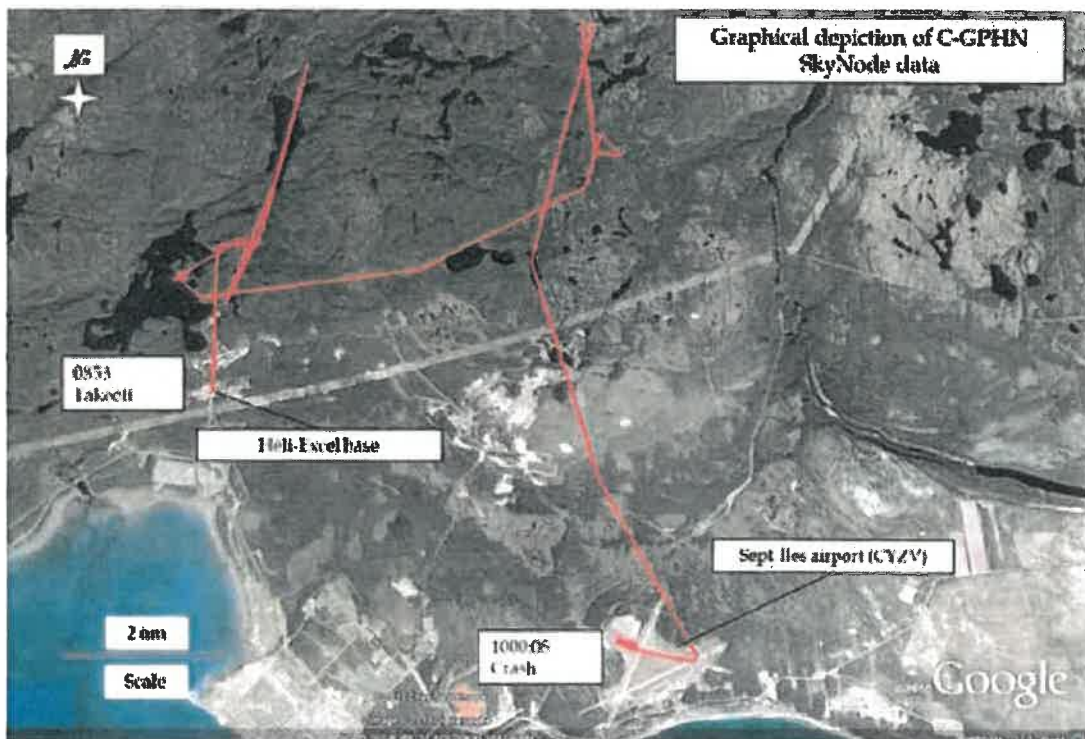
Figure 1. Aircraft flight path (Source: Google Earth, with TSB annotations)

At 0954, after completing drills for engine failure at the hover at the threshold of Runway 27, the helicopter took off to carry out hydraulic failure drills on Runway 31. Shortly after

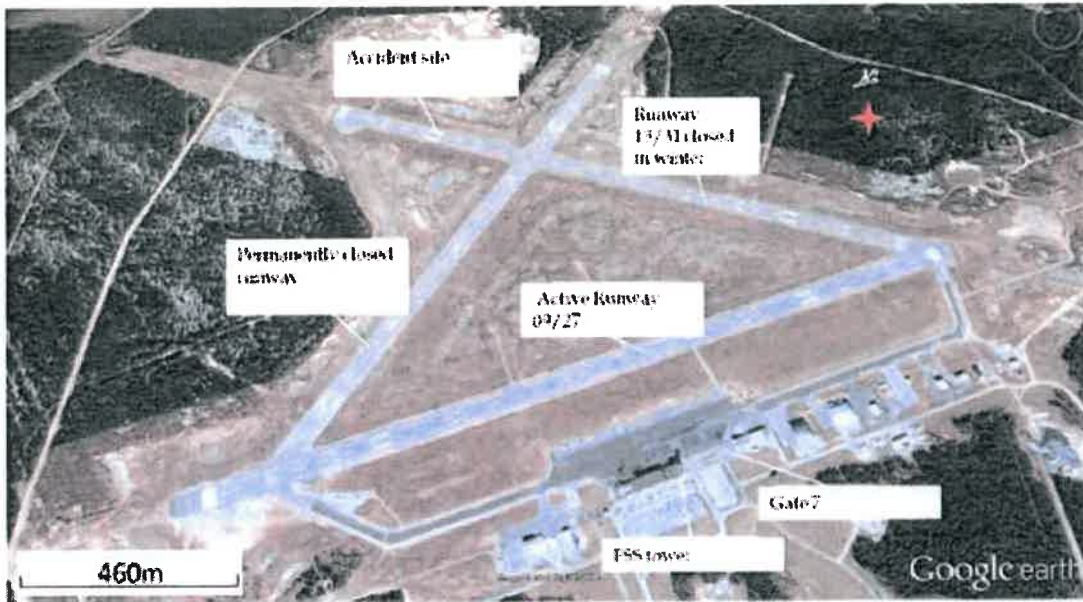
The Sept-Îles Airport is certified, operated and maintained by TC. The airport has a flight service station (FSS) operated by NAV CANADA. Its reference altitude is 180 feet above sea level (asl). The airport has 2 runways: Runway 09/27 and Runway 13/31 (Figure 6). The elevation of the Runway 31 threshold is 173 feet asl. At the time of the occurrence, Runway 27 was the active runway.

Runway 13/31 had been closed since 31 January 2013. Its paved surface was covered with ice and patches of snow. Communications between the helicopter and the FSS revealed that the crew reported no problems and did not declare an emergency situation before or after the crash.

Figure 6. View of the Sept-Îles Airport (Source: Google Earth, with TSB annotations)

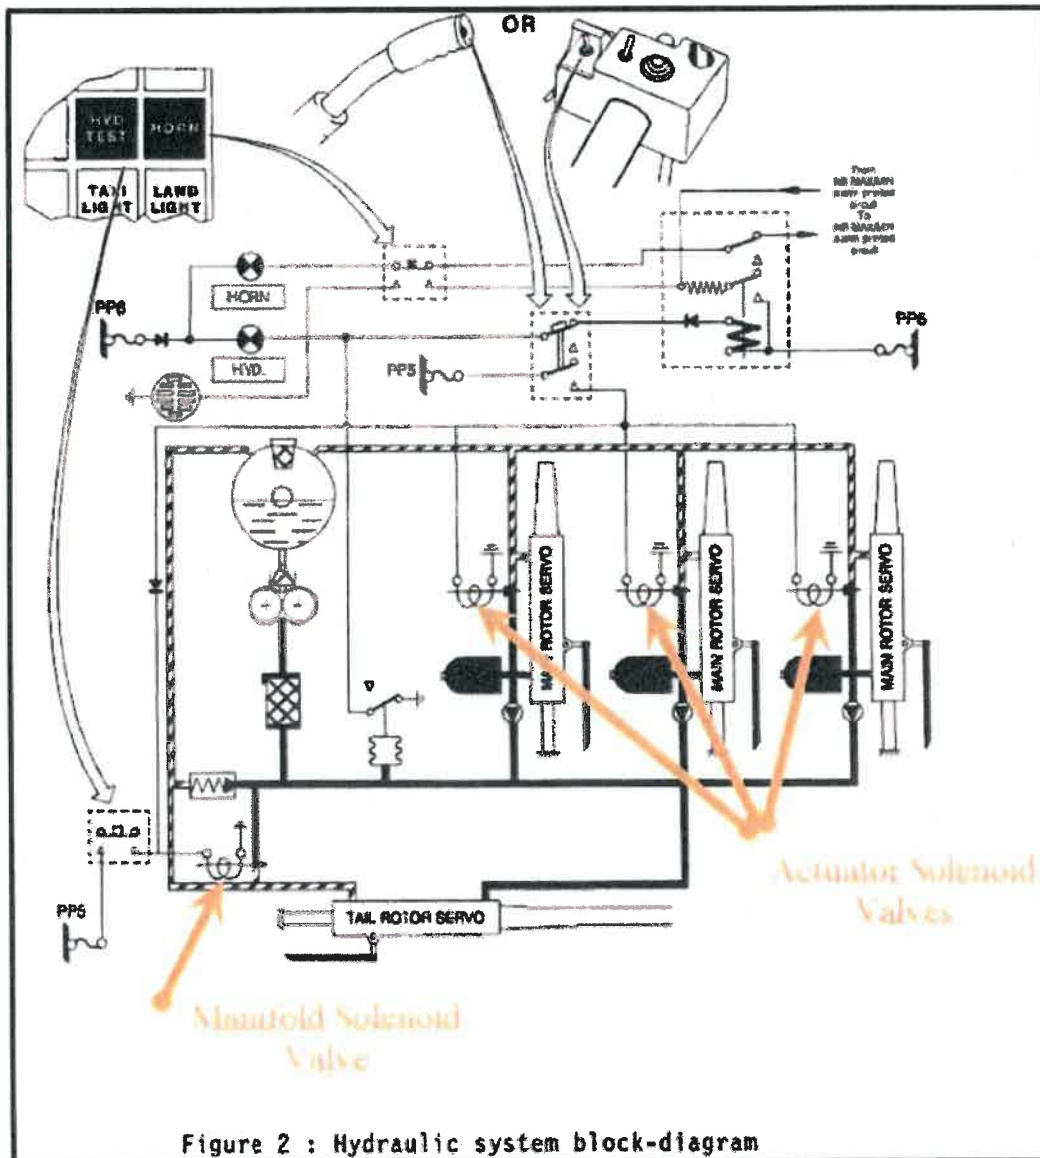
Activation of the HYD TEST switch opens the manifold solenoid valve and depressurizes the hydraulic system.

Activation of the HYD CUT OFF switch opens the actuator solenoid valves of each servoactuator accumulators and depressurizes the accumulators for flight without hydraulic pressure assistance.

Figure 2 : Hydraulic system block-diagram

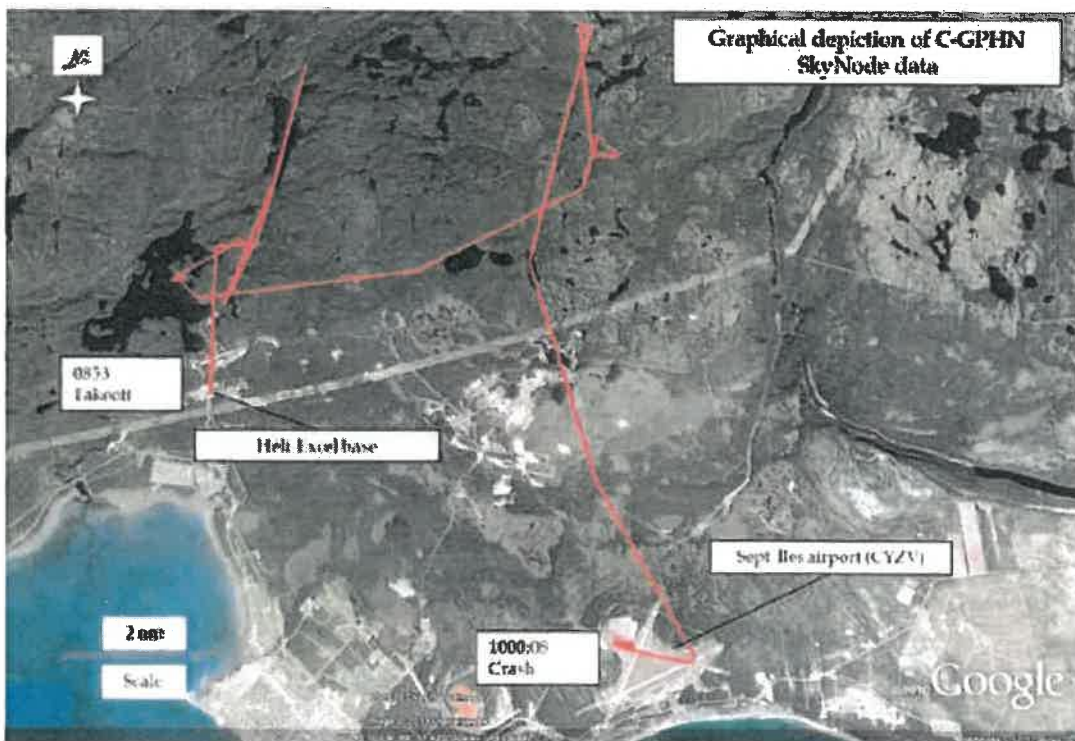
Figure 1. Aircraft flight path (Source: Google Earth, with TSB annotations)

At 0954, after completing drills for engine failure at the hover at the threshold of Runway 27, the helicopter took off to carry out hydraulic failure drills on Runway 31. Shortly after

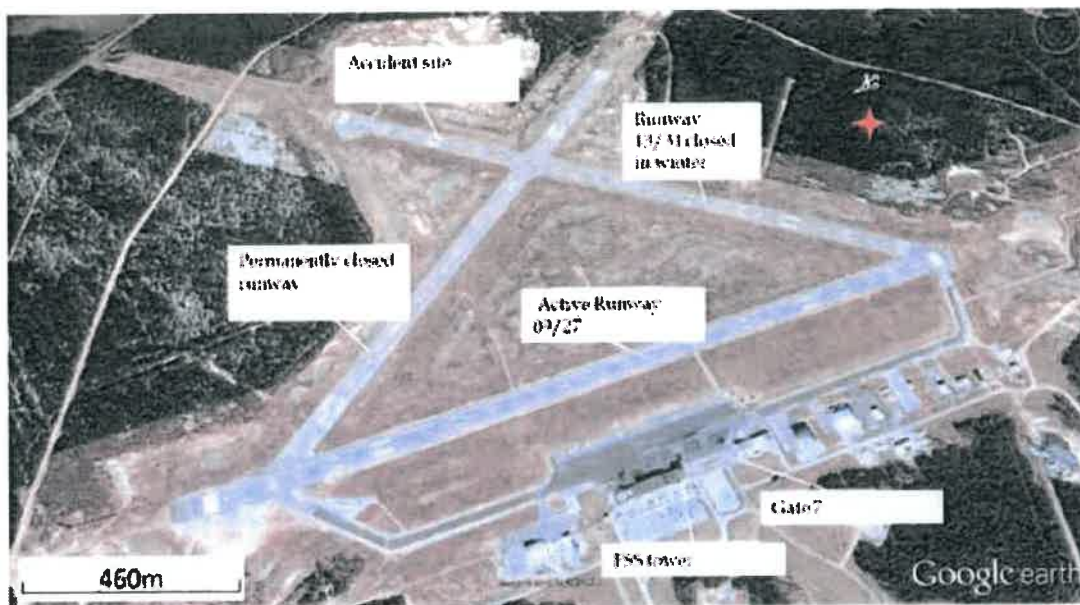
The Sept-Îles Airport is certified, operated and maintained by TC. The airport has a flight service station (FSS) operated by NAV CANADA. Its reference altitude is 180 feet above sea level (asl). The airport has 2 runways: Runway 09/27 and Runway 13/31 (Figure 6). The elevation of the Runway 31 threshold is 173 feet asl. At the time of the occurrence, Runway 27 was the active runway.

Runway 13/31 had been closed since 31 January 2013. Its paved surface was covered with ice and patches of snow. Communications between the helicopter and the FSS revealed that the crew reported no problems and did not declare an emergency situation before or after the crash.

Figure 6. View of the Sept-Îles Airport (Source: Google Earth, with TSB annotations)

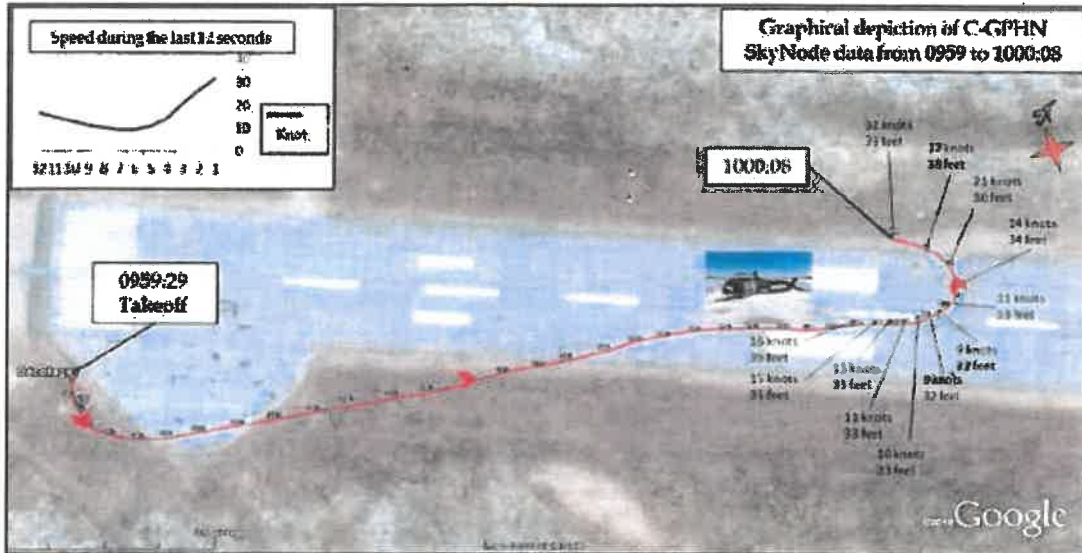
Figure 7. Flight path during last hydraulic failure drill (Source: Google Earth, with TSB annotations)

The SkyNode memory contained data from 1345:57 UTC⁹ to 1500:08 UTC. The SkyNode recorded data every 2 minutes, except for the last 2 minutes of the flight when data were recorded every second. With these data, the approximate flight path could be reconstructed (Figure 7). The last recording indicates that the helicopter was 39 feet above ground level (agl) at a groundspeed of 32 knots (Figure 8).

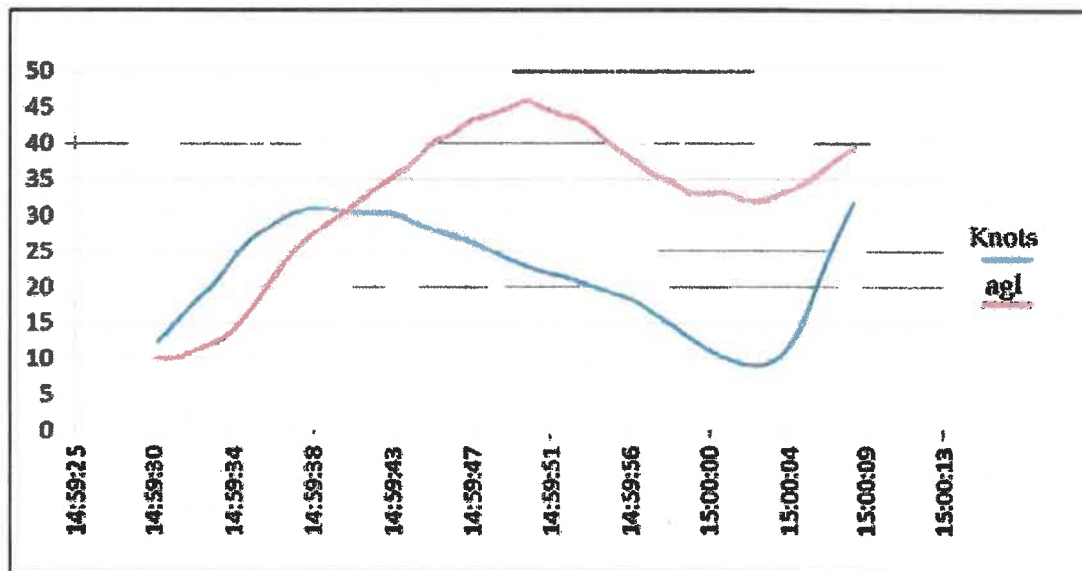
Figure 8. Groundspeed and height of the aircraft before the crash

The marks from the impact and the data from the SkyNode system show that the loss of control occurred while the helicopter was slightly north of the runway, at about 35 feet above ground level (agl), and flying at a ground speed of 32 knots (Figure 8). Since the aircraft was not aligned with the runway centreline, the pilot in training was probably applying additional pressure, moving the cyclic stick to the left, in order to reach the landing area at the end of the runway.

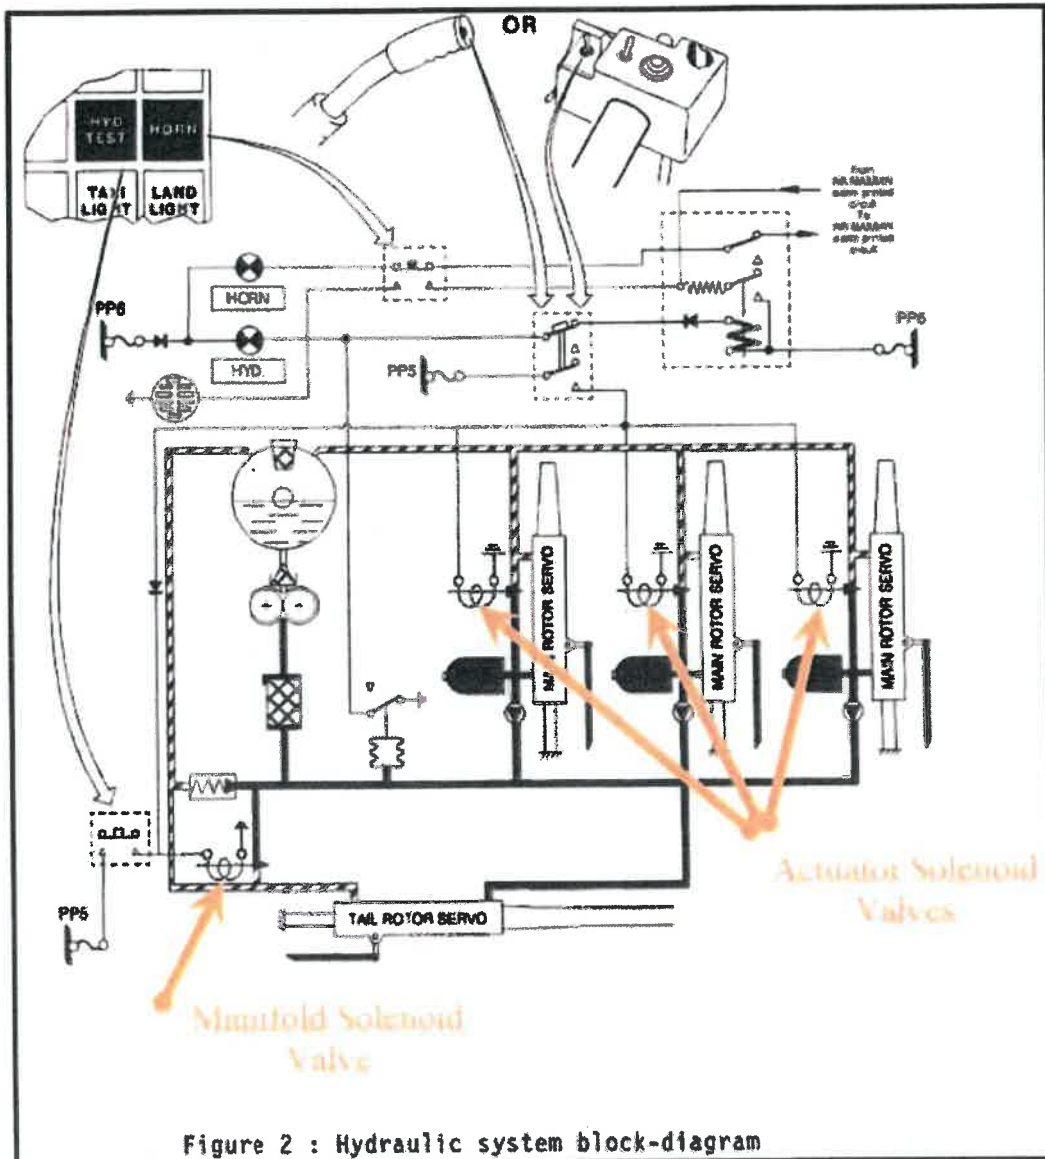
Activation of the HYD TEST switch opens the manifold solenoid valve and depressurizes the hydraulic system.

Activation of the HYD CUT OFF switch opens the actuator solenoid valves of each servoactuator accumulators and depressurizes the accumulators for flight without hydraulic pressure assistance.

Figure 2 : Hydraulic system block-diagram

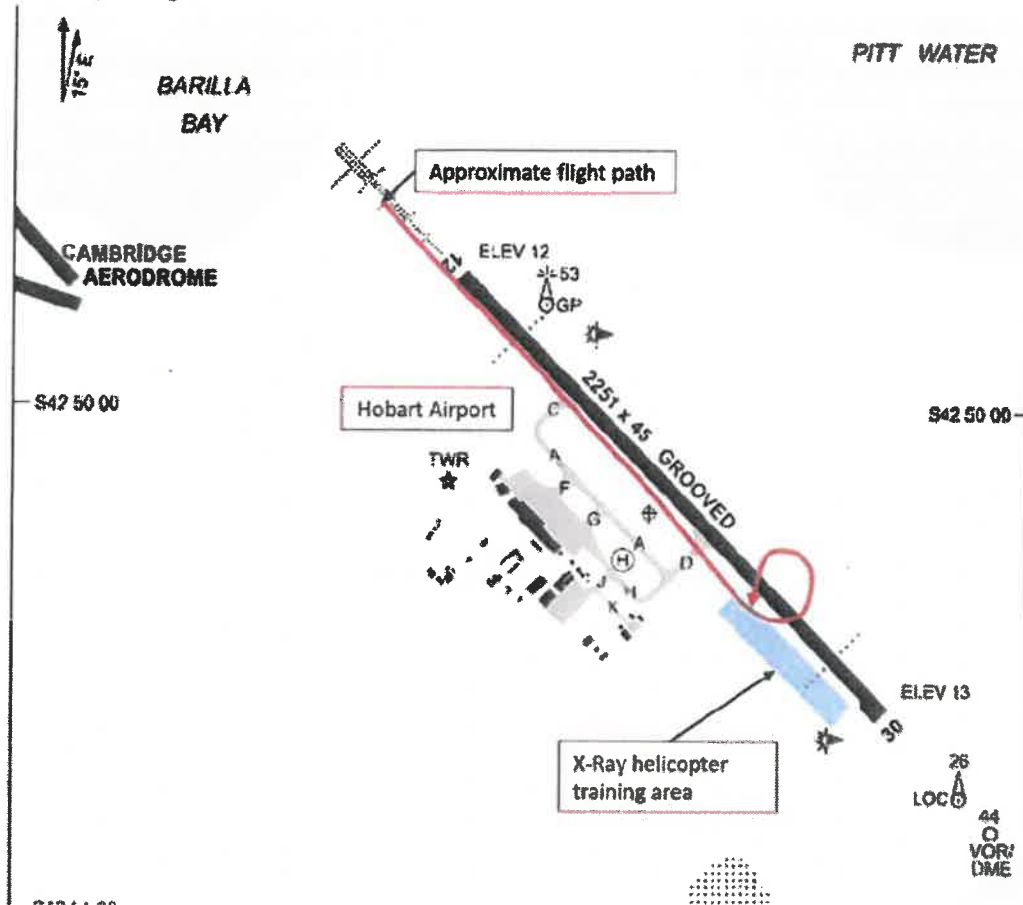
Figure 1: Approximate flight path of the helicopter (not to scale), showing the approach to the X-Ray training area, where the helicopter slowed before making an abrupt left turn and impacting terrain.

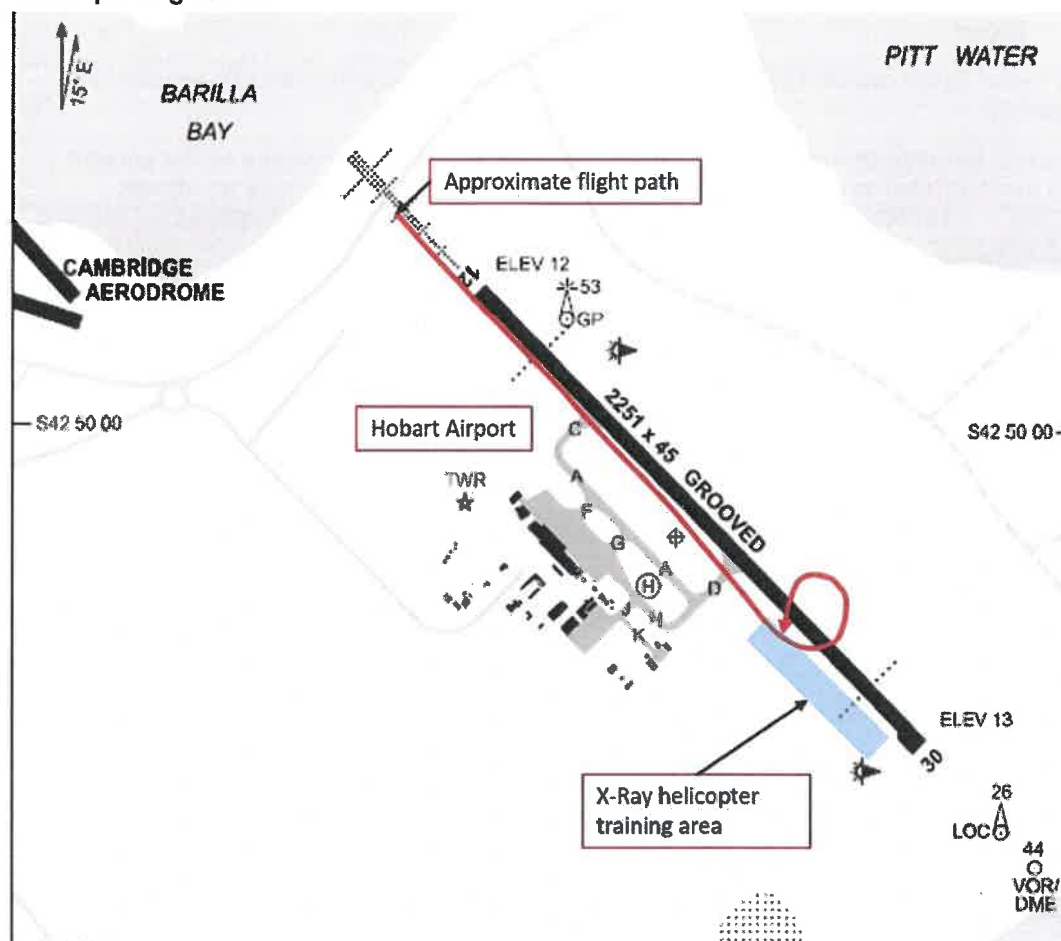
Figure 1: Approximate flight path of the helicopter (not to scale), showing the approach to the X-Ray training area, where the helicopter slowed before making an abrupt left turn and impacting terrain.
