Descent below minimum permitted altitude involving Airbus A319, VH-VCJ

Near Melbourne Airport, Victoria | 15 May 2015

ATSB Transport Safety Report
Aviation Occurrence Investigation
AO-2015-048
Final – 24 November 2017

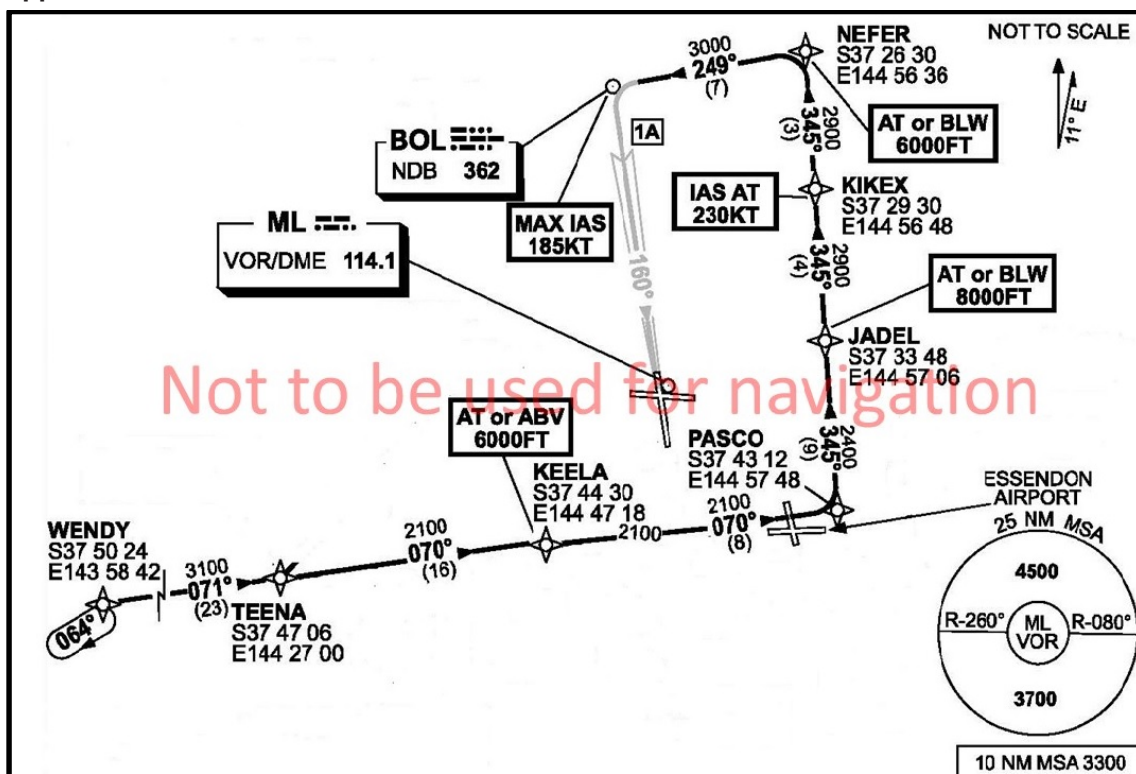
Figure 1: The Wendy 1A standard arrival procedure to Melbourne runway 16 ILS approach

As SND2 approached waypoint KIKEX (Figure 1) at 0134:25, ATC cleared the aircraft to descend to 3,000 ft and for the ILS approach to runway 16. The PF set 3,000 ft into the altitude function of the aircraft's flight control unit (FCU). At that time, the aircraft was passing 5,900 ft at an indicated airspeed of 253 kt.

Approaching waypoint NEFER, at 0135:30 and passing about 4,700 ft, SND2 commenced a left turn towards BOL (Figure 1). At 0136:38 the PF requested, and the PM selected, flap 1. The flaps reached this setting two seconds later. At 0136:39, the aircraft had completed the turn and rolled level on the NEFER to BOL track.

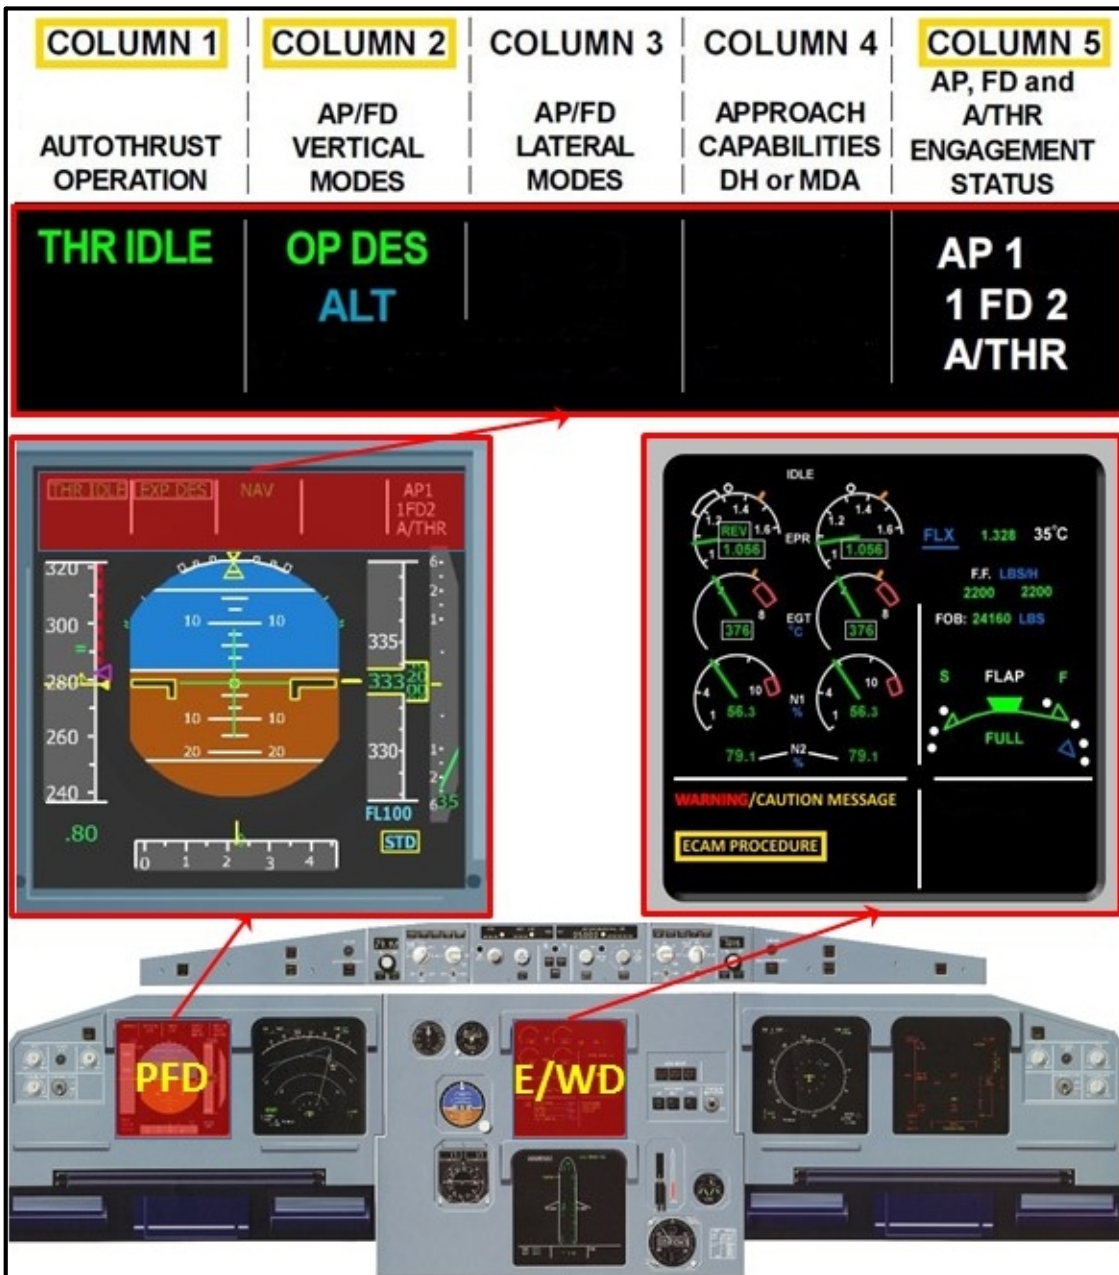
Figure 4: The PFD and E/WS displays expanded, with FMA highlighted

on the vertical mode section of Figure 4), identifying that the autoflight system had captured the 3,000 ft target altitude.

The selection of another managed or selected vertical guidance mode, or the selection of a higher altitude on the FCU, will disengage the expedite mode. The expedite mode will automatically disengage when the FMGS captures the target altitude set in the FCU altitude window. When this occurs, column 2 of the FMA (Figure 4) will display ALT*.

- thrust is frozen and remains locked at the thrust value when the A/THR pushbutton was pressed
- column 1 of the FMA (Figure 4) will display THR LK, flashing, in amber
- the master caution light will flash and the single chime audio alert will sound
- the ECAM caution messages AUTOFLT: A/THR OFF and ENG: THRUST LOCKED will be displayed on the E/WD
- the E/WD will display the procedure THR LEVERS ... MOVE.
