Derailment of MTM train TD1064

Near Rushall Station, Melbourne, Victoria | 6 February 2016

ATSB Transport Safety Report
Rail Occurrence Investigation
RO-2016-002
Final – 16 May 2018

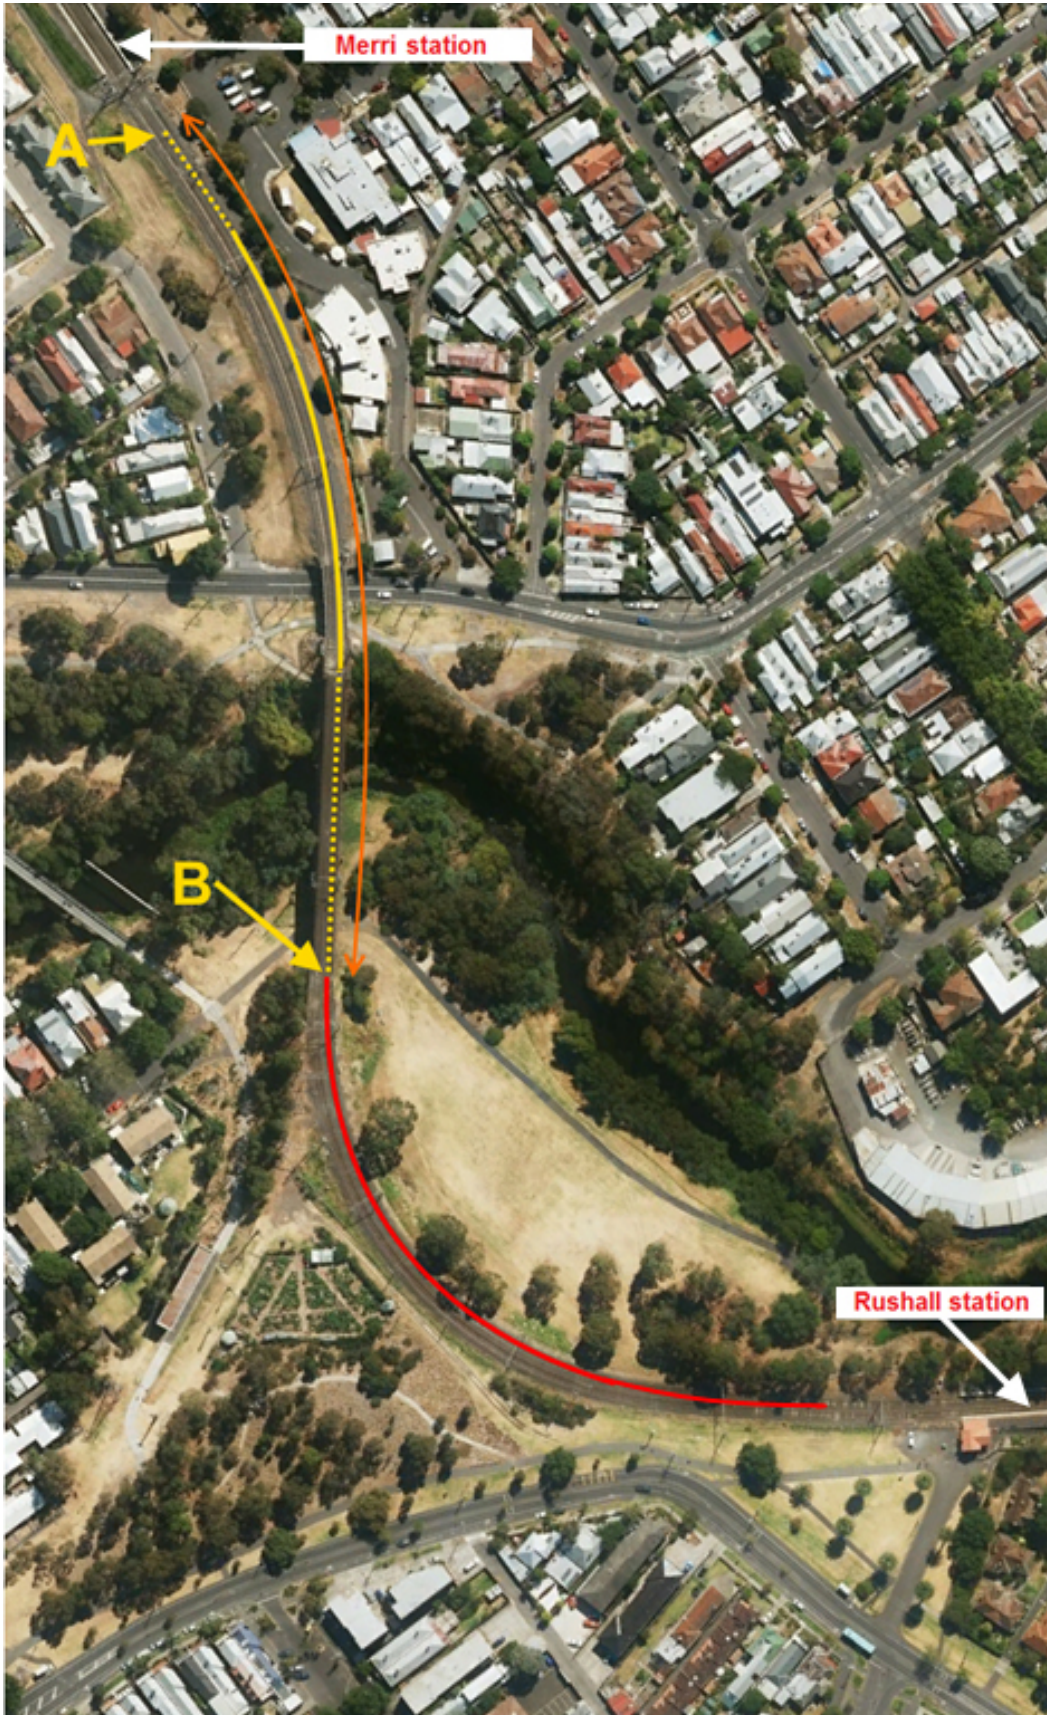
Figure 10: Location of the rail lubricator, identified as point A

Lubrication can be used to reduce friction levels between rail gauge-face and wheel flange. MTM used mechanical rail lubricators (known colloquially as 'grease pots') to dispense grease to the rail gauge-face at certain locations. The rail lubricator intended to service the outside rail of the Rushall curve (travelling towards Melbourne) was located about 20 m past Merri Railway Station and about 330 m before the Rushall curve (Figure 10).

The train was travelling from Merri toward Rushall. Point A represents the position of the rail lubricator on the Up (Melbourne-bound) track, and point B depicts the start of the 118 m curve (the target curve for lubrication) in red. The yellow dotted line represents tangent track and the yellow solid line is the intervening curve. The distance from A to B (orange) was about 330 m.
 Source: Google Earth, annotated by the Chief Investigator, Transport Safety (Vic)

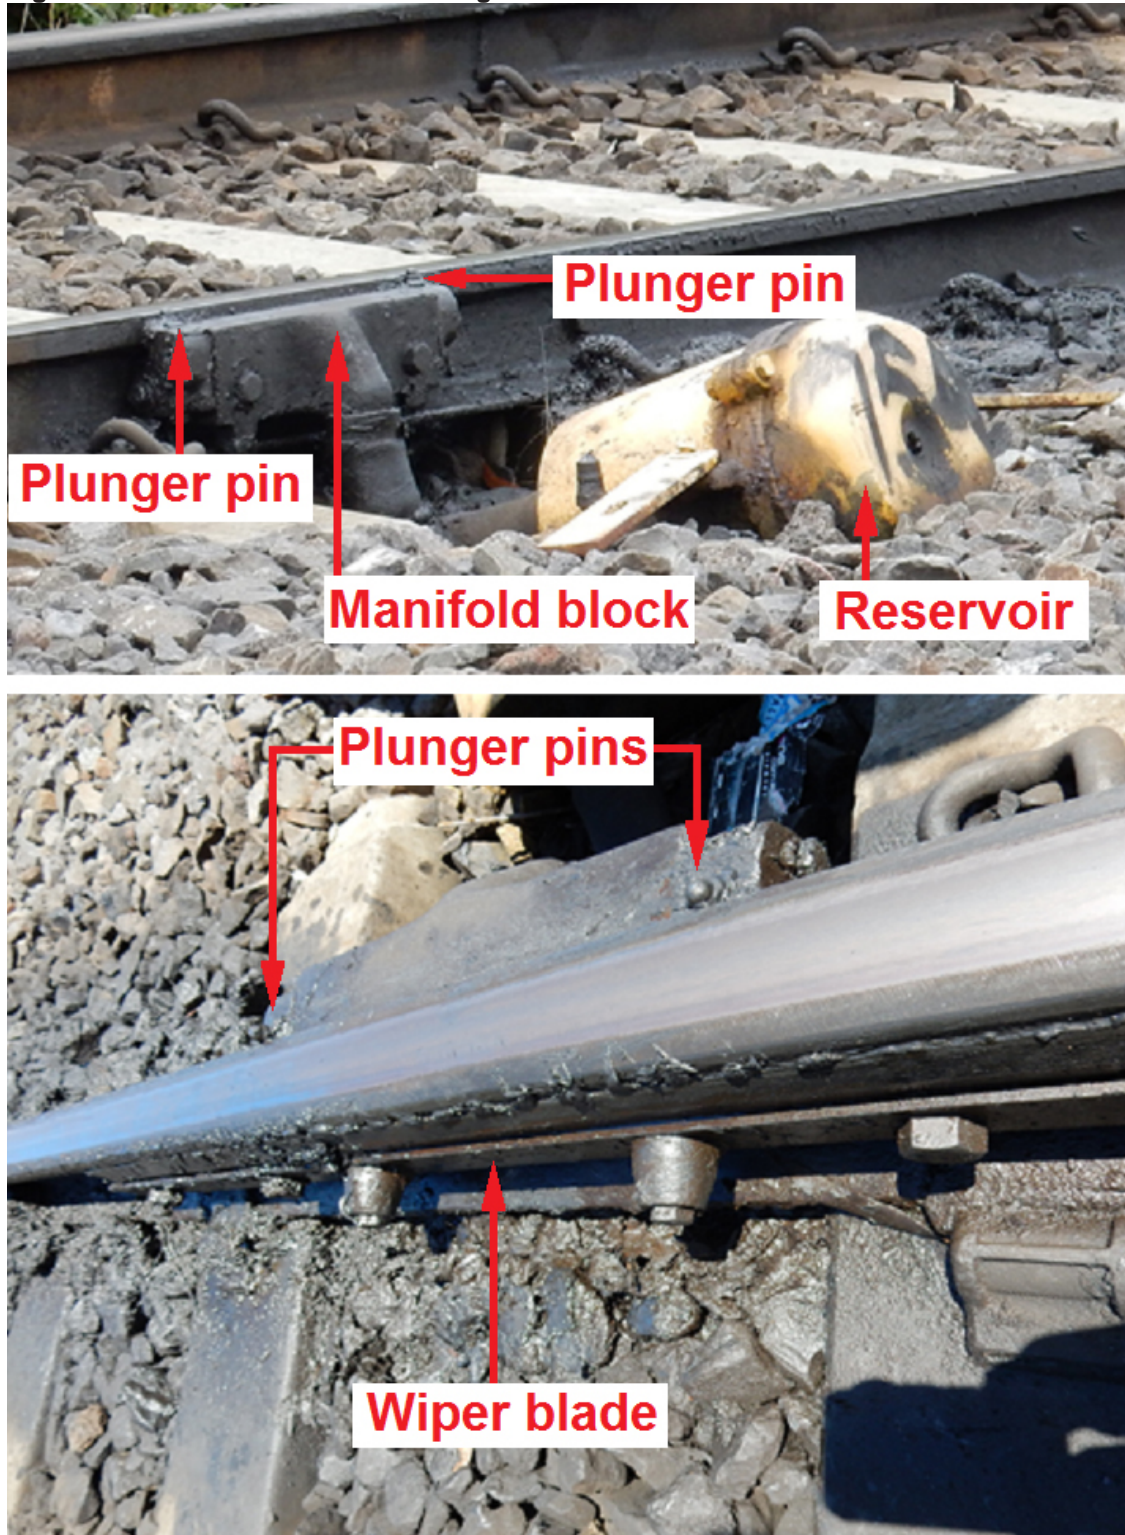
Figure 11: The rail lubricator servicing the outside rail of the Rushall curve

The lubricator ahead of the Rushall curve was typical of that used on the Melbourne Metropolitan network (Figure 11). A spring-loaded piston within the lubricator reservoir pressurises the grease. When two lubricator plunger pins (integral to the manifold block) are actuated by a passing wheel tread, grease is pumped from the manifold block to a dispensing ‘wiper’ blade attached to the gauge-face of the rail. From here grease is picked up by wheel flanges (assuming effective flange contact with the rail head) and distributed along the gauge-face.

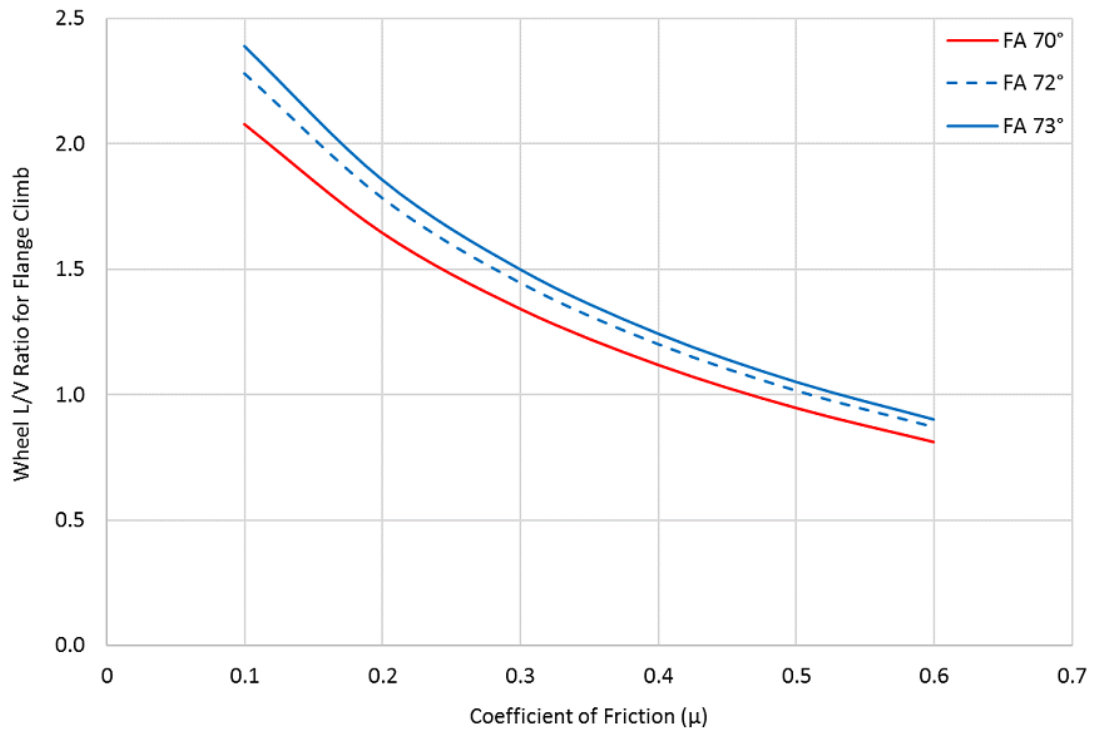
Figure 17: L-on-V ratio for flange climb, for a range of flange angles (FA)

The current MP2 wheel profile has been in service on the Melbourne network for more than 20 years, with no known reported issues. The MP2 wheel flange angle of 70 degrees (to the horizontal) provides good protection against flange-climb, particularly when combined with effective rail lubrication in sharp curves. As the MP2 wheels wear, the flange angle increases to around 72 degrees, which improves protection against flange climb (Figure 17).

*The figure shows the effect of flange angle on the relationship between the L/V ratio required for flange climb and contact coefficient of friction. The MP2 wheel profile in a new or newly-machined condition represents the worst case in terms of flange-climb risk, with a flange angle of 70°. As this profile wears, the flange angle increases to an average of around 72° (matching the typical gauge-face profile), with an upper level of around 73°, and the potential for flange-climb reduces.
Source: Institute of Railway Technology (Monash University)*

The wheels of derailed car 1305T had been re-machined to the MP2 wheel profile the day before the derailment and had only run over a distance of 79 km. Although the MP2 profile provided good protection against flange-climb, the flange angle of the newly-machined wheels increased the risk of flange-climb compared to wheels that were in a worn condition.

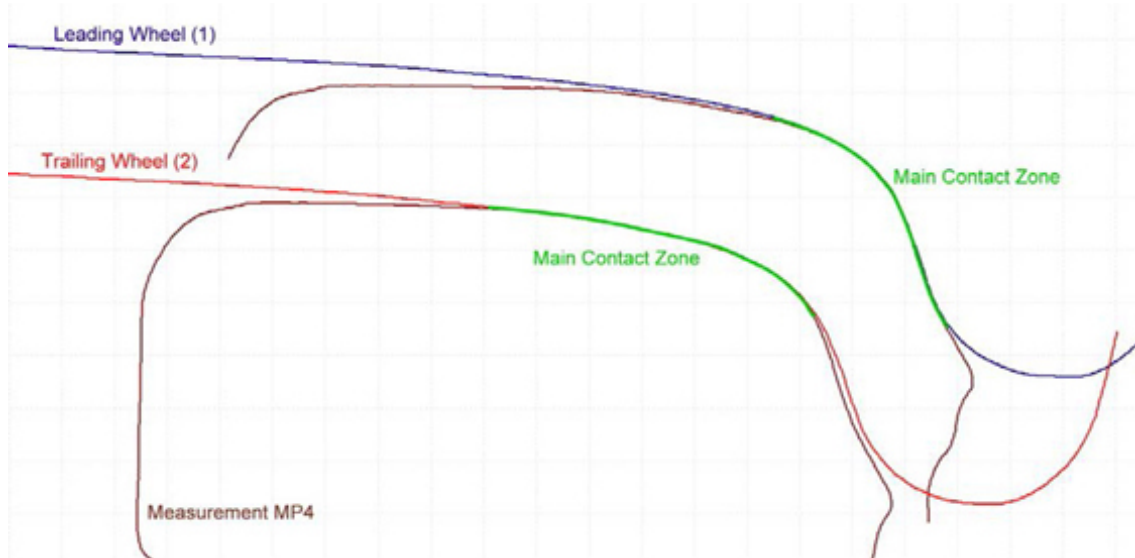
Figure 18: Wheel - rail profile overlay for the right-hand wheels of the derailed bogie

An overlay of wheel and rail profiles (Figure 18) showed no significant abnormality and rail contact conditions were generally consistent with expectations. Comparison between this overlay and a worn wheel-to-rail overlay found that the newly-machined wheel rode slightly higher on the rail.

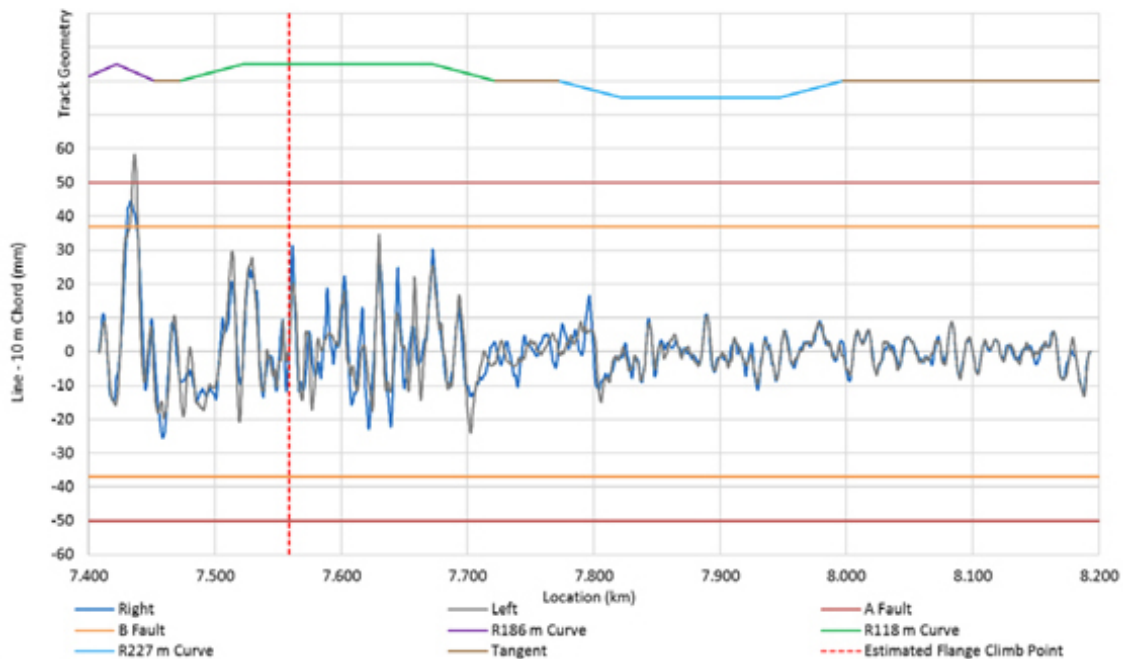
Figure 22: Track 'line' through the Rushall curve measured following the derailment

The track geometry recorded after the derailment showed several peaks (positive) and troughs (negative) in rail line deviation (Figure 22). In the area of the derailment, all peaks and troughs were below the 40 km/h 'B' Fault criteria. The series of peaks leading to the PoFC are consistent with the joint spacing.

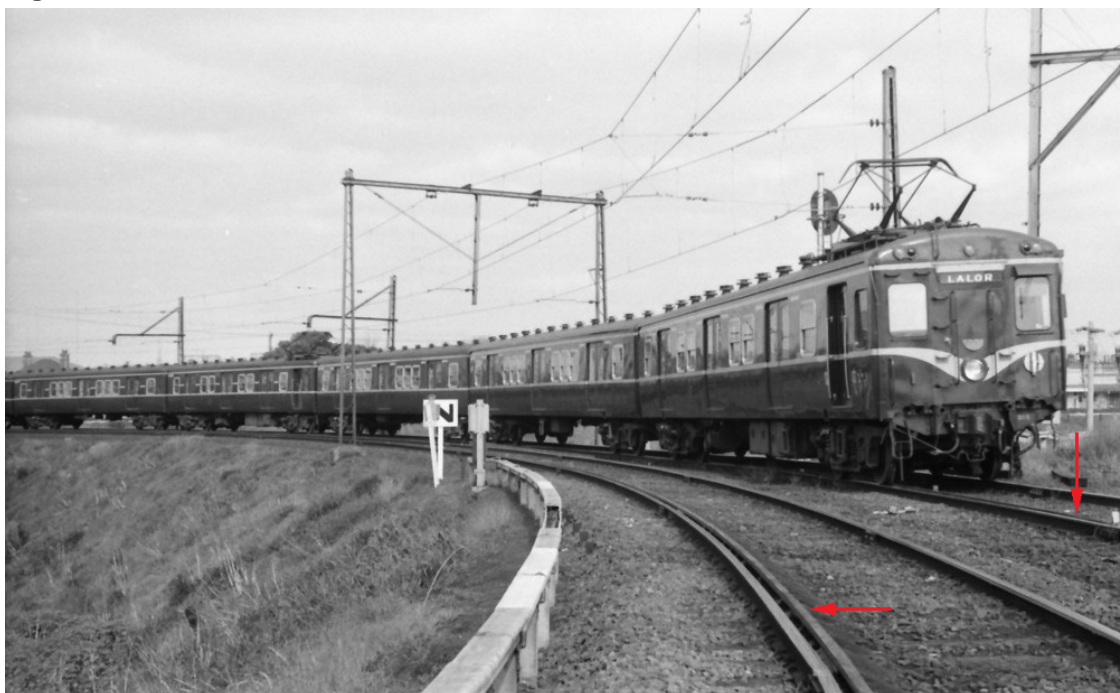
Figure 29: Historical use of check rails on Rushall curve c1965.

Check rails have long been a common global track engineering feature, although their use in Australia has diminished. Check rails were previously used on the Melbourne metropolitan rail network until their general use was discontinued at some point during the 1960s. Check rails had previously been installed on the Up and Down Rushall curves (Figure 29).

The red arrows show check rails on both Up and Down tracks. The left-hand track in this image is the derailment curve.
 Source: Bob Wilson, annotated by the Chief Investigator Transport Safety (Vic)
