DEPARTMENT OF CIVIL AVIATION

AVIATION
SAFETY DIGEST

No. 6

JUNE, 1956

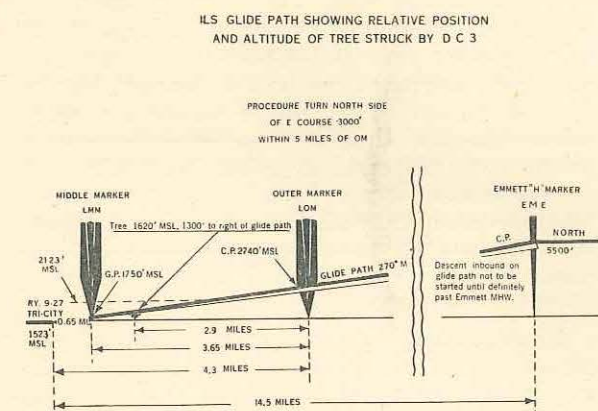
It is evident that his ILS approach was not made in accordance with the company's flight manual and the chief pilot's instructions. Both passages over the outer marker inbound were higher than the glide path interception altitude. The procedure turn outbound was 1,500 feet above the specified minimum altitude and this altitude was maintained inbound to the outer marker. The 360-degree right descending turn to 3,200 feet MSL at the outer marker did not allow sufficient time or distance to establish a stabilized course or air speed for the final approach. The second attempt to intercept the glide path was too high; therefore, the corrective action by the captain should have been to execute a missed approach procedure, or, after advising approach control, to proceed outbound again on the localizer course a sufficient distance to make his procedure turn and return inbound descending to the specified altitude. It seems probable that with the aircraft over the outer marker a nearly 500 feet above the glide path the descent was steepened in an attempt to get on the glide path and the aircraft went through and below the glide path before the "pull-up" was made. According to the captain contact with the top of the tree occurred within 30 seconds after he had started his missed approach. The tree which was struck is 2.9 miles west of the outer marker and 1,300 feet to the right of the localizer course and 319 feet below the glide path. If the captain had maintained a constant air speed of 120 m.p.h. and a constant descent of not more than 535 feet per minute after passing the outer marker inbound, according to his testimony he would have been several hundred feet above the top of the tree and above the glide path. It is obvious, considering that the point of impact was 1,300 feet to the right of the localizer course, that the aircraft had deviated seriously from the intended course.

The Board determined that the probable cause of the accident was the action of the pilot in not following the approved procedures for an ILS approach, which resulted in the aircraft striking a tree.
