Commonwealth of Australia

# AVIATION SAFETY DIGEST

No. 11  
SEPTEMBER 1957

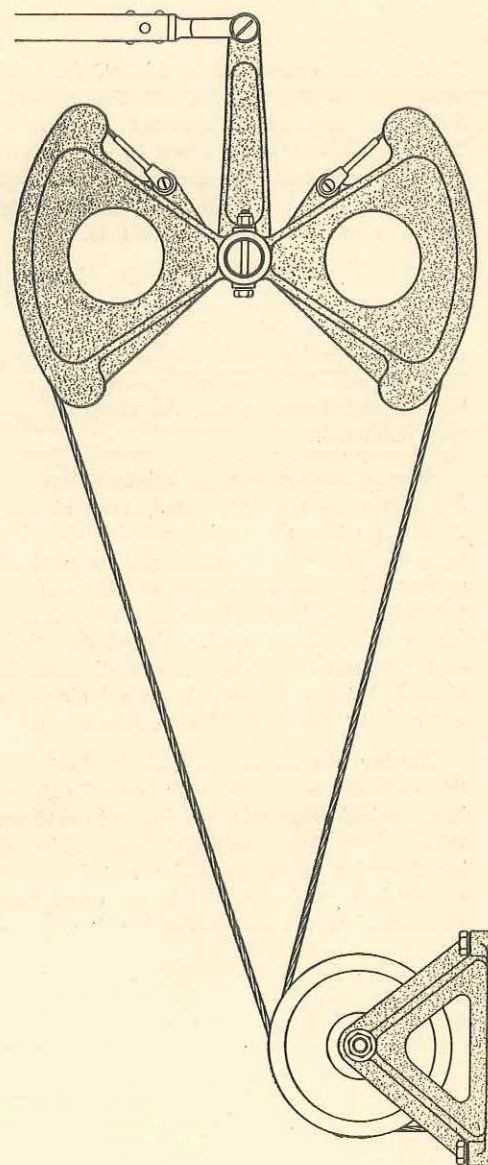
Note: Some aircraft engineers are likely to consider cross-connected cables as being an "elementary", and therefore insignificant design detail. That this is an erroneous assumption is proved by the records of repeated accidents due to this cause. It is definitely an engineering responsibility to prevent repetition of such occurrences.

\*\* Murphy's Law: "If an aircraft part can be installed incorrectly, someone will install it that way."
