DIGEST

No. 27, SEPT., 1961

DEPARTMENT OF CIVIL AVIATION

Prepared in the Division of Air Safety Investigation
Department of Civil Aviation.

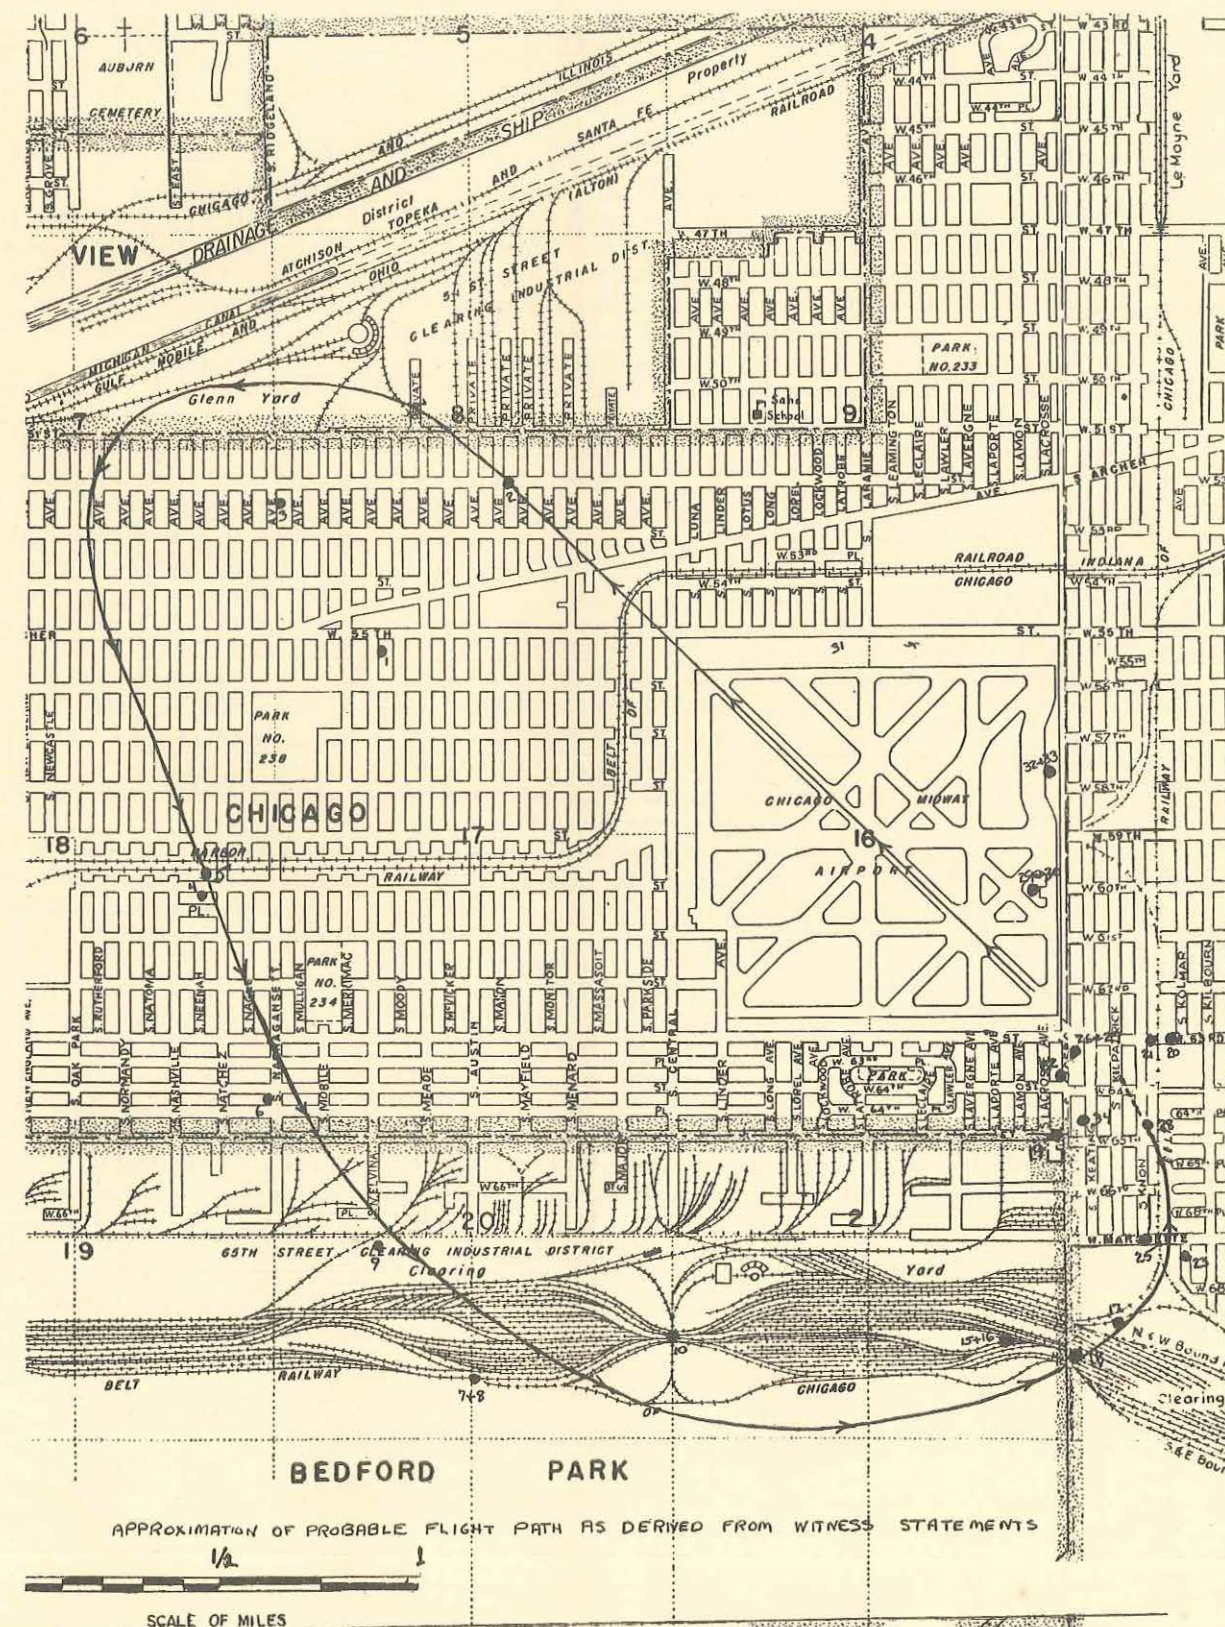
Precautionary Landing

Examination further revealed the No. 2 engine had been shut down and its propeller feathered. There was no evidence of any in-flight fire; however, the fire extinguisher had been activated in the No. 2 engine. The ground fire and impact damage precluded any testing of the fire warning system serving the No. 2 engine. Engines No. 1, 3 and 4 appeared to be in good condition apart from impact damage.
