AVIATION SAFETY

DIGEST

No. 34, JUNE, 1963

DEPARTMENT OF CIVIL AVIATION

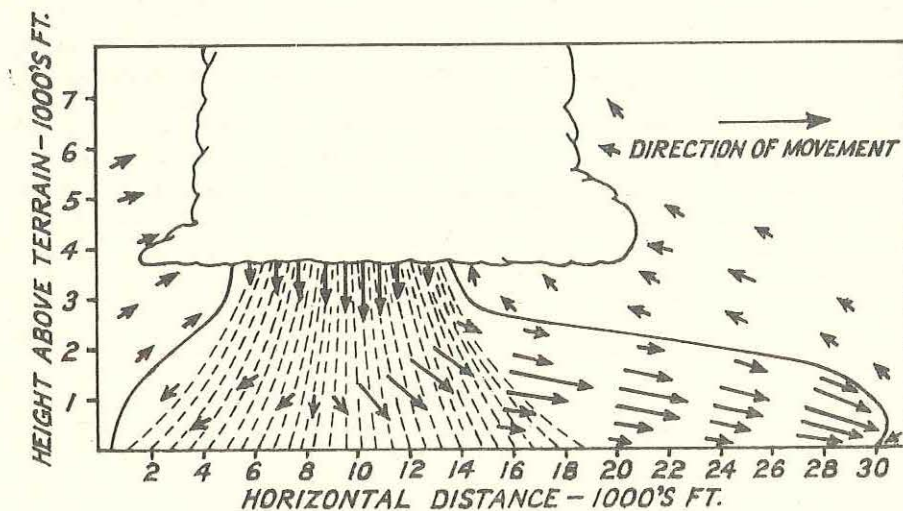
Mustang Destroyed in Dandenong Ranges

At 1018 hours Eastern Standard Time, on 12th April, 1962, a British registered Mustang aircraft departed Moorabbin Aerodrome, Victoria, for Bankstown Aerodrome, New South Wales. The only occupant of the aircraft was the pilot whose intention it was to fly to Bankstown for the purpose of having some items of radio and navigation equipment serviced. Six minutes after departure the pilot advised Air Traffic Control that he was returning to Moorabbin because he was unable to proceed in conformity with the visual flight rules. Three minutes later again, he advised that he was having trouble and was flying in cloud at 3,000 feet. Air Traffic Control requested the pilot to maintain 3,000 feet and to home on the Moorabbin N.D.B. but soon after this request, the aircraft was seen to emerge from low cloud in the vicinity of Kallista and strike trees and the ground in a steep dive. The aircraft was destroyed by impact forces and the pilot was killed.
