# AVIATION SAFETY

# DIGEST

No. 35, SEP., 1963

Prepared in the Division of Air Safety Investigation,  
Department of Civil Aviation.

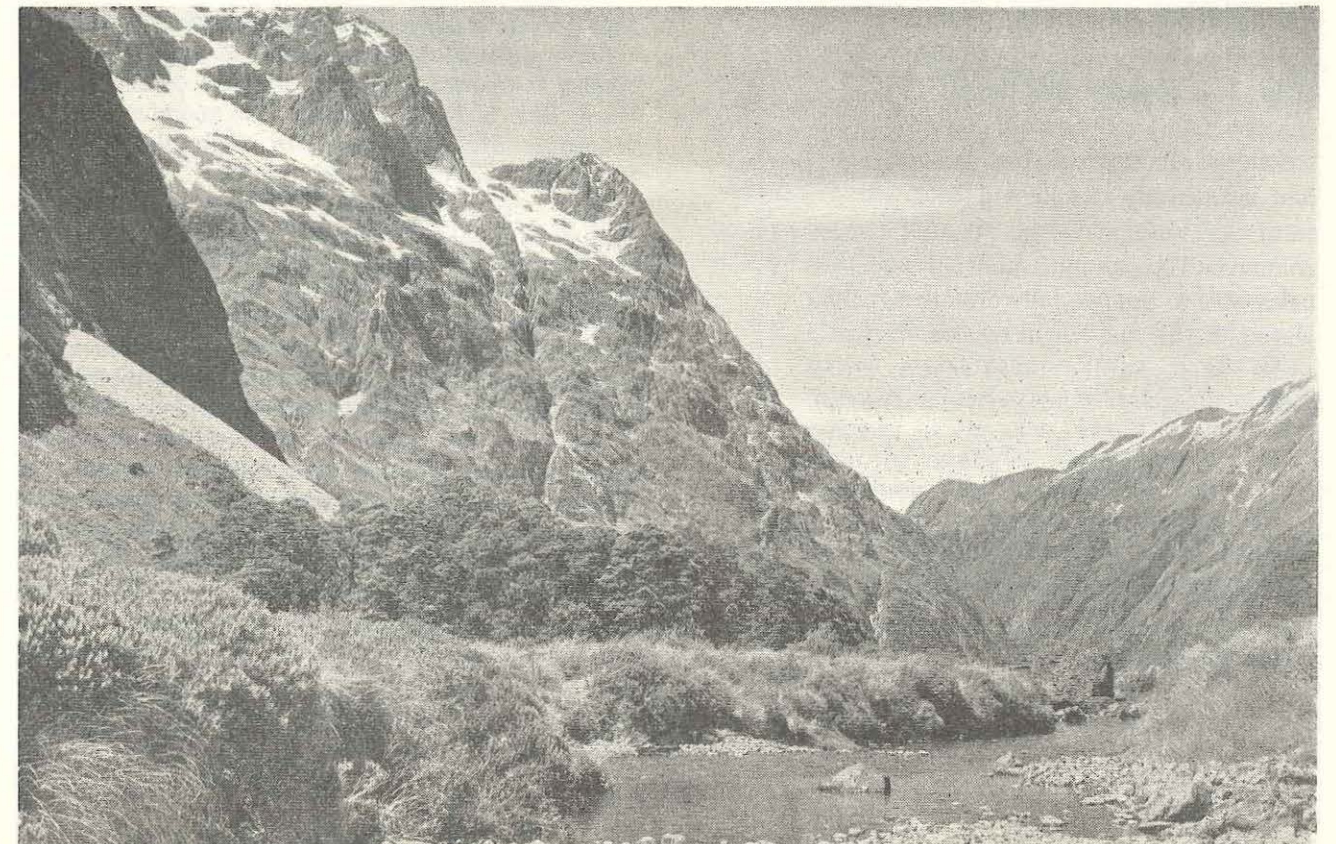
*This scene does not depict the accident site but as it is taken in the area, it will convey to the reader an idea of the terrain in the vicinity of the accident.*
