AVIATION SAFETY

DIGEST

No. 38, JUNE 1964

DEPARTMENT OF CIVIL AVIATION

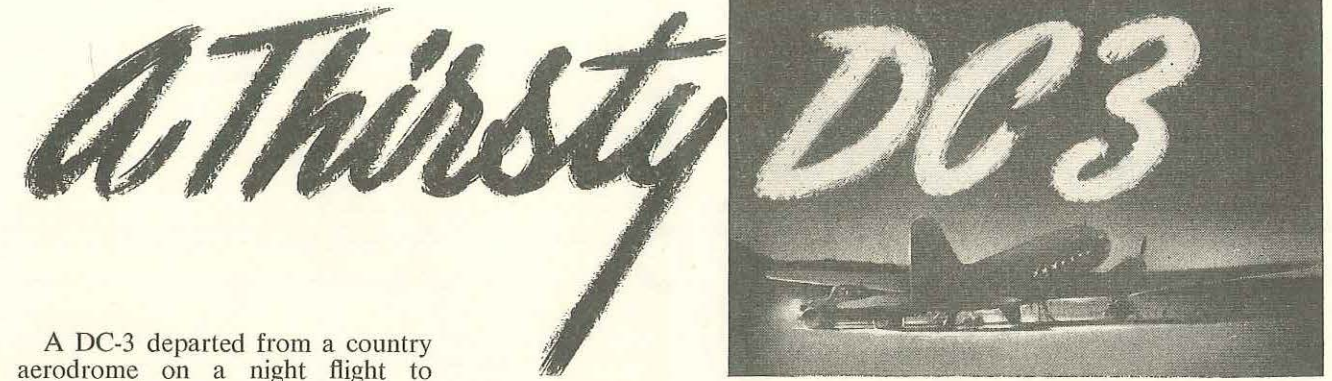
A DC-3 departed from a country aerodrome on a night flight to Sydney with adequate reserves of fuel. When the aircraft reached cruising level, both engines were selected to the port auxiliary tank which contained sufficient fuel for at least one hour's operation at the two engine consumption rate. Although it was then noticed that the two main tank fuel gauges were indicating a slightly assymmetric fuel distribution, the readings appeared to be quite consistent with the fuel gauge inaccuracies experienced on this type of aircraft, and no abnormality was suspected.

Investigation in Sydney revealed that the aircraft had used approximately 140 gallons during the 53 minute flight from Bathurst. This, when related to the normal fuel consumption of the aircraft for the same flying time, showed an excess fuel usage of 123 per cent. The high rate of consumption was traced to a leak in the supply line between the fuel pump and the carburettor. This leak had allowed fuel to be discharged under pressure into the nacelle area between the engine "dish pan" and the fire-wall and it thus constituted an extremely serious fire hazard.

The leak in the three-quarter diameter stainless steel fuel pipe line was found to have been caused by prolonged chafing of the line against the rear crankcase vent pipe. In view of the thickness of the fuel line the chafing had probably been taking place from the time the engine was installed in the aircraft 1025 flying hours before.
