AVIATION SAFETY DIGEST

DEPARTMENT OF CIVIL AVIATION

Prepared in the Air Safety Investigation Branch,
Department of Civil Aviation, Commonwealth of Australia.

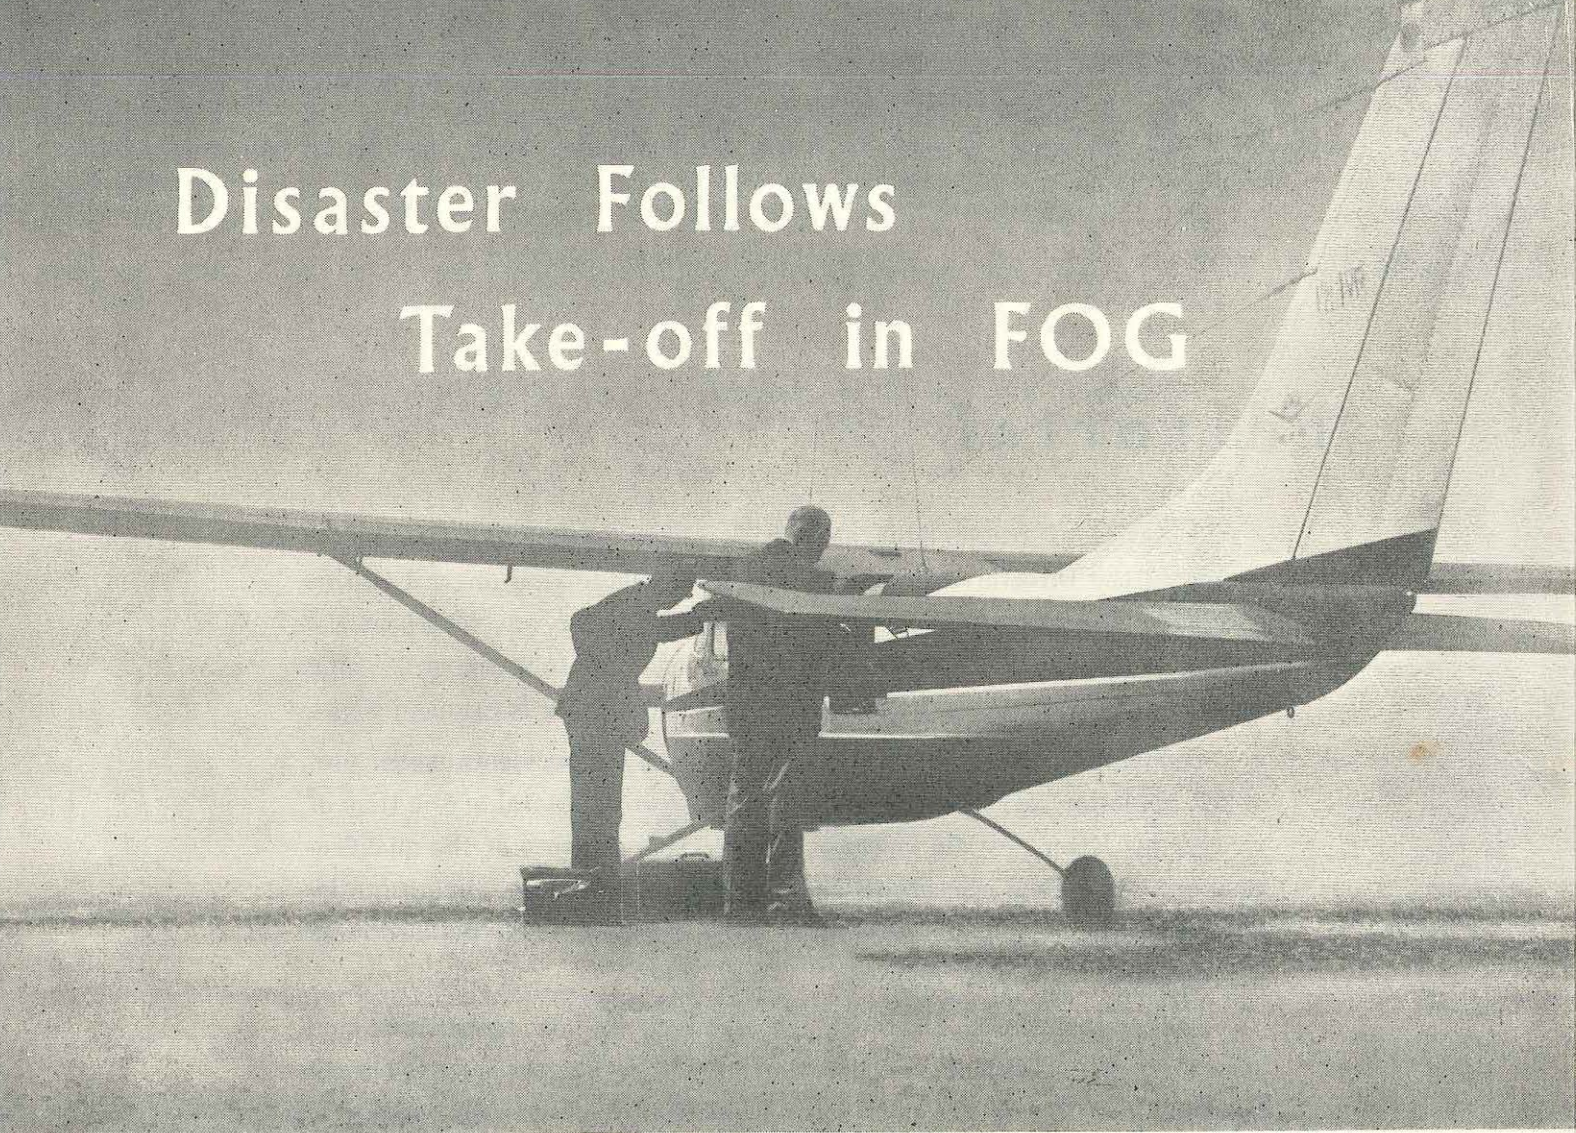
The aircraft had taken off from the parking area into the south-west and the wreckage was found three-quarters of a mile beyond the river, almost in line with the direction of NE-SW runway. Examination of the wreckage and the spindly trees among which the crash occurred, clearly showed that the aircraft had dived almost vertically into the ground at high speed. The propeller hub was buried 15 inches in the ground, and the entire cabin area and the mainplanes had been crushed and telescoped. Only the tail assembly and the section of the fuselage aft of the luggage compartment remained substantially intact, though badly buckled in places. The damage to the engine and flying controls was so severe that it was impossible to determine their settings before the crash, but no evidence was found of any failure that was not the result of impact forces. The

The accident occurred simply because the pilot deliberately placed himself in a situation which demanded instrument flying ability beyond his capacity. It is sobering to reflect that the worst conditions in which any aircraft is permitted to take off are those specified as the minima for IFR flights in multi-engined turbo-jet aircraft departing from airports equipped with radio navigational aids. The *minimum* runway visibility in such operations is 800 yards—conditions vastly better than the estimated 100 feet visibility that existed at Burketown.

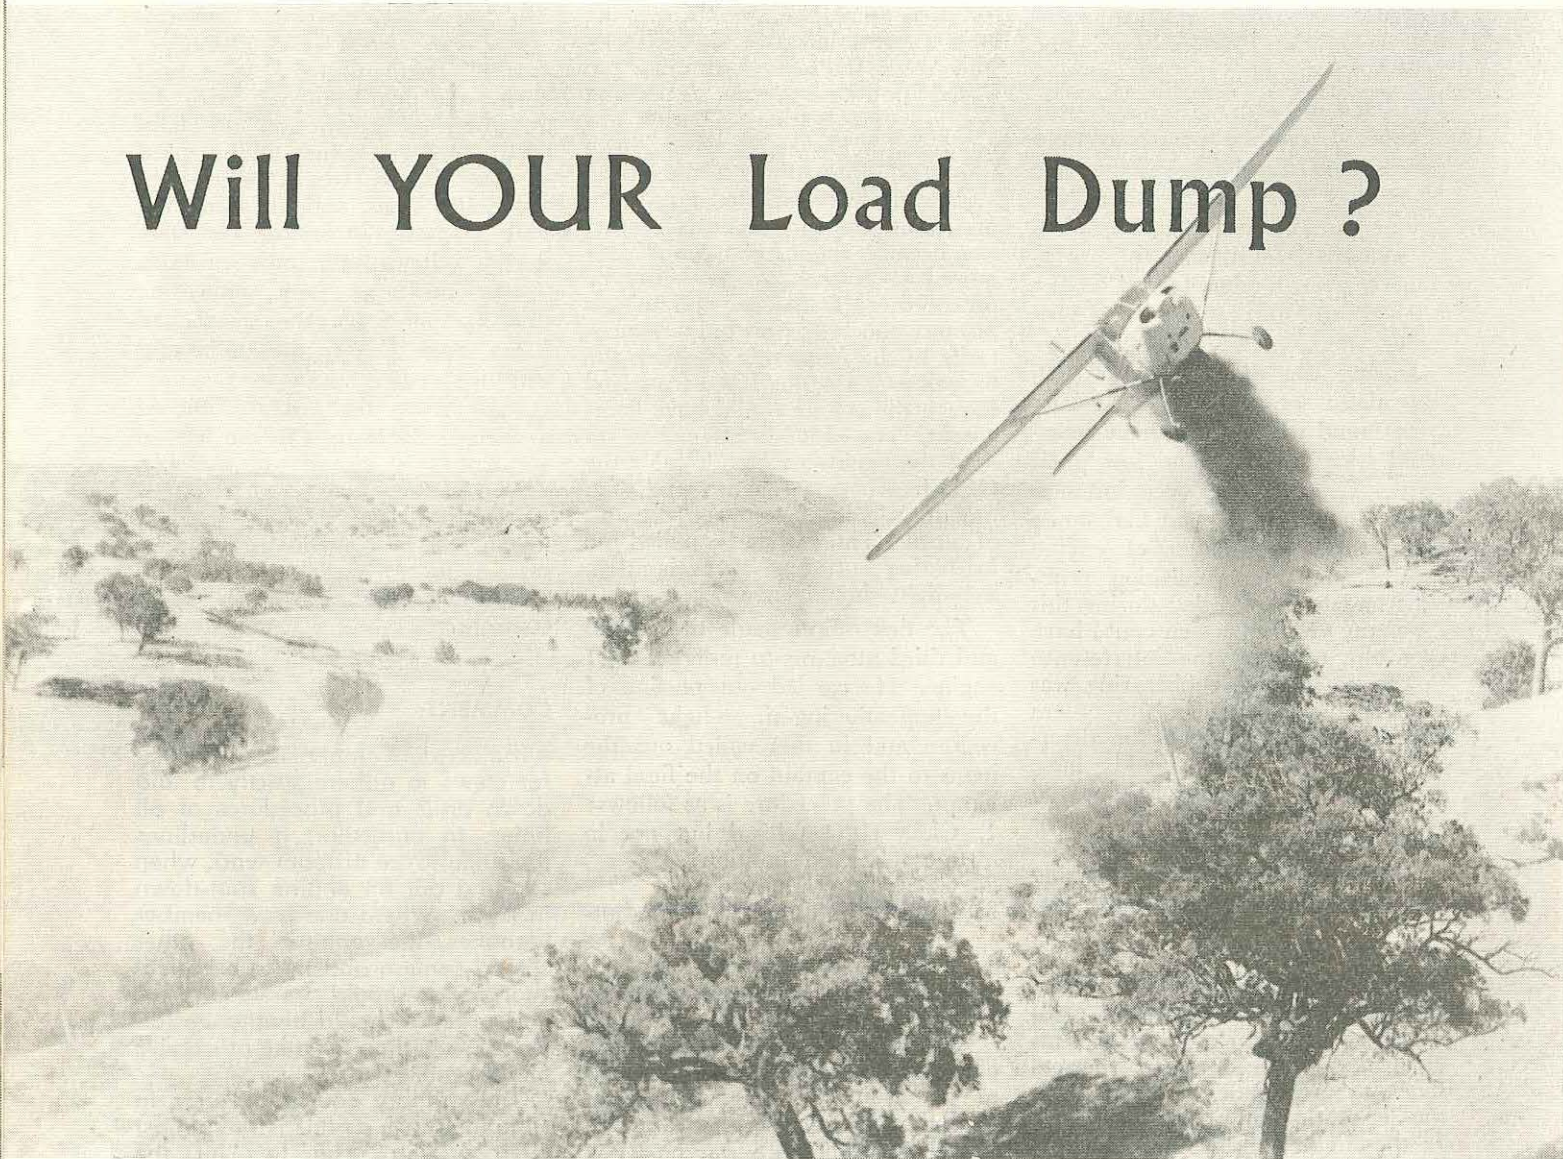
A large piece of reinforced packing paper was found in the wreckage associated with the base of the hopper and the louvers. This had probably prevented the dumping of the load. It was also probable that it had prevented the hopper from discharging fully on the previous flight, with the result that the aircraft could have been overloaded for the second flight. Numerous other pieces of packing paper were found in the bulk super-phosphate heap at the airstrip. The fertilizer had been transported in rail trucks lined with the paper and pieces had apparently been torn out when the trucks were being unloaded.

This is not considered to be a situation warranting mandatory procedures, but it would certainly seem that all agricultural operators and pilots should be conscious of the hazard and should implement preventative measures which ensure that the safety of their operations is not prejudiced.
