AVIATION SAFETY DIGEST

DEPARTMENT OF CIVIL AVIATION

No. 43

SEPTEMBER, 1965

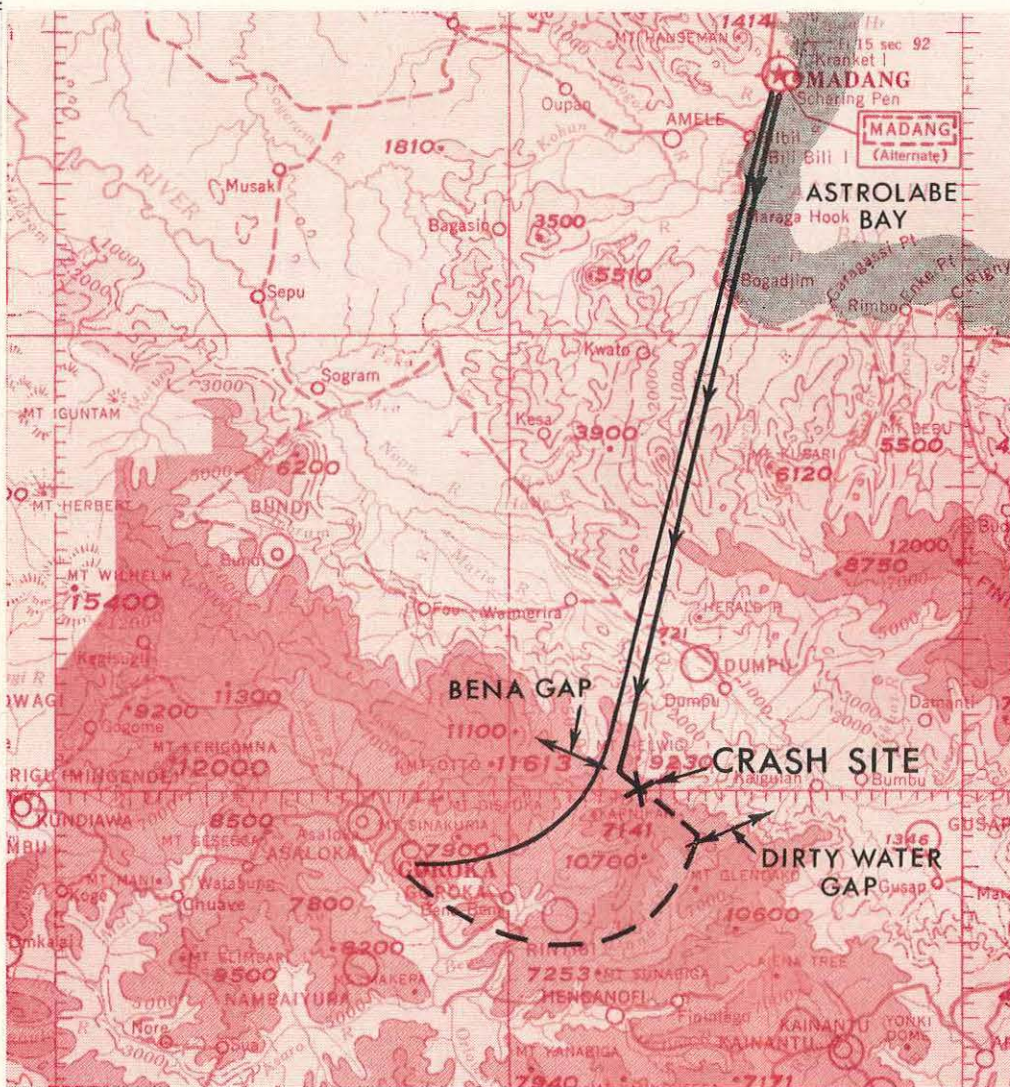
MADANG - GOROKA AREA

Pilots flying the Madang-Goroka route sometimes use the Dirty Water Gap as an alternative route into the Goroka Valley when all other gaps are closed. In this case, because cloud conditions prevented his entry to the Bena Gap, the pilot had evidently followed this practice and turned towards the Dirty Water Gap,

which, in this type of aircraft, is a flight of less than five minutes. No Mayday calls were received from the aircraft before the crash and its final flight path indicated that it had flown into the mountainside in level flight with normal engine power settings. It is therefore reasonable to assume that the accident was not caused by a loss of control while in cloud. Rather, it is probable that the accident occurred when the pilot intentionally flew into cloud believing that he was approaching, or had arrived at the Dirty Water Gap and that visual conditions would be encountered in the Dirty Water Valley.

SHOWING ACTUAL AND PROPOSED FLIGHT PATHS

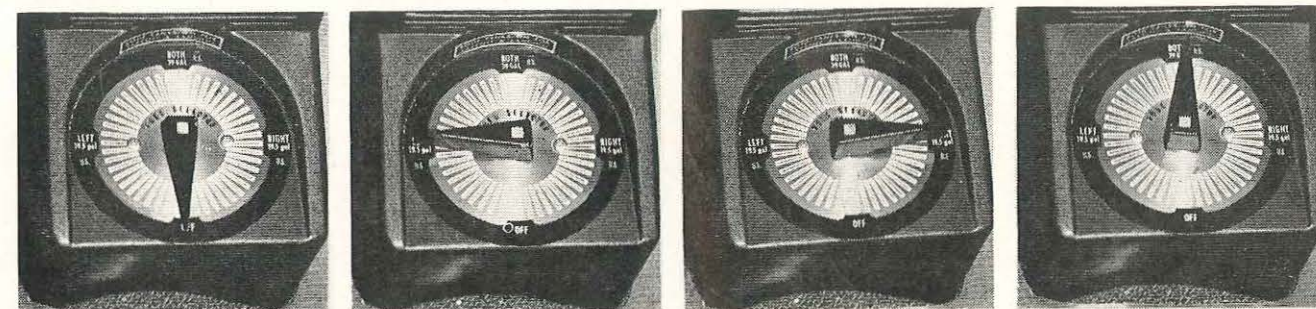
The pilot had been trained and had done most of his previous flying in Cessna 150 and 172 aircraft and was familiar with the four-position fuel selector, installed in these Cessna types (see Figure 1). The four-position selector in the Beechcraft Musketeer at first glance appears to be similar in operation to the Cessna fitting, but in fact functions in the reverse sense. It also differs in having no "Both" position, two of the four positions being "Off" positions (see Fig-

Fig. 1: Cessna fuel selector positions: (a) Fuel Off. (b) Port Tank Selected. (c) Starboard Tank Selected. (d) Both Tanks Selected.

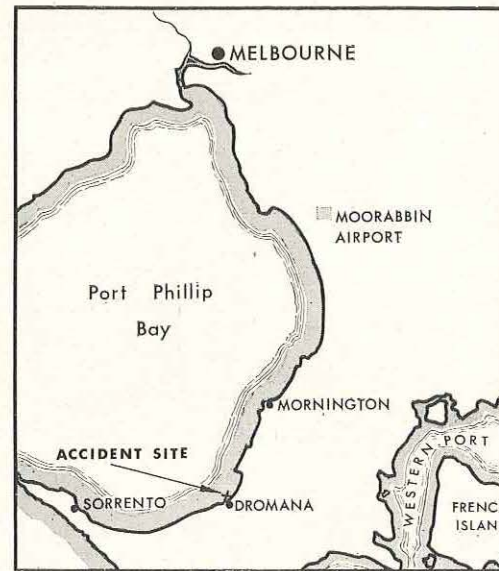
The damage to the aircraft showed that it had struck the water at a moderate to high speed while in a slightly nose down attitude with the wings almost horizontal and with some degree of skid to starboard. The virtually undamaged propeller was consistent with the pilot's evidence that he had closed the throttle before impact. A thorough examination of

the aircraft indicated that it was fully serviceable at the time of the crash.
